Niewydolność mięśnia sercowego

Heart failure

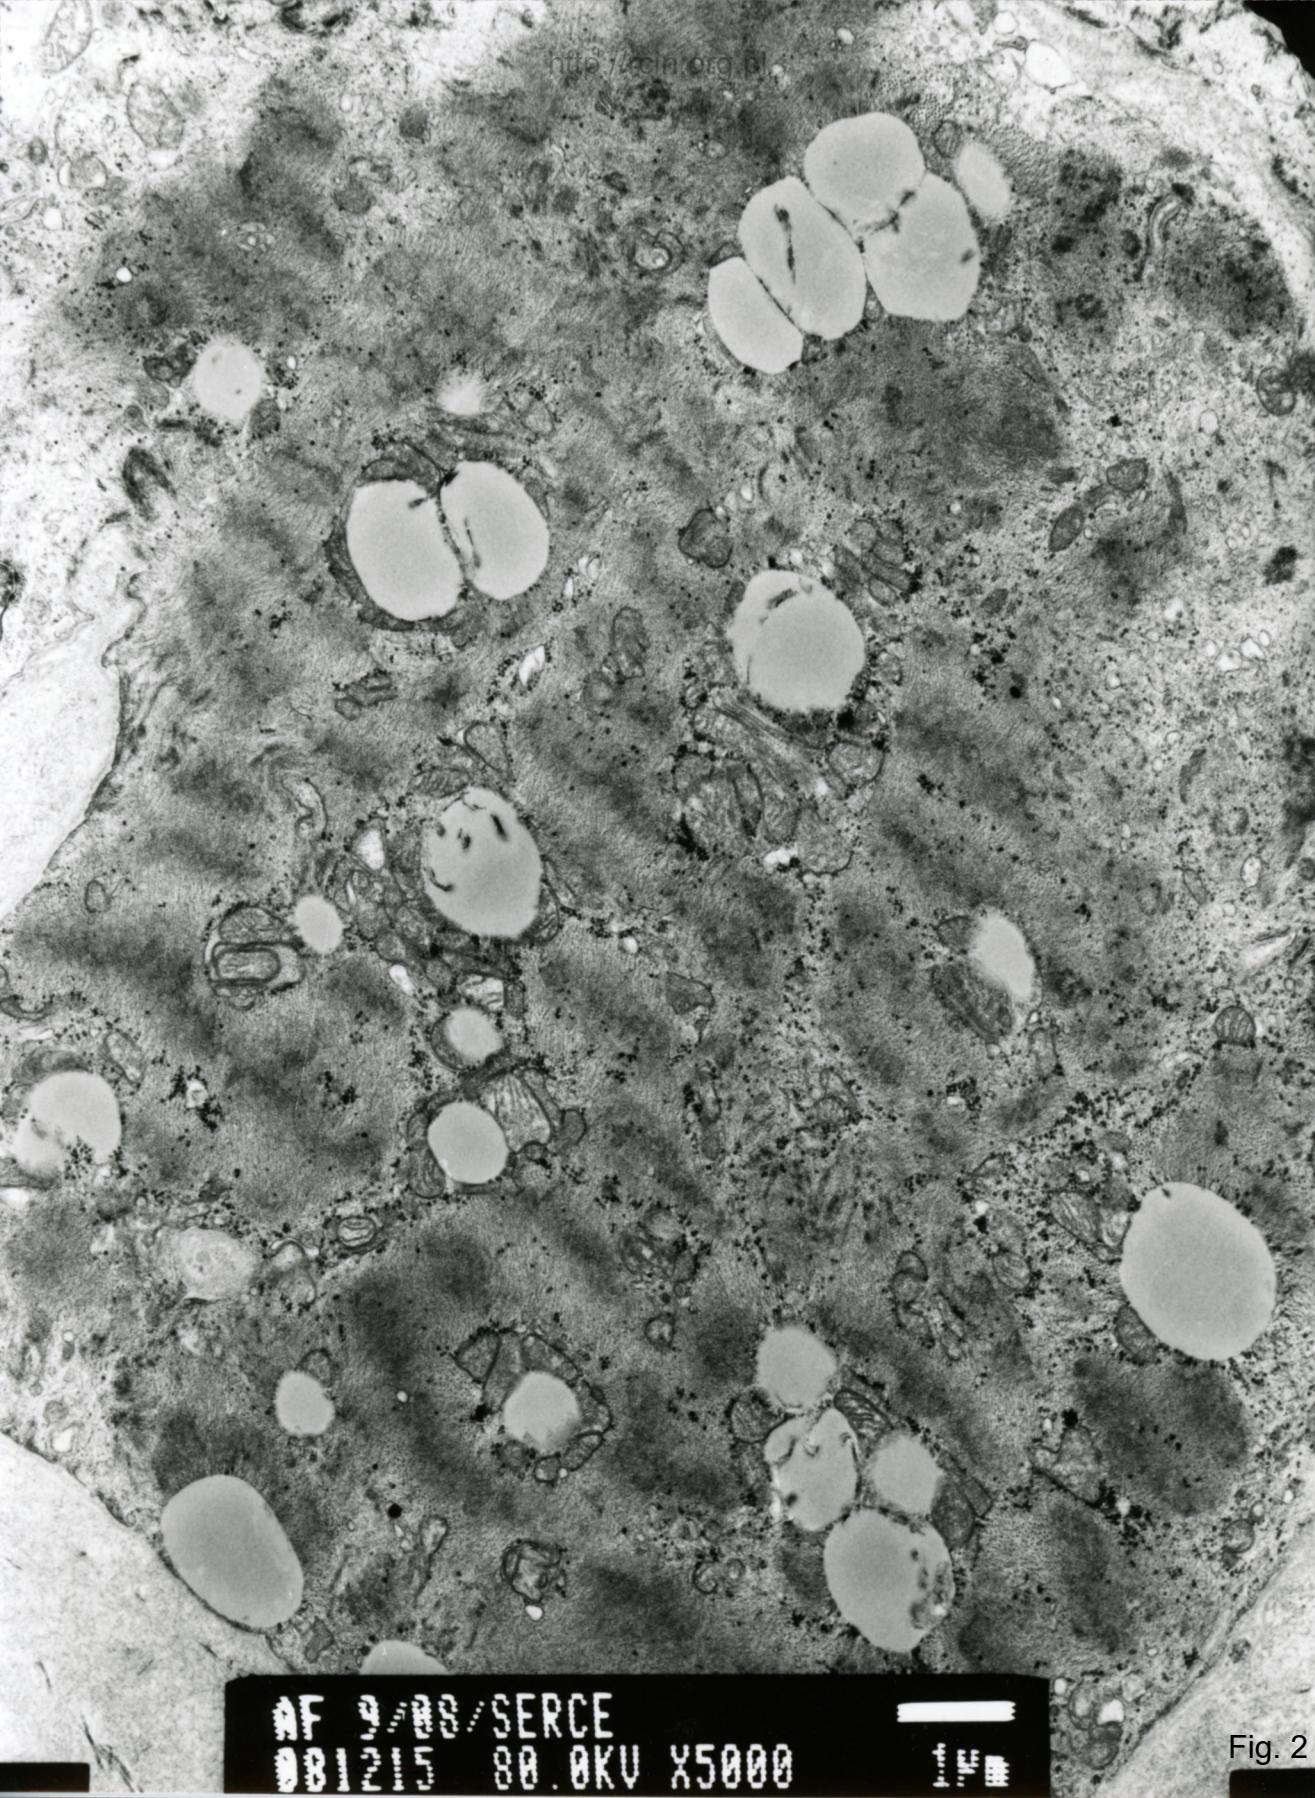
Fig. 1

AF 9/88/SERCE/
BBB735 80.0KV X7500

Analiza ultrastrukturalna wykazała nieprawidłowości w budowie morfologicznej kardiomiocytów. W licznych komórkach obserwowano zmiany w strukturze sarkomerów. Miofibryle charakteryzowały się nieregularnym przebiegiem. Cytoplazmę kardiomiocytów wypełniały licznie mitochondria i struktury wakuolarne (Fig. 1). Oprócz mitochondriów w cytoplazmie kardiomiocytów obecne były liczne krople lipidów (Fig. 2,3). W większości komórek obserwowano liczne skupiska ziaren glikogenu otoczonych błoną (Fig. 4,5,6,7). W obrębie skupisk glikogenu często obserwowano wakuole autofagalne (Fig. 8, 9, 10). Jądra kardiomiocytów charakteryzowały się nieregularnym kształtem (Fig. 11).

Ultrastructural analysis revealed abnormalities in the morphological structure of the cardiomyocytes. In many cardiomyocytes changes in the structure of the sarcomeres were observed. The course of myofibrils was irregular. The cytoplasm of cardiomyocytes was filled with numerous mitochondria and vacuolar structures (Fig. 1). Except mitochondria, numerous fat droplets were present in the cytoplasm of cardiomyocytes (Figs. 2,3). In most cells, frequently clusters of membrane-surrounded glycogen granules were seen (Figs. 4,5,6,7). Within glycogen clusters, autophagous vacuoles were often observed (Figs. 8, 9, 10). Cardiomyocytes nuclei were irregularly shaped (Fig. 11).
