38/10 biopsja nr 1 (patrz też 39/10 – biopsja nr 2)

Dilated cardiomyopathy

Transplanted heart

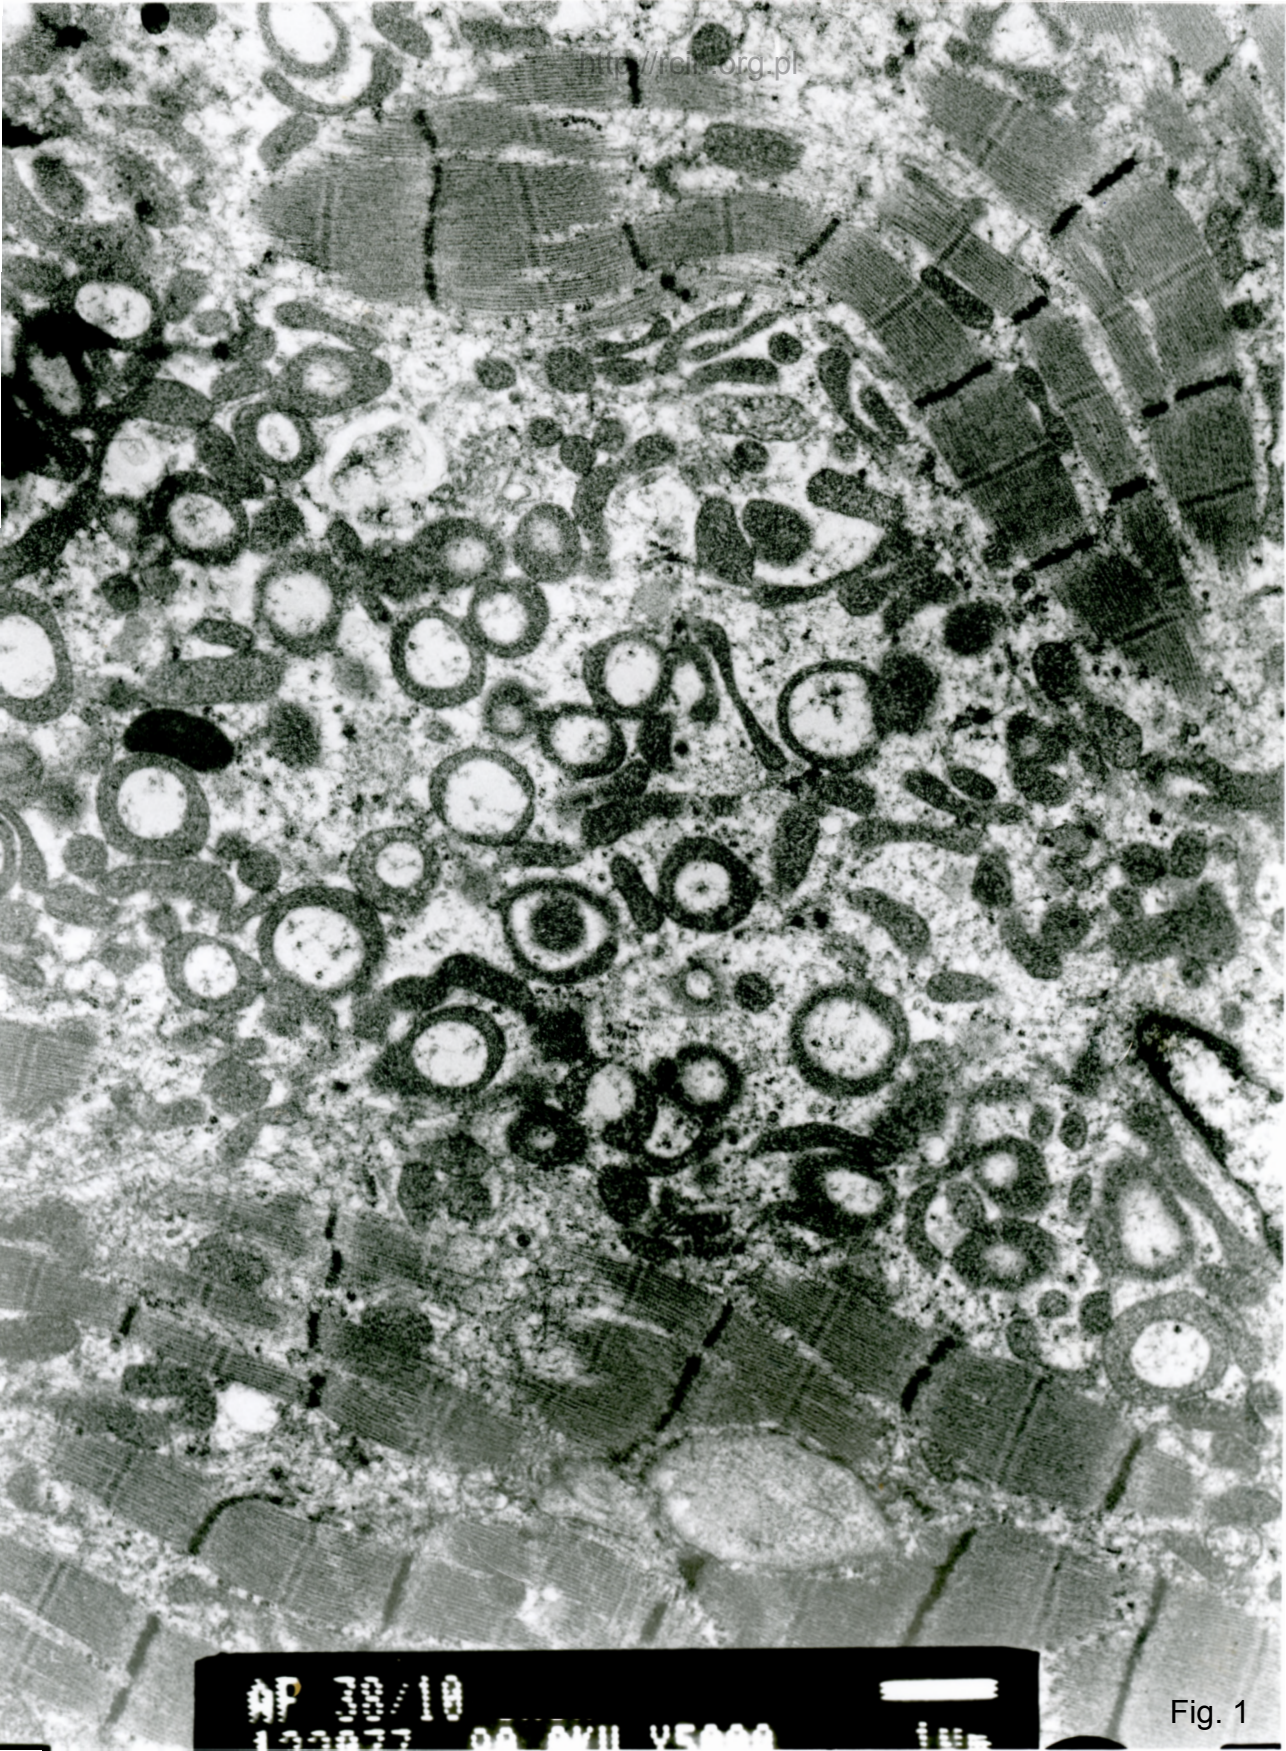
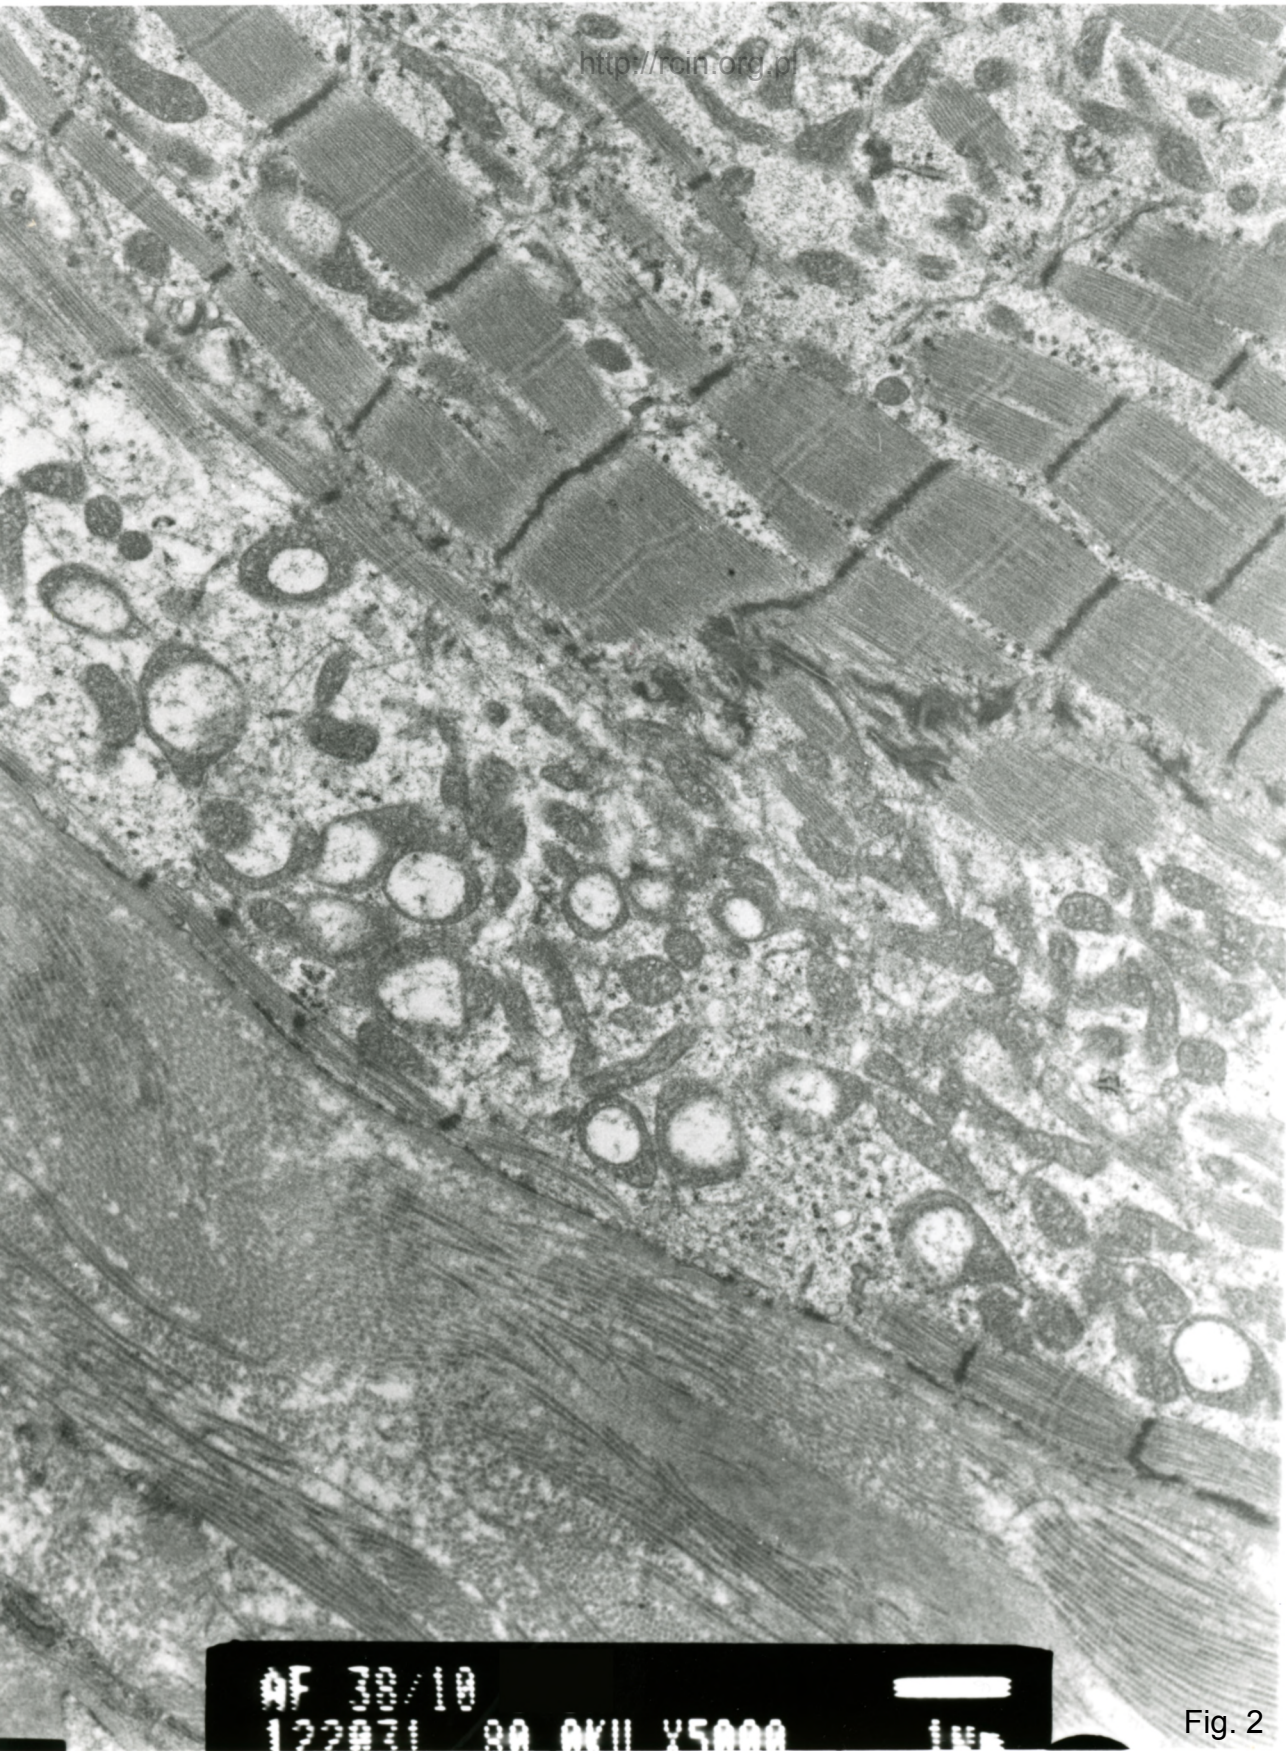
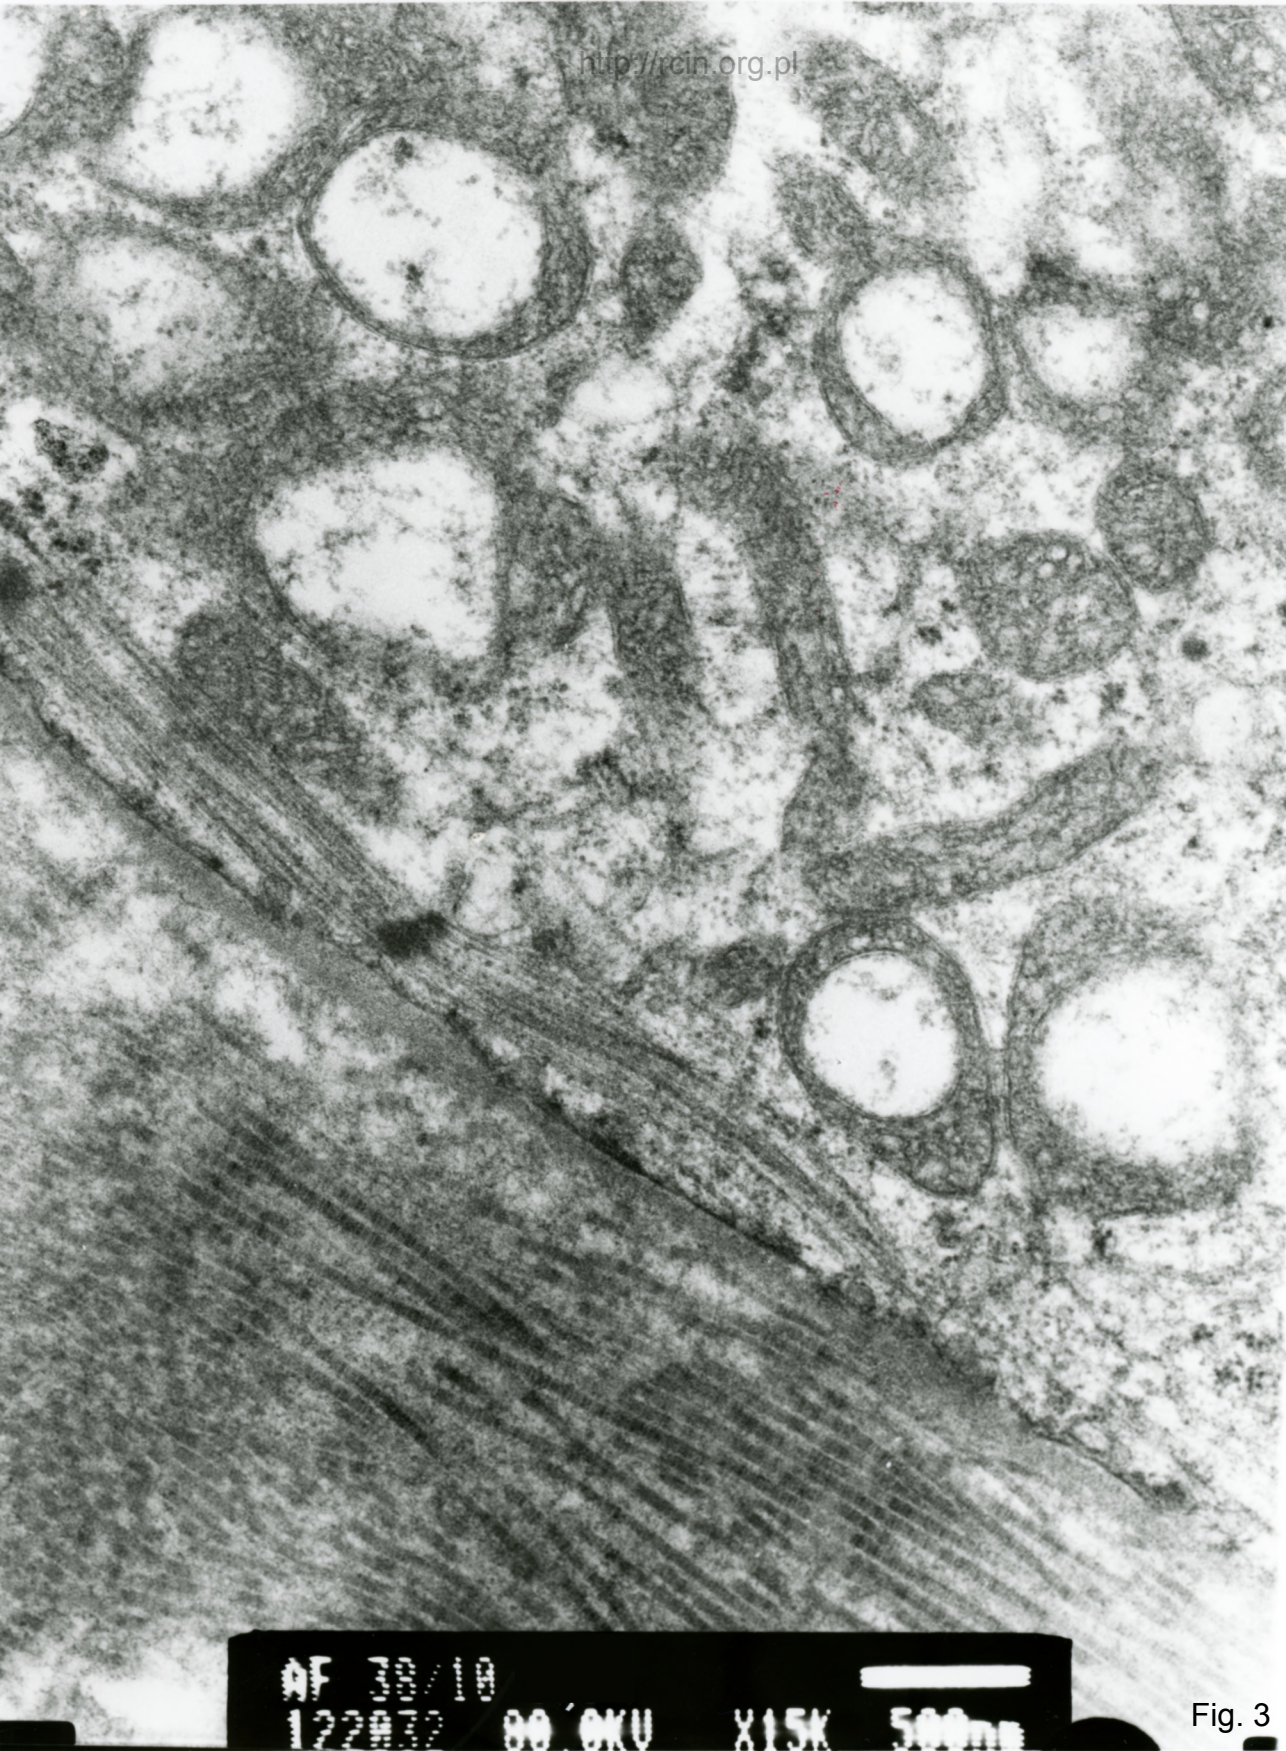
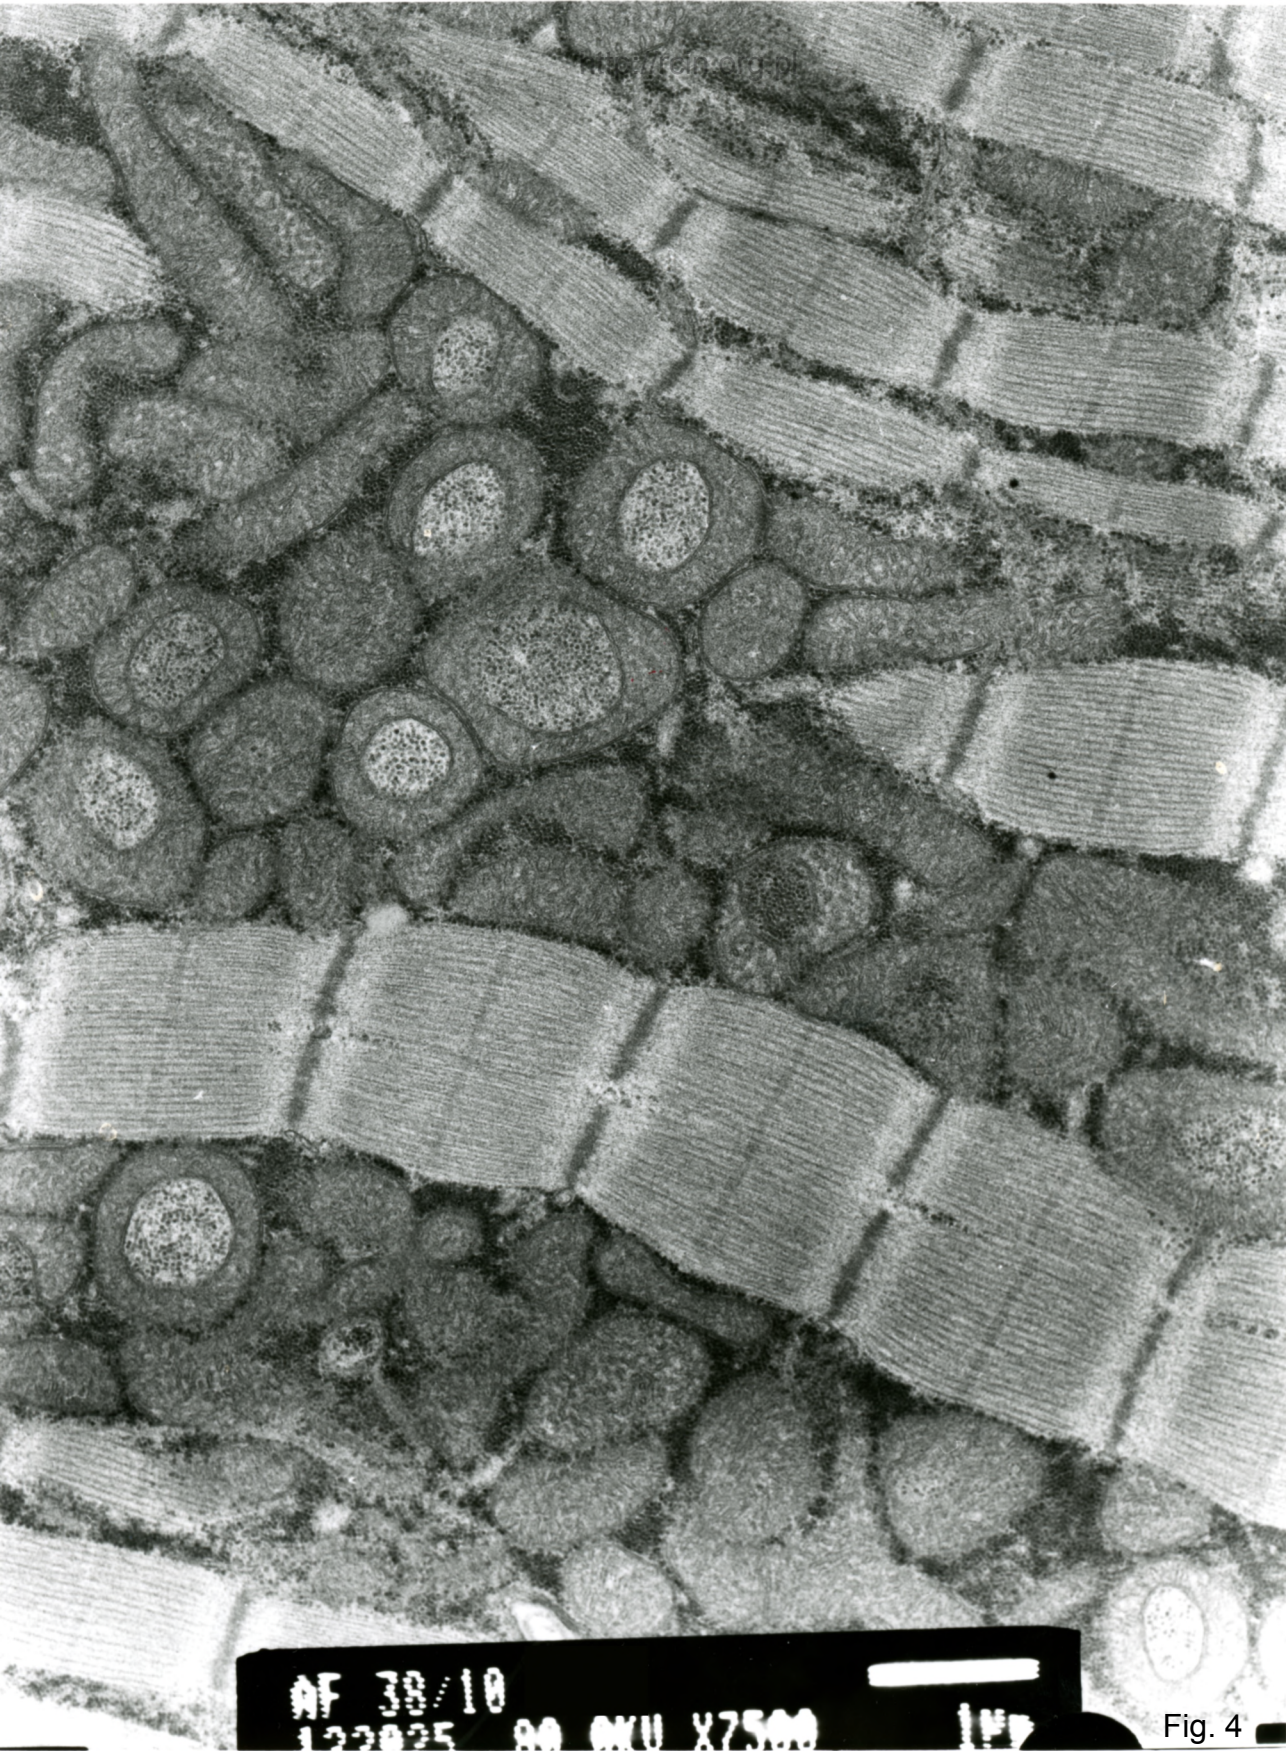
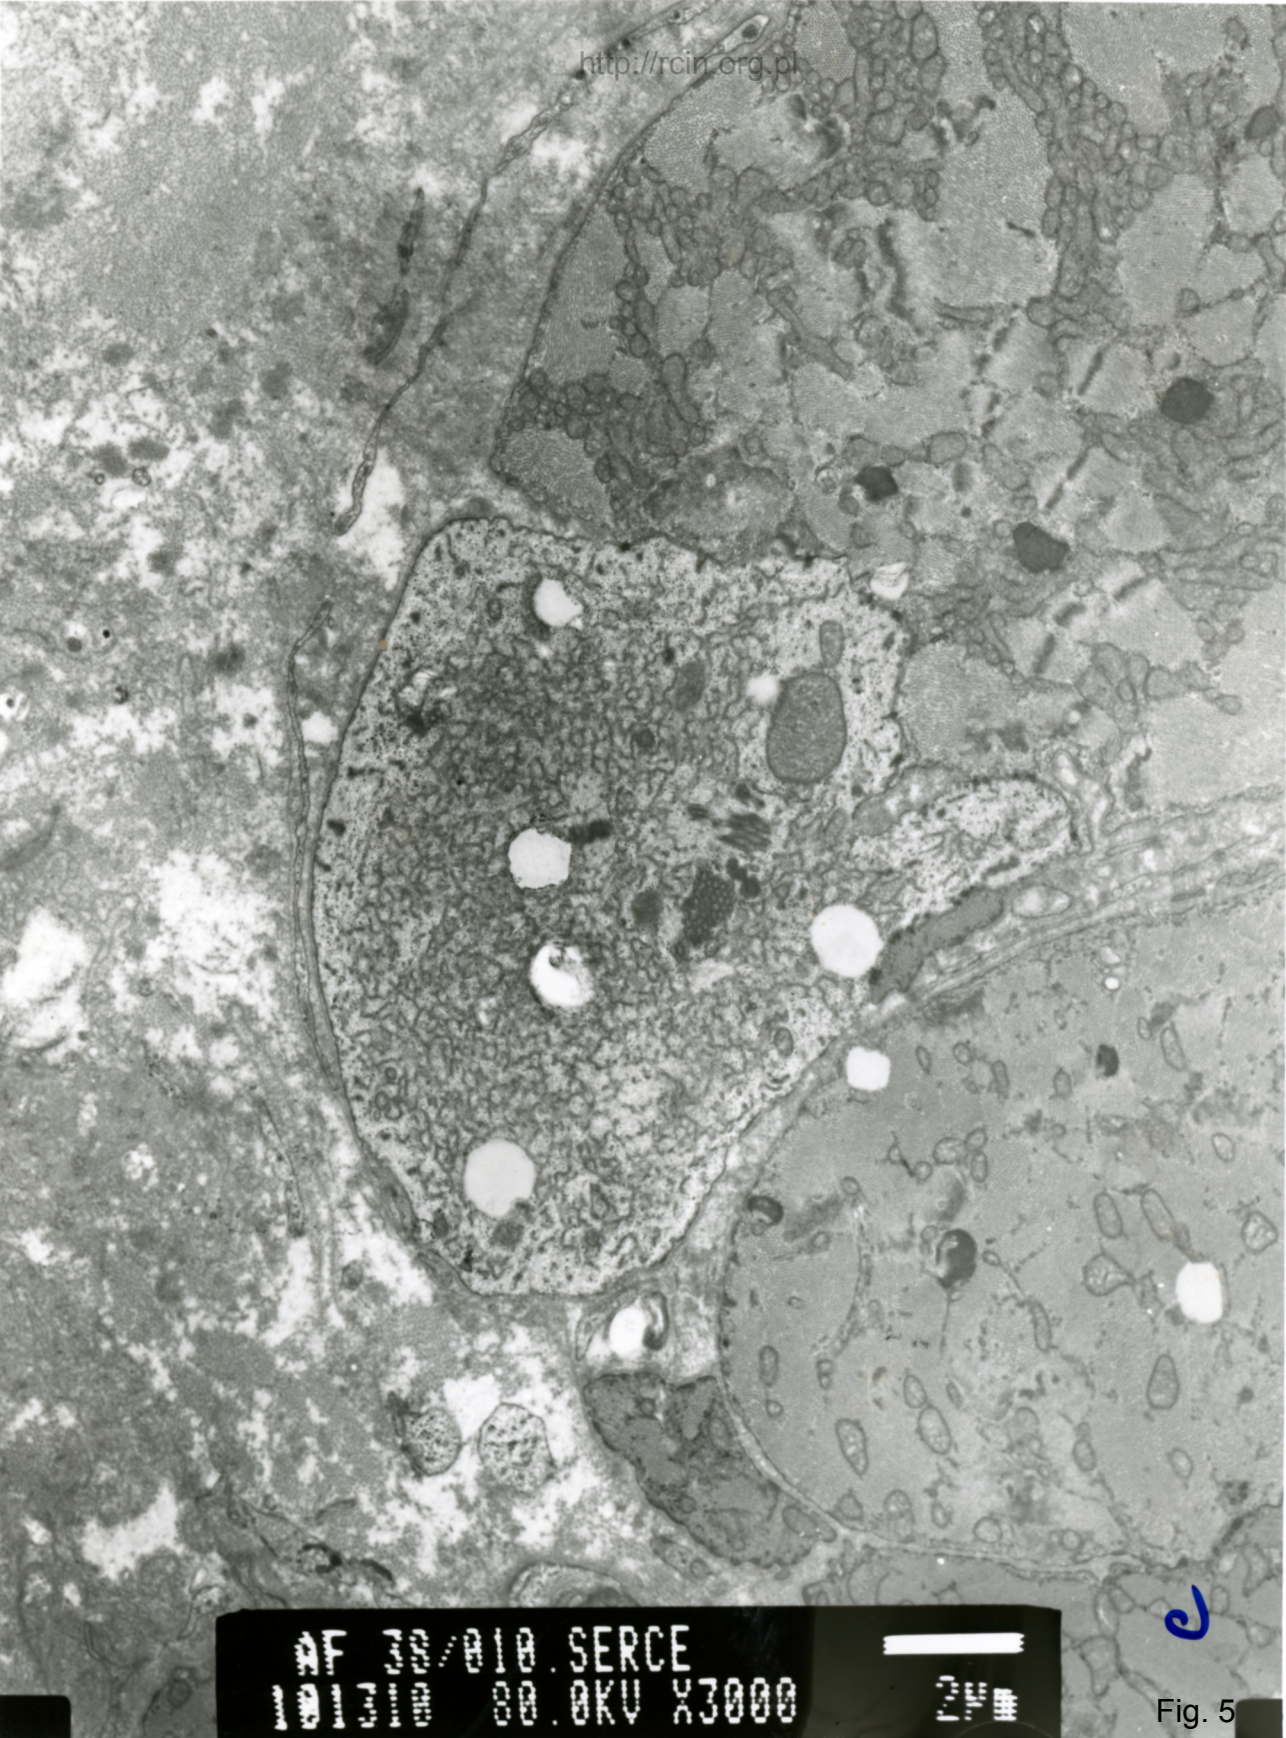
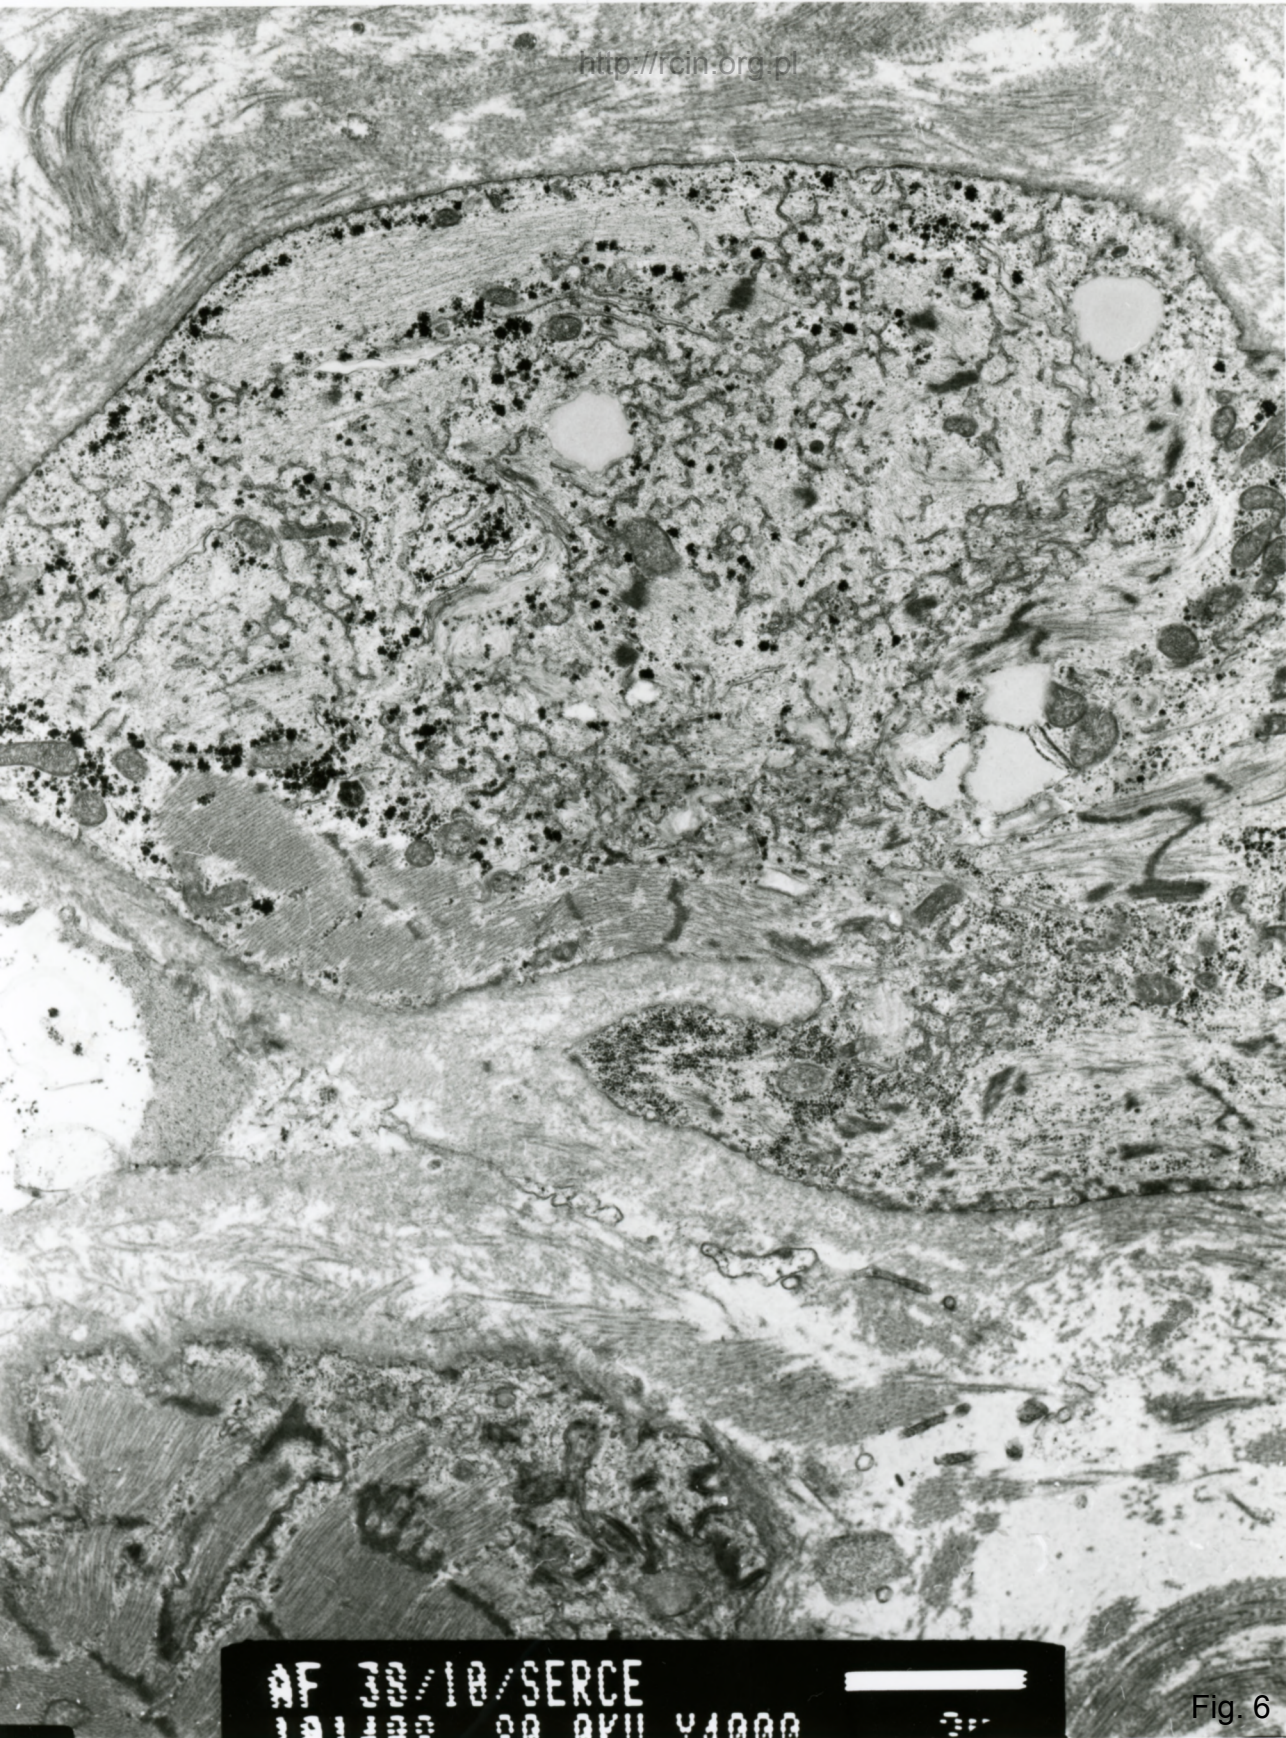
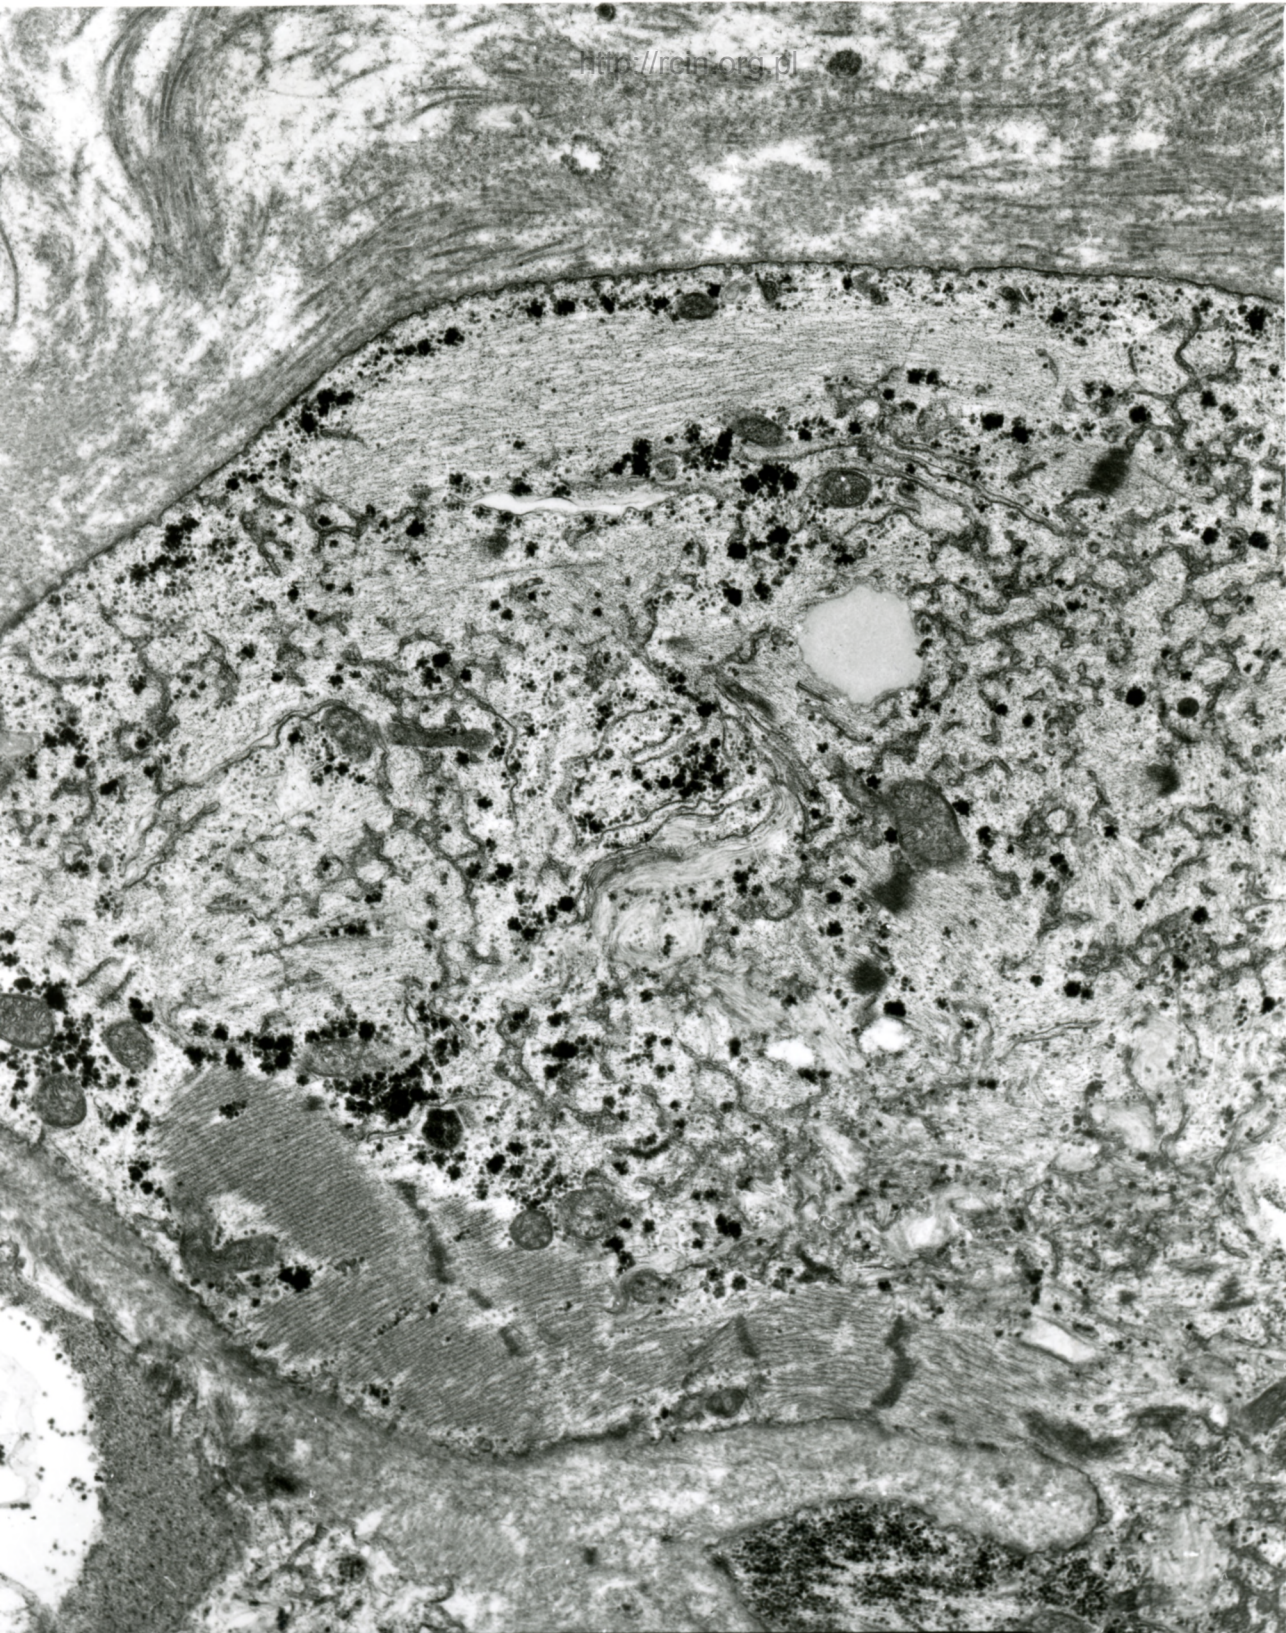
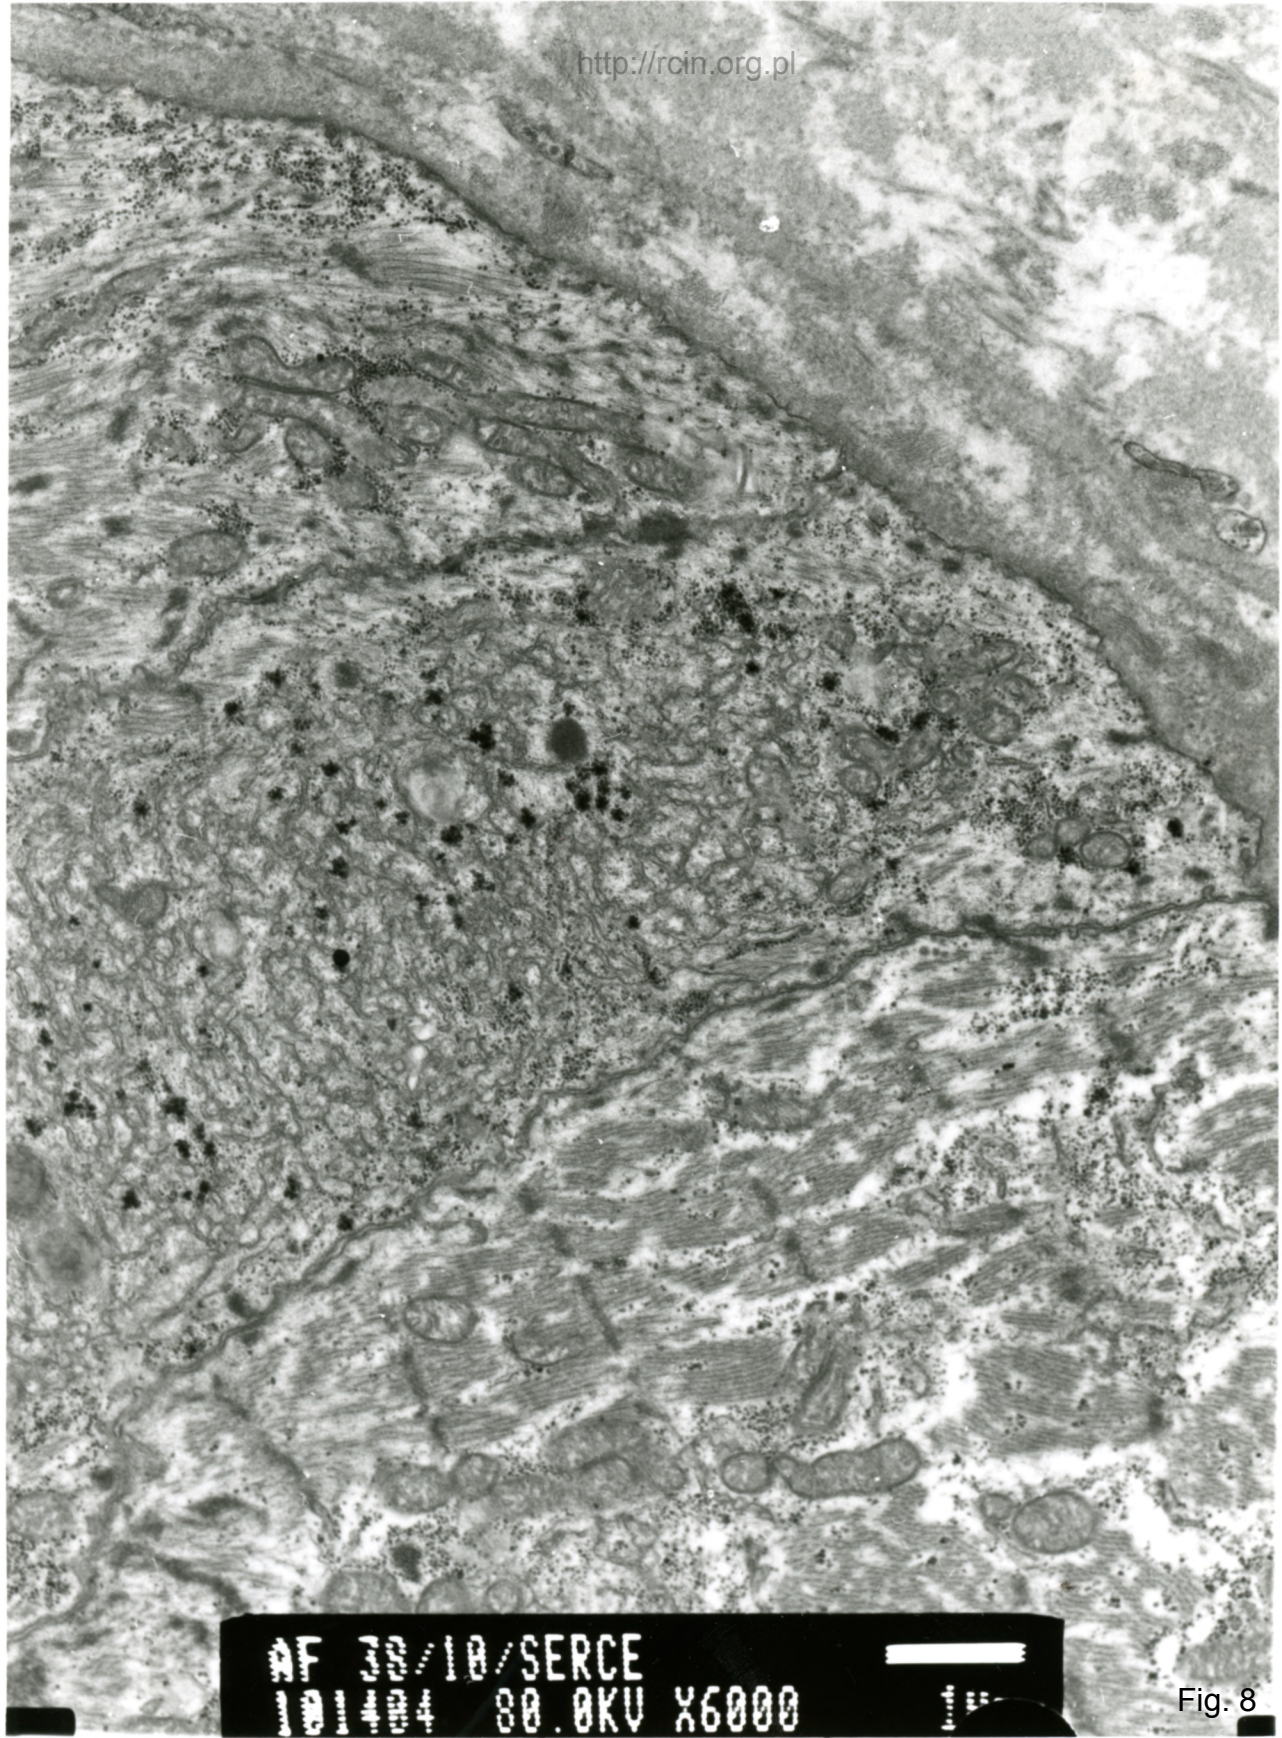
Ultrastructural analysis revealed changes in the contractile apparatus of cardiomyocytes. Myofibrils were irregular or ruptured. Morphologically altered mitochondria characterized by blurred structure of cristae gathered at the periphery were present and the vacuoles inside mitochondria interior were seen (Fig. 1-4). In some cardiomyocytes, in addition to disorganization of the contractile apparatus, disorganization of the membranous cellular structures also occurred (Figs. 5-13). Lipid droplets were sometimes observed in such areas. In some cardiomyocytes numerous autophagal structures were seen in the sarcoplasm (Figs. 14-18). Some myocardial cells were characterized by the presence of granular-fibrillar material of desmin fiber morphology (Figs. 19,20). Changes within the cardiomyocytes nuclei were seen. They were irregularly shaped and numerous indentations in the nuclear envelope were seen. Vacuoles were observed inside some nuclei (Figs. 21-24).

Analiza ultrastrukturalna wykazała zmiany w aparacie kurczliwym kardiomiocytów. Miofibryle miały nieregularny przebieg lub ich ciągłość była przerywana, a w sąsiedztwie licznie występowały zmienione morfologicznie mitochondria. Mitochondria charakteryzowały się obecnością wakuoli wewnątrz organellum oraz zatartą strukturą zgromadzonych na obrzeżach grzebieni (Fig. 1-4). W niektórych kardiomiocytach oprócz dezorganizacji aparatu kurczliwego występowała również dezorganizacja błoniastych struktur komórki (Fig. 5-13). Na takich obszarach obecne były czasami krople lipidów. Niektóre kardiomiocyt zawierały w sarkoplazmie liczne figury autofagalne (Fig. 14-18). Cechą charakterystyczną niektórych komórek mięśnia sercowego była obecność granularno-włókienkowego materiału o morfologii włókienek desminy (Fig. 19,20). Zmiany w obrębie kardiomiocytów dotyczyły również jąder komórkowych. Posiadały one nieregularny kształt, liczne wgłobienia w otoczcze, a niektóre wakuole (Fig. 21-24).
