38/10 biopsja nr 1 (patrz też 39/10 – biopsja nr 2)

Dilated cardiomyopathy

Transplanted heart

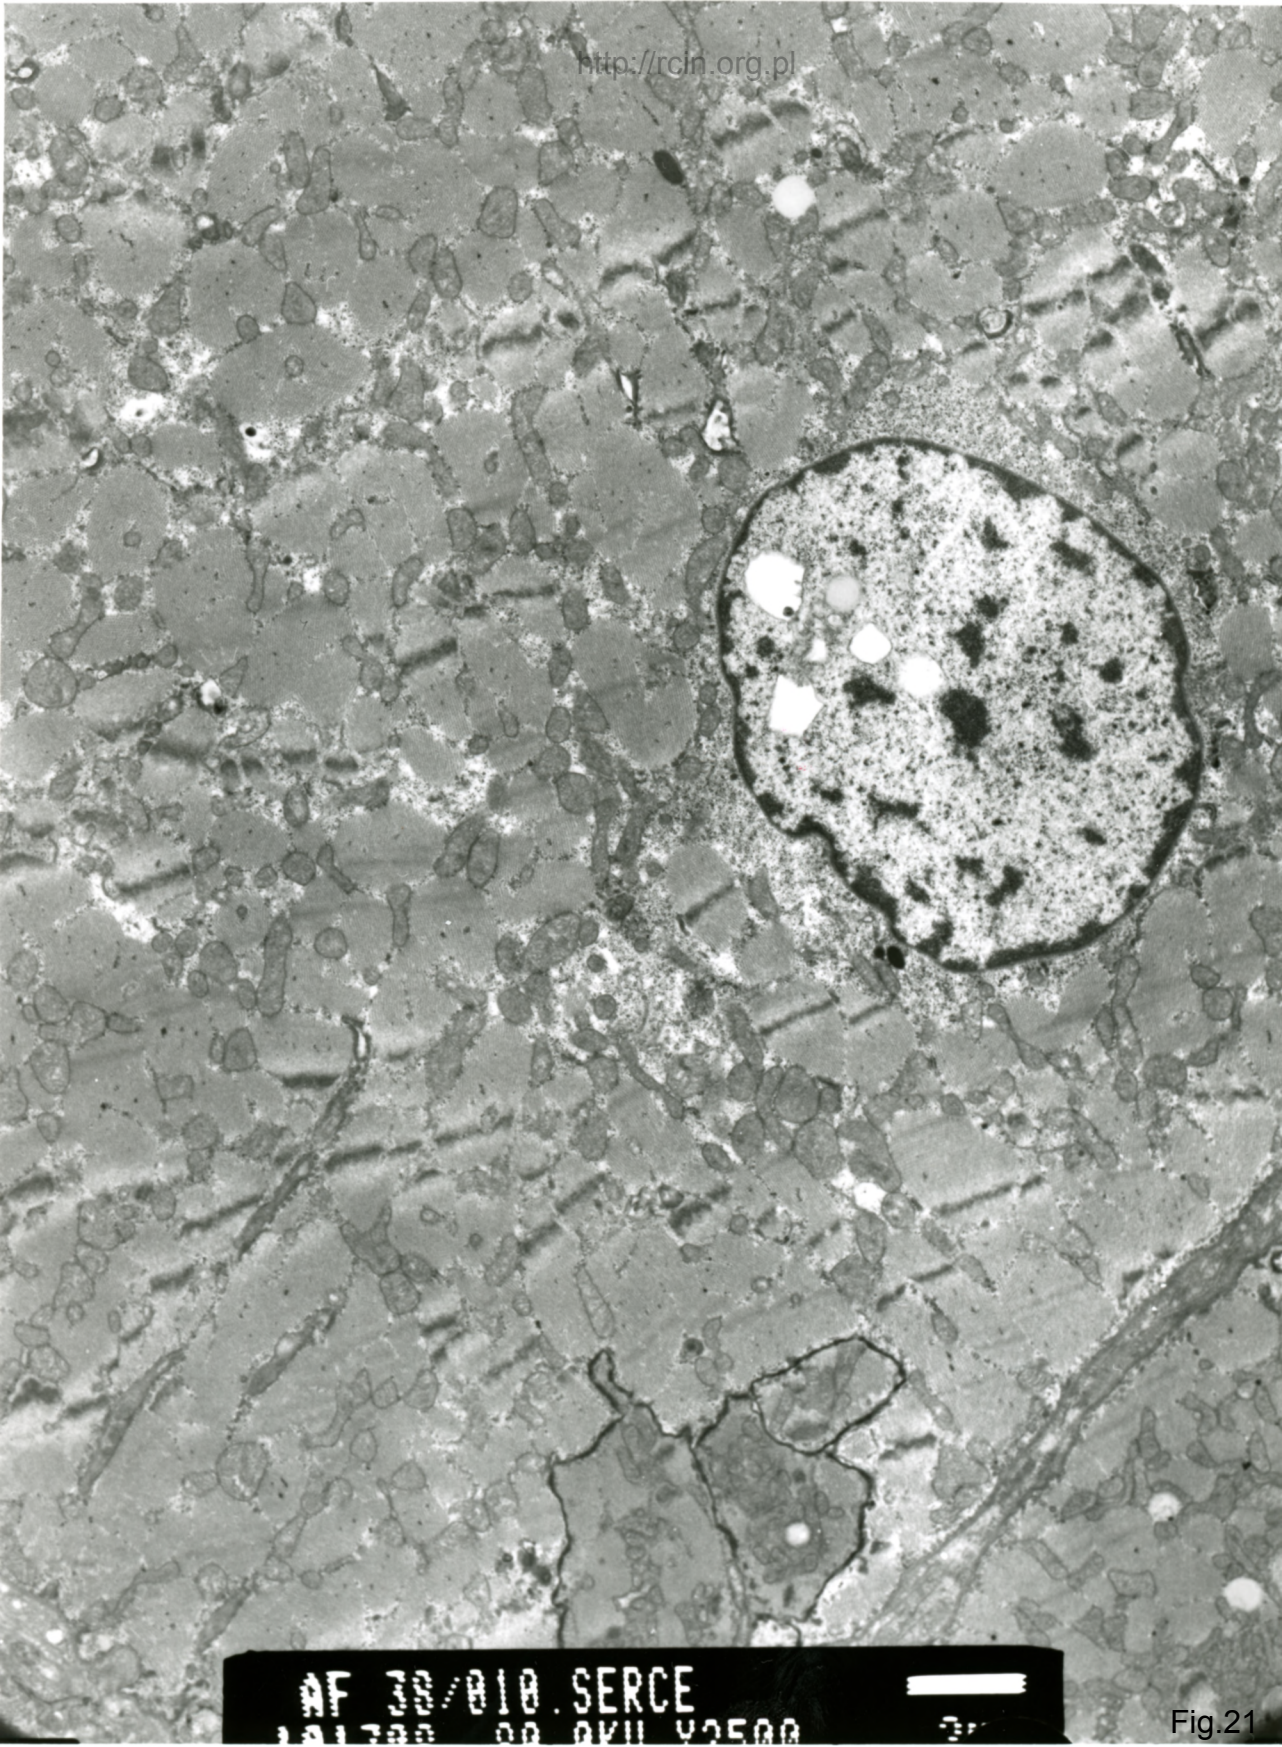
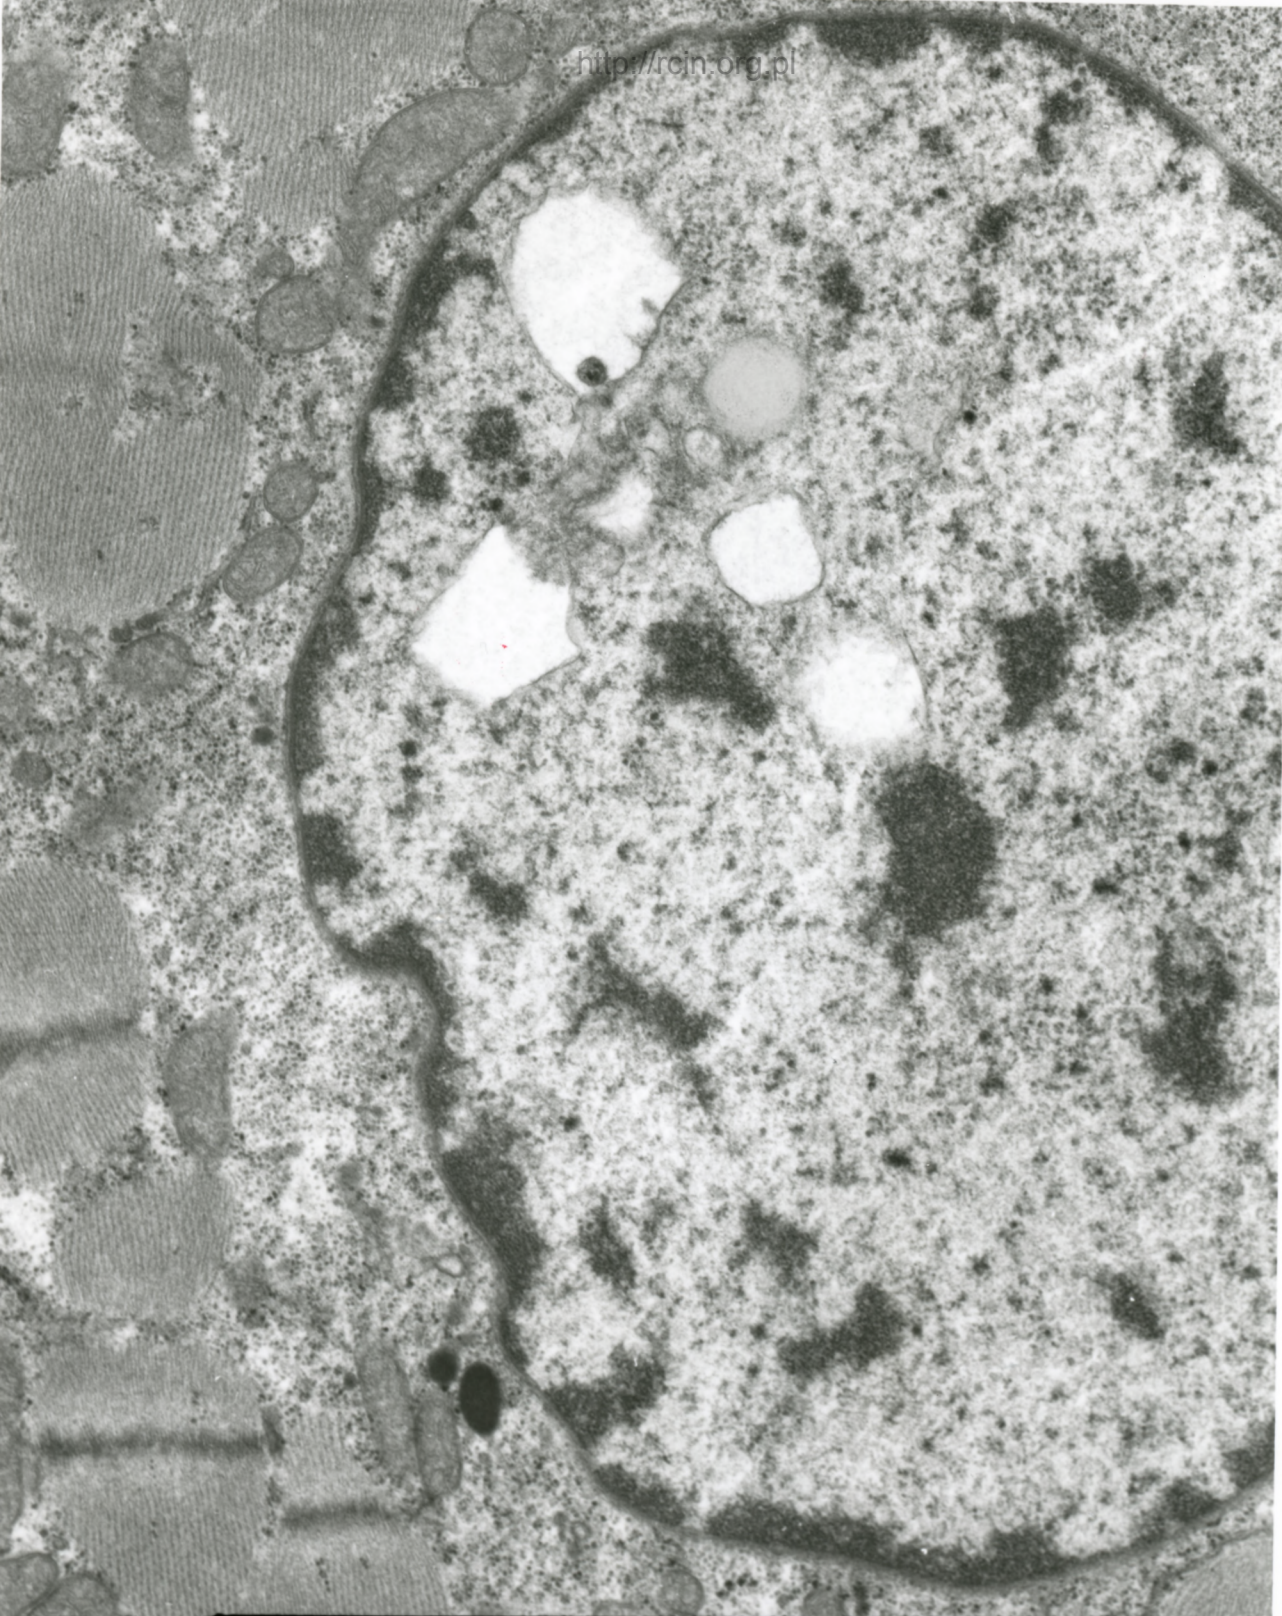
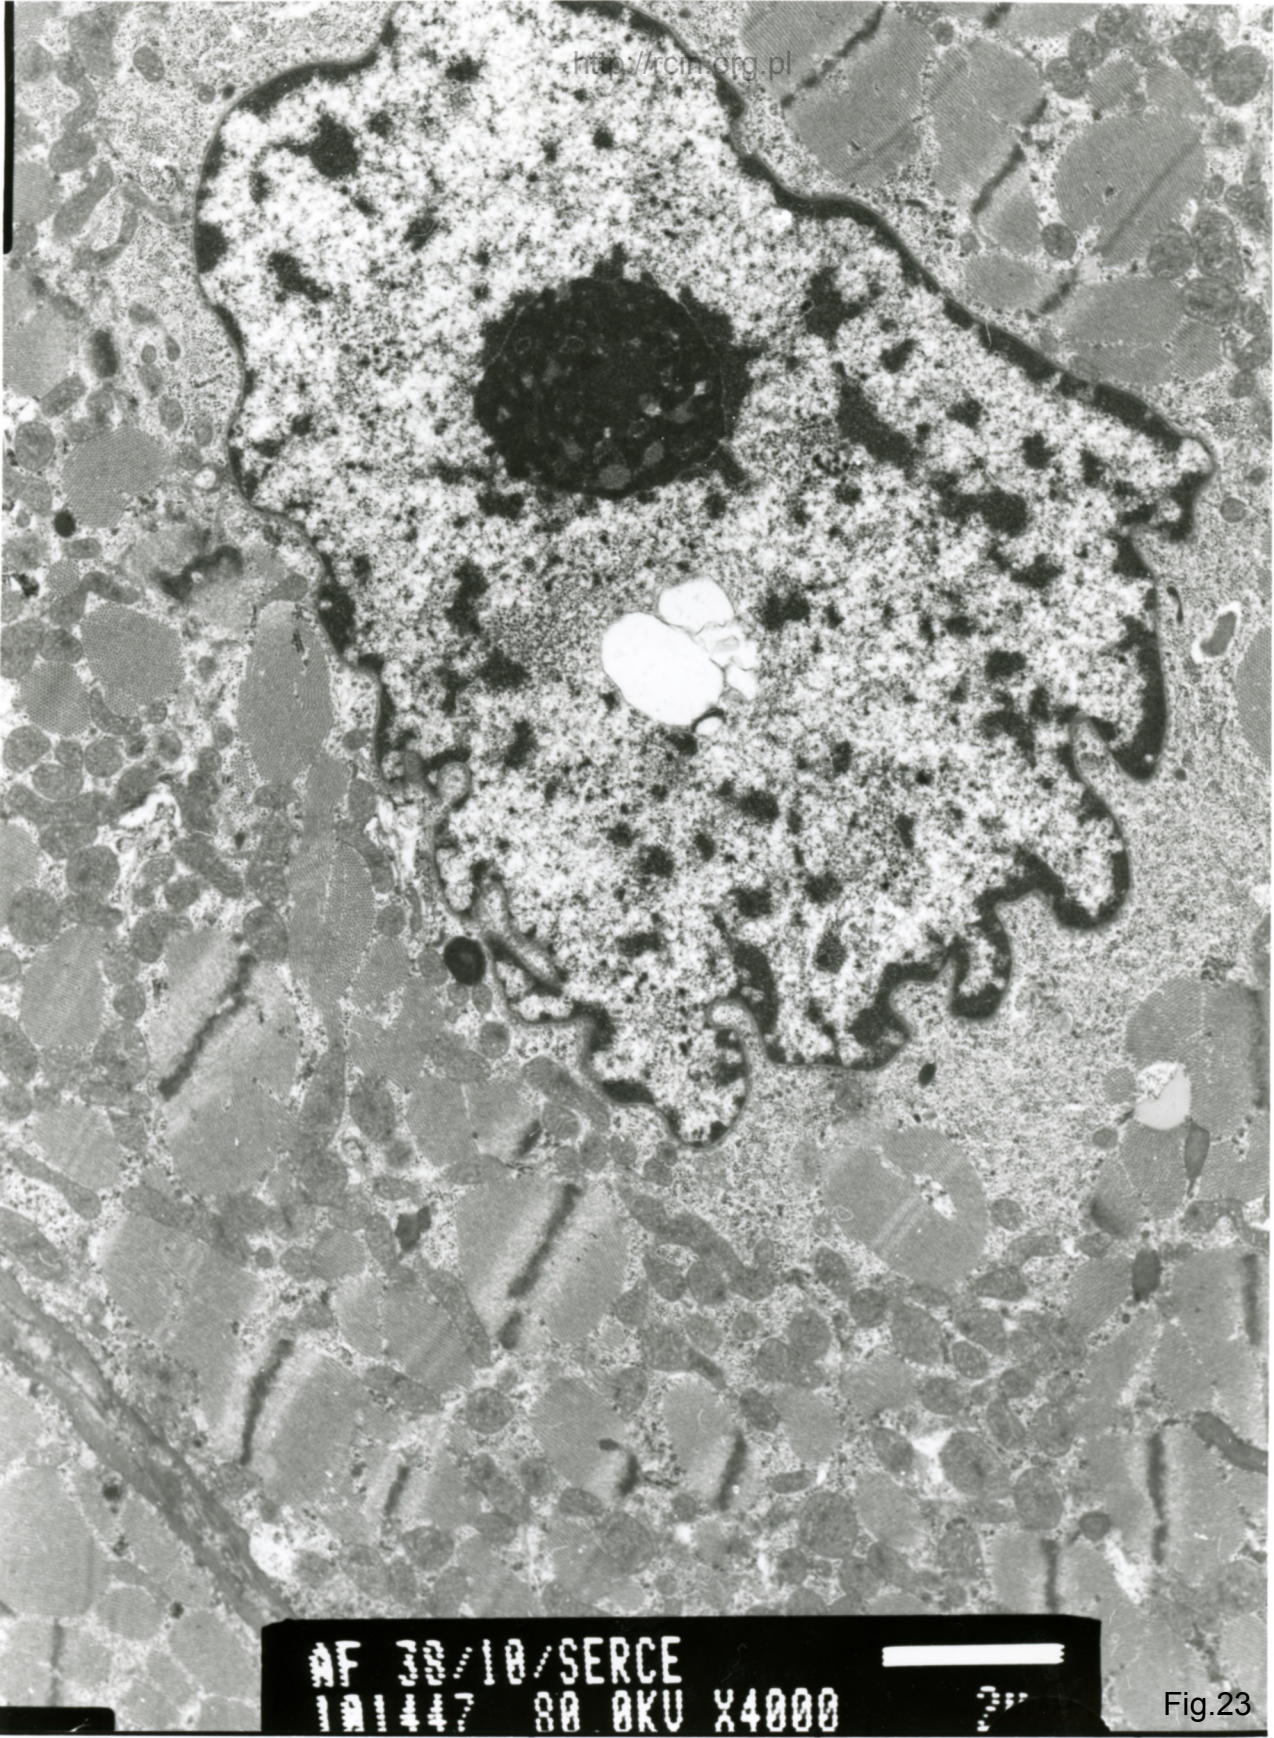
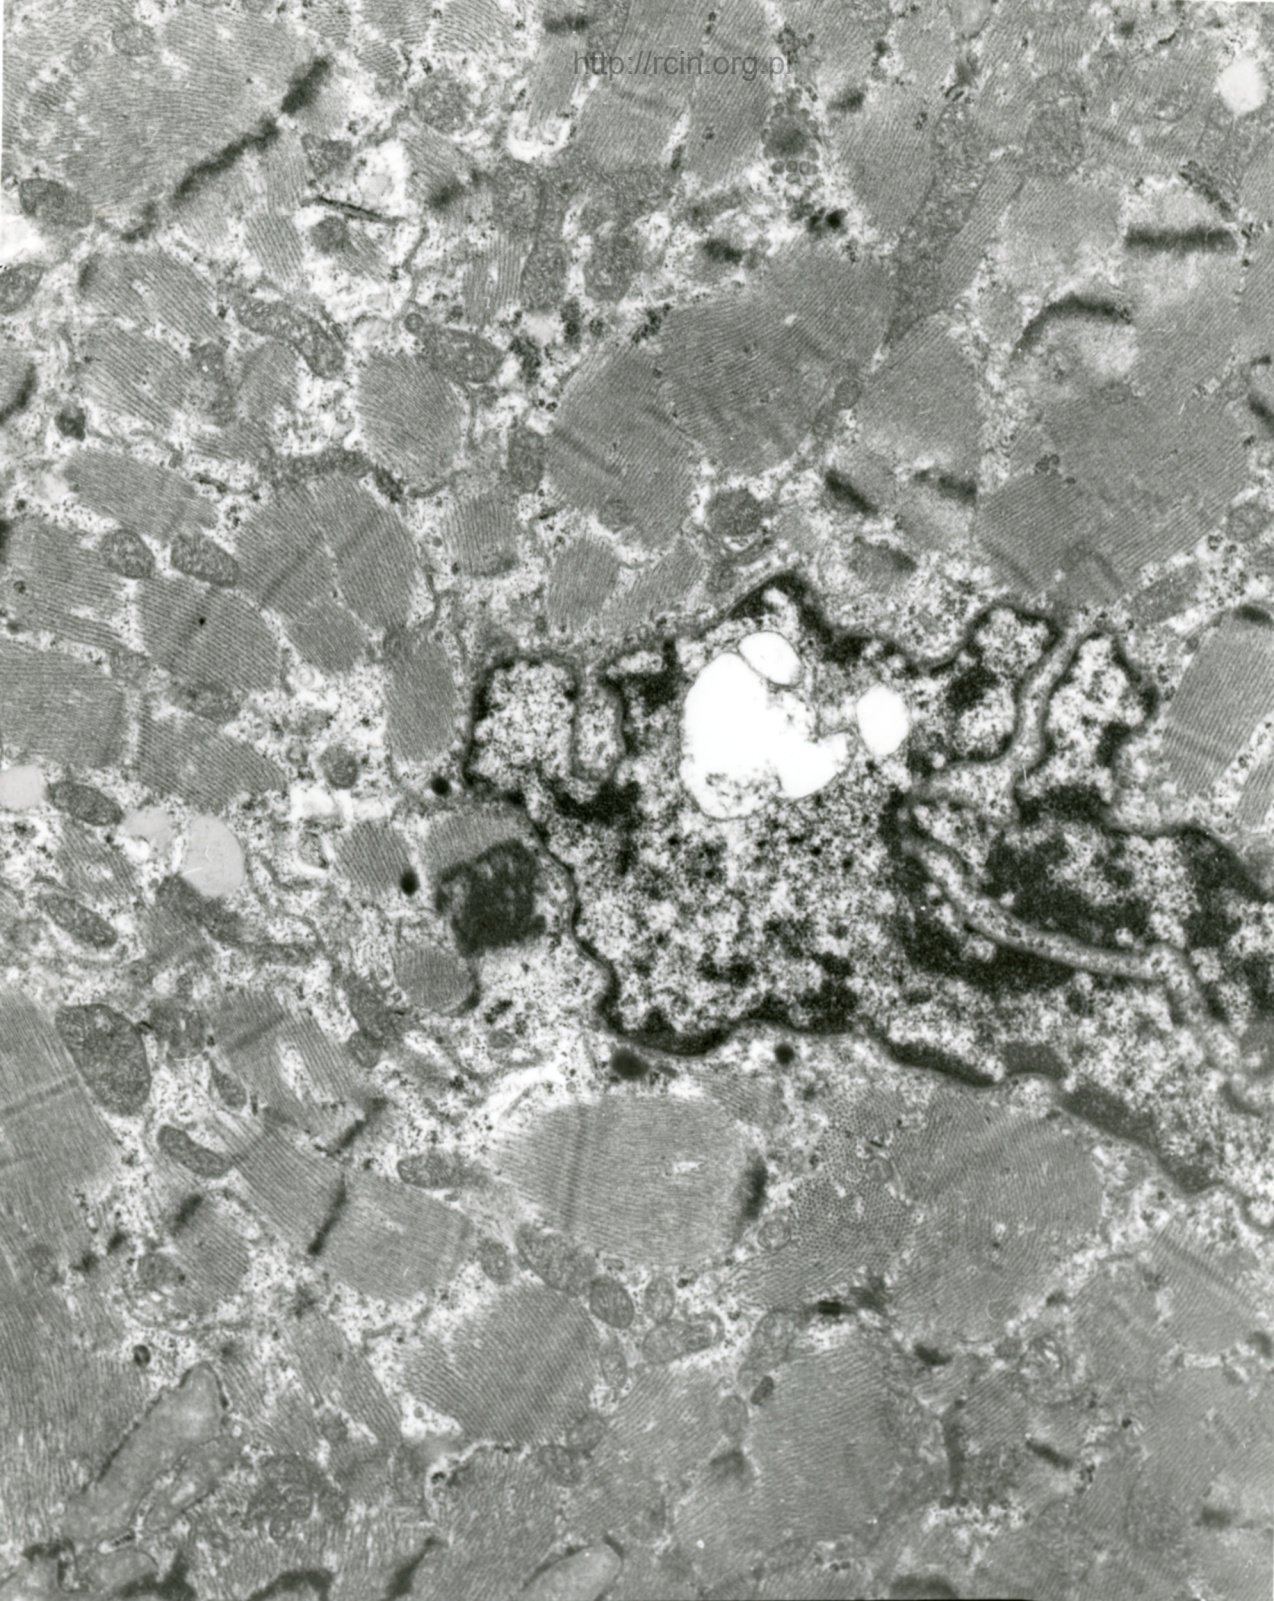
Ultrastructural analysis revealed changes in the contractile apparatus of cardiomyocytes. Myofibrils were irregular or ruptured. Morphologically altered mitochondria characterized by blurred structure of cristae gathered at the periphery were present and the vacuoles inside mitochondria interior were seen (Fig. 1-4). In some cardiomyocytes, in addition to disorganization of the contractile apparatus, disorganization of the membranous cellular structures also occurred (Figs. 5-13). Lipid droplets were sometimes observed in such areas. In some cardiomyocytes numerous autophagal structures were seen in the sarcoplasm (Figs. 14-18). Some myocardial cells were characterized by the presence of granular-fibrillar material of desmin fiber morphology (Figs. 19,20). Changes within the cardiomyocytes nuclei were seen. They were irregularly shaped and numerous indentations in the nuclear envelope were seen. Vacuoles were observed inside some nuclei (Figs. 21-24).

Analiza ultrastrukturalna wykazała zmiany w aparacie kurczliwym kardiomiocytów. Miofibryle miały nieregularny przebieg lub ich ciągłość była przerywana, a w sąsiedztwie licznie występowały zmienione morfologicznie mitochondria. Mitochondria charakteryzowały się obecnością wakuoli wewnątrz organellum oraz zatartą strukturą zgromadzonych na obrzeżach grzebieni (Fig. 1-4). W niektórych kardiomiocytach oprócz dezorganizacji aparatu kurczliwego występowała również dezorganizacja błoniastych struktur komórki (Fig. 5-13). Na takich obszarach obecne były czasami krople lipidów. Niektóre kardiomiocyt zawierały w sarkoplazmie liczne figury autofagalne (Fig. 14-18). Cechą charakterystyczną niektórych komórek mięśnia sercowego była obecność granularno-włókienkowego materiału o morfologii włókienek desminy (Fig. 19,20). Zmiany w obrębie kardiomiocytów dotyczyły również jąder komórkowych. Posiadały one nieregularny kształt, liczne wgłobienia w otoczcze, a niektóre wakuole (Fig. 21-24).
