Rozpoznanie: kardiomiopatia popołożowa

Heart biopsy from patient with postpartum cardiomyopathy was taken and examined.

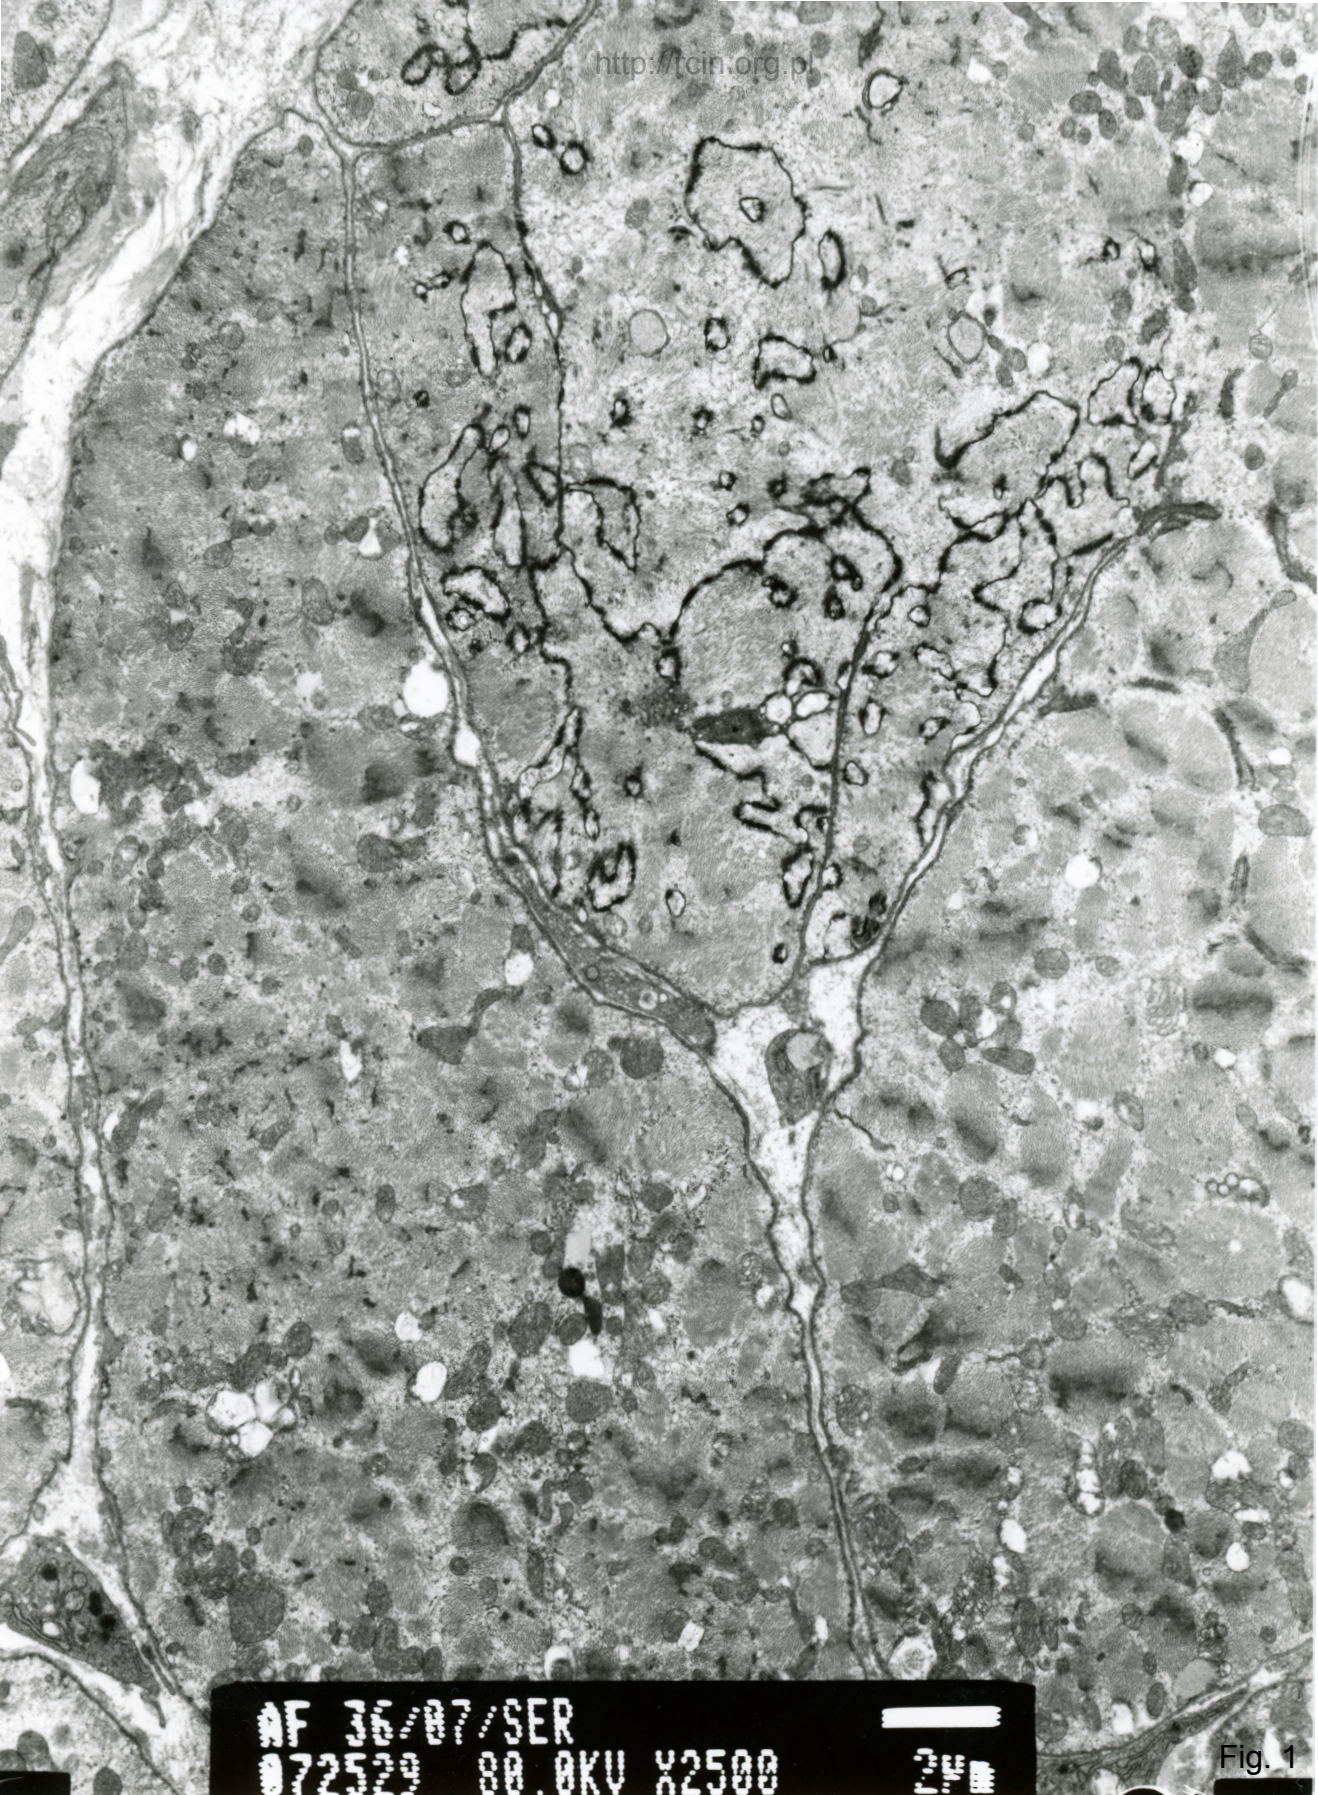
Ultrastructural analysis revealed changes in the contractile apparatus of cardiomyocytes. The structure of sarcomeres was blurred and myofibrils were disorganized and scattered (Figs. 1-12). Normal cell nuclei were observed, whereas some mitochondria were characterized by loss of mitochondrial cristae (Figs. 13-17). Numerous fat droplets of various sizes were present in the biopsy (Figs. 18-21). The extracellular space was filled with abundant connective tissue and immune cells, mainly mast cells, were observed (Figs. 22-27).

Analiza ultrastrukturalna wykazała zmiany aparacie kurczliwym kardiomiocytów. Struktura sarkomerów była zatarta, obserwowano też zaburzenia w układzie miofibrili, miejscowo ich rozproszenie, a nawet zanik (Fig. 1-12). Obserwowano prawidłowe jądra komórkowe, natomiast część mitochondriów charakteryzowała się ubytkiem grzebieni mitochondrialnych (Fig. 13-17). W bioptacie obecne były liczne krople tłuszczu różnej wielkości (Fig. 18-21). Przestrzeń zewnątrzkomórkowa wypełniona była obfitą tkanką łączną, obecne były też komórki układu odpornościowego, przede wszystkim komórki tuczne (Fig. 22-27).
