93/02

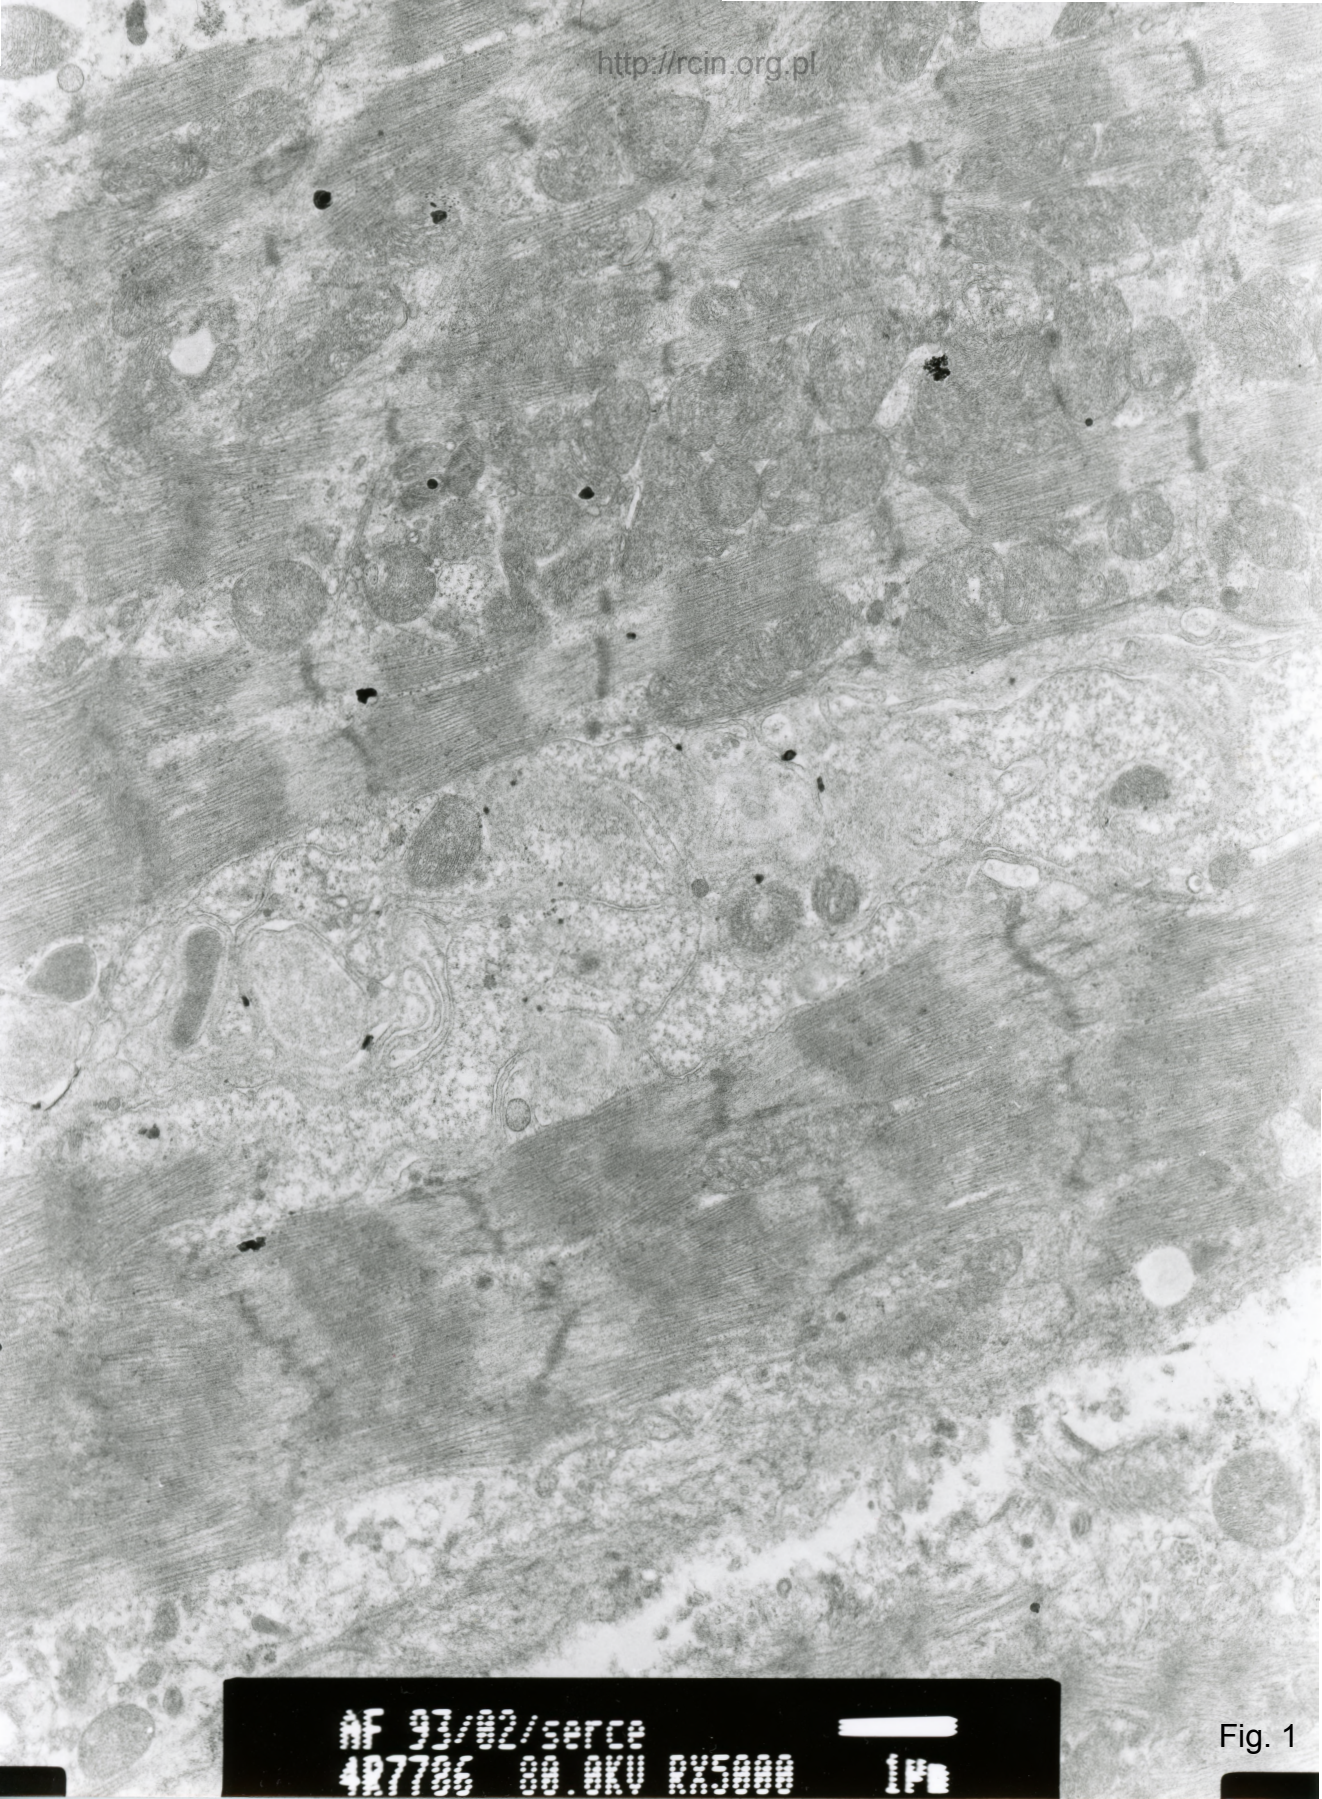
Ultrastructural analysis revealed changes in the sarcomere pattern in some cardiomyocytes (Figs. 1,2). Sarcomeres were disrupted, and blurred mitochondria as well as membranous structures were present at the site of myofibril loss.

Analiza ultrastrukturalna wykazała zmiany w układzie sarkomerów w niektórych kardiomiocytach (Fig. 1,2). Sarkomery były przerwane, w miejscu ubytku miofibrili występowały mitochondria o zatartej strukturze i struktury błoniaste.

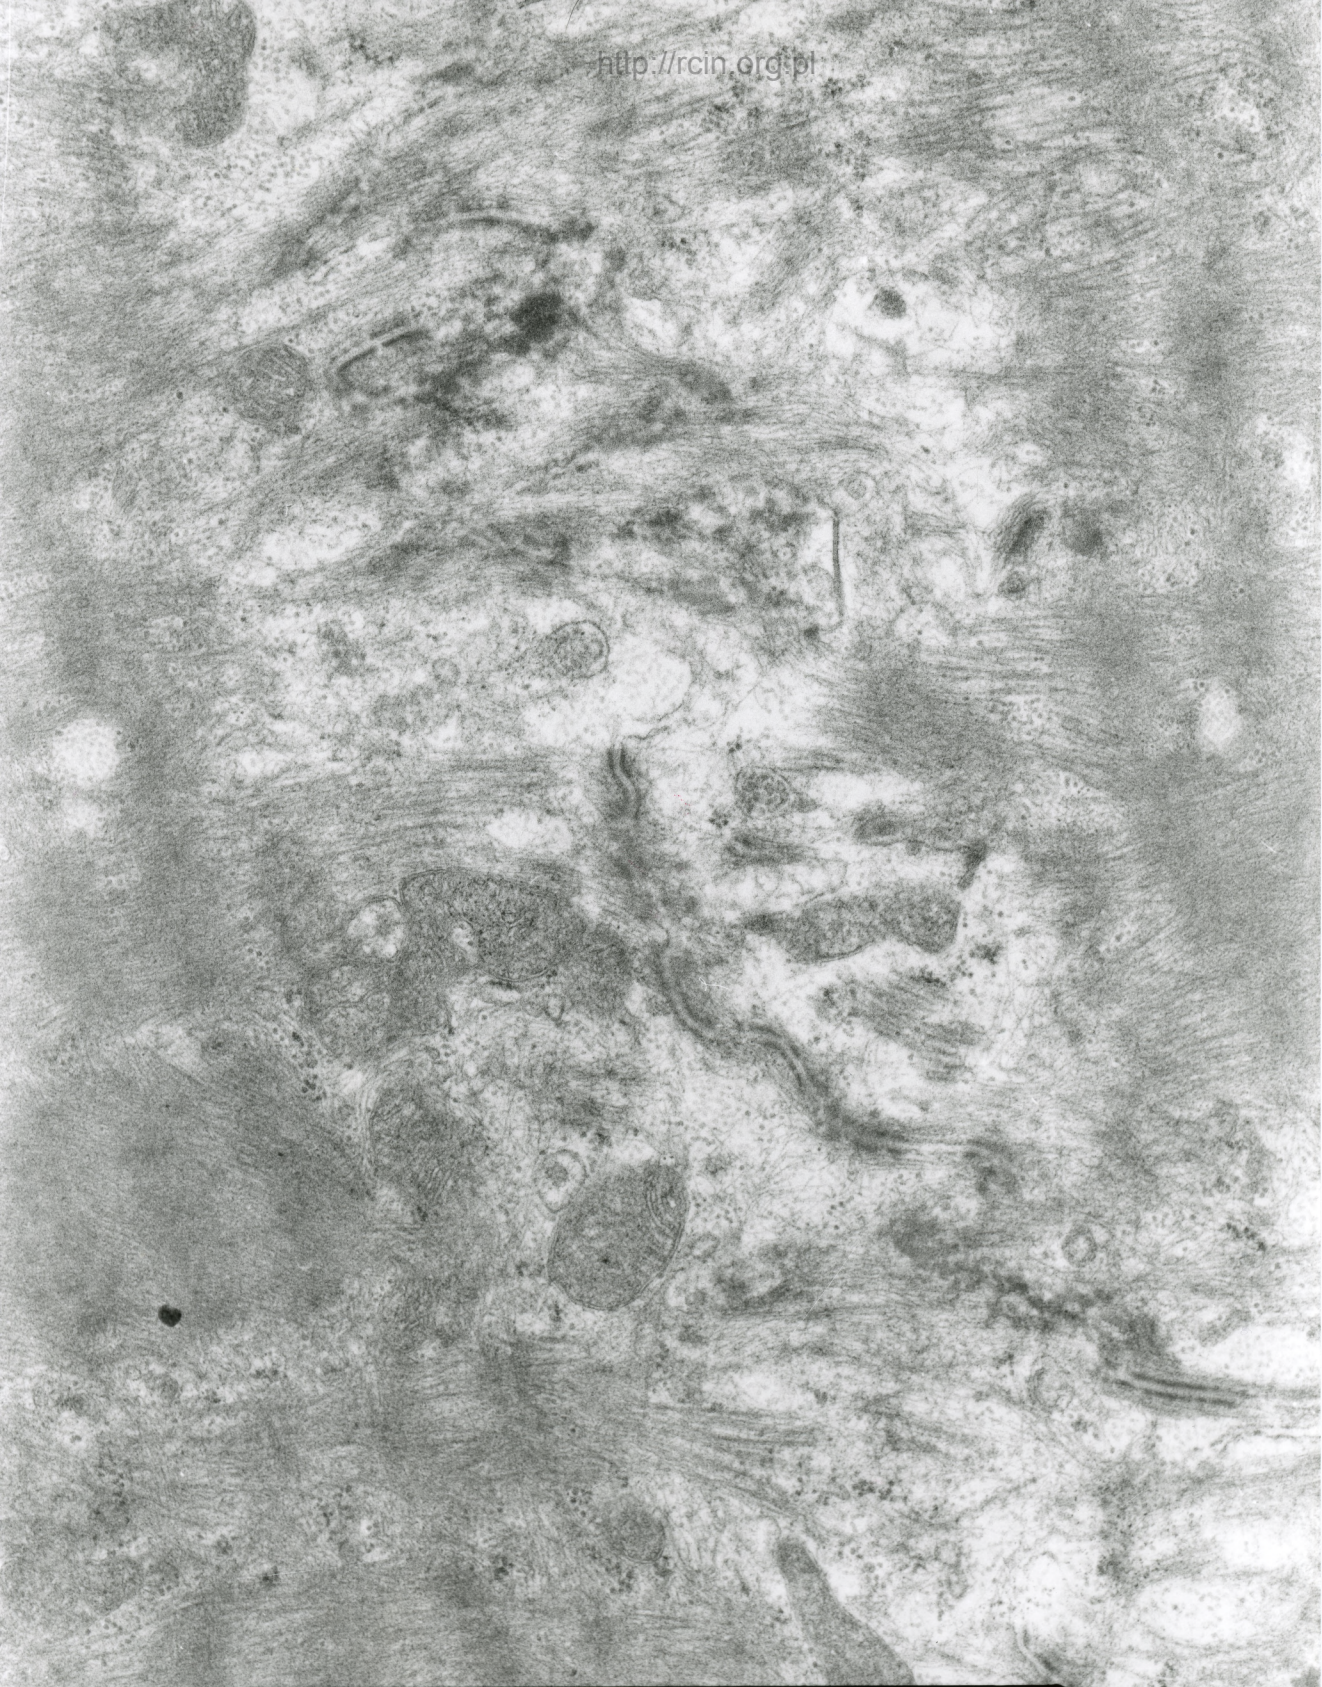
In a significant part of cardiomyocytes, altered course and morphological structure of the intercalated disc were observed. Focal widening and breaks of intercalated disc were seen (Figs. 3-7).

W znacznej części kardiomiocytów przebieg i budowa morfologiczna wstawki (intercalated disc) były zmienione. Ogniskowo występowało poszerzenie i przerwanie wstawki (Fig. 3-7).
