WRECK W-6. A PRELIMINARY REPORT

THE UNDERWATER ARCHAEOLOGICAL RESEARCH PROGRAMME AT THE POLISH MARITIME MUSEUM, GDAŃSK

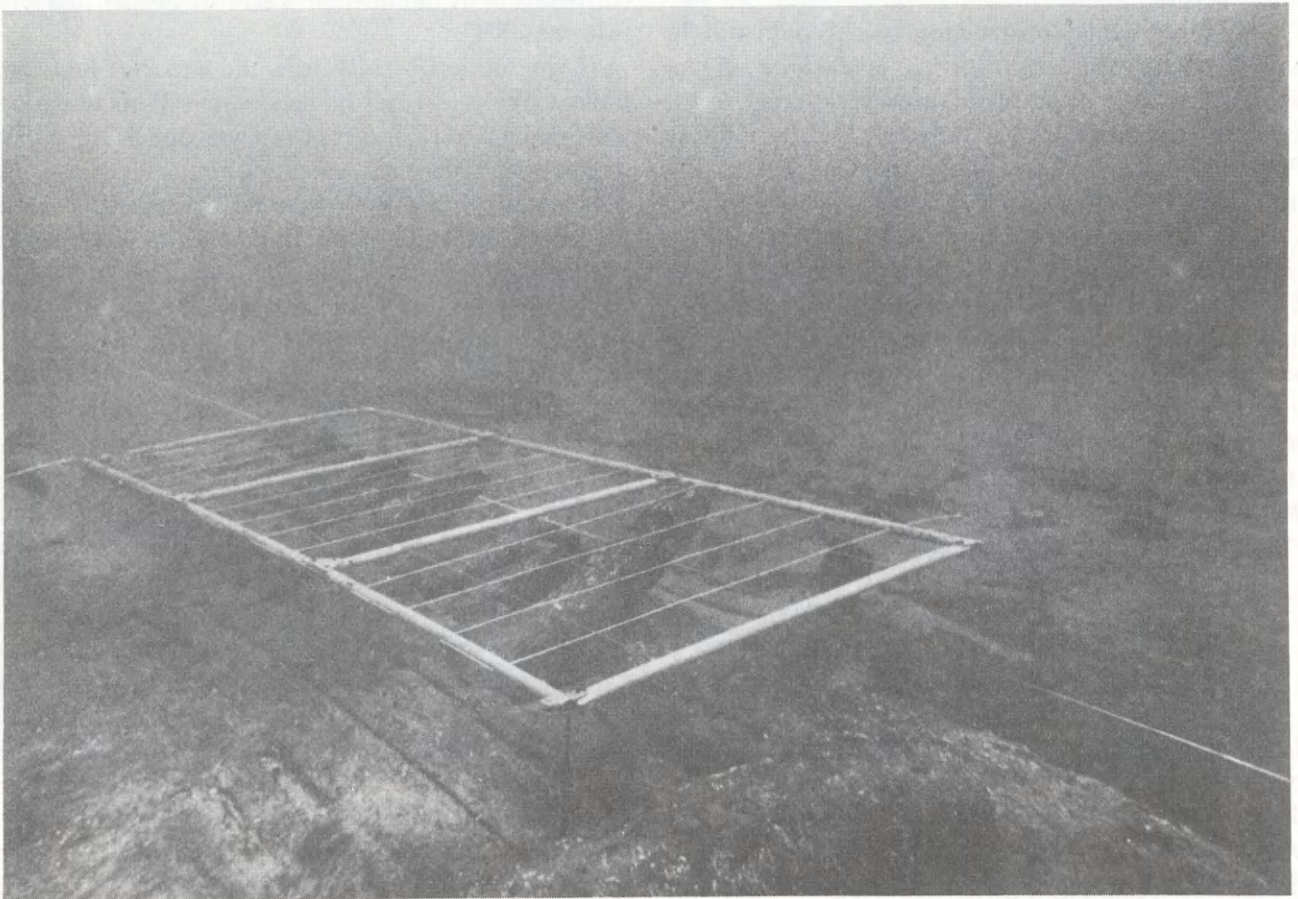
Fig. 3. 1 × 3-m. grid used for drawing details during the exploration of the W-6 wreck.

Once the site had been "organized", the next job was to put in place a rigid measurement framing screwed together from metal tubes. This framing comprised a rectangle 33 × 11 m which encompassed the wreck entirely. The two longer sides were numbered at 1-metre intervals from 1 to 33, the shorter ones were lettered from A to K. The metre sections of

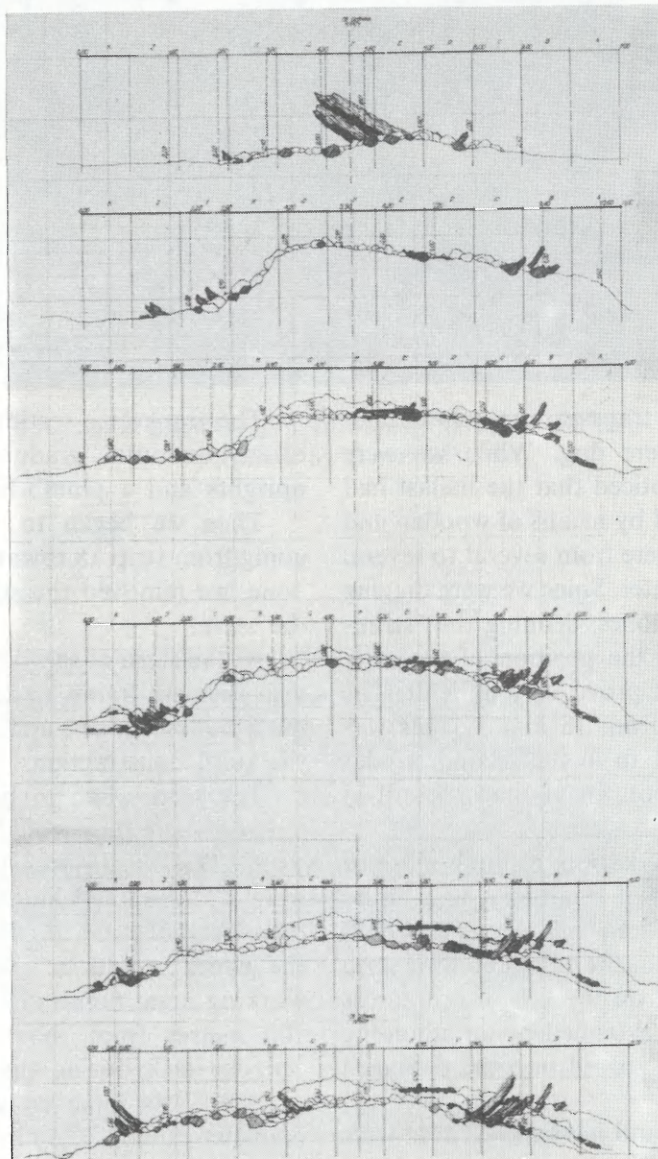
Figs. 4. and 5. Longitudinal profile (plotted along the wreck's axis of symmetry) and transverse profiles of the W-6 wreck, carried out in summer 1970.

Lying on a SE–NW axis, the wreck at first sight looked like a low hill or heap some 25 m long, 9 m wide and 1,5 m high. This heap was due to the ballast stones which were encrusted with mussels. The fissures between the mussels were filled with sand. Along the edges of these heaps, fragments of the wooden hull construction could be seen. At either end of the “hill” the remains of the stem and stern posts could be made out. What was left of the stern-post protruded from the bottom with a slight list to starboard, and the remains of the stem lay about 5 m in front of the fore part of the wreck. Cannon barrels were lying on the ballast stones, along the sides of the wreck and between the wreck and the stem. The still-legible dates on their first reinforce sections showed that they had been cast at the end of the 16th and at the beginning of the 17th centuries. An inspection of the surface layer of ballast stones revealed other objects of historical interest. It was likely that the wreck was what remained of the hull of a warship which had sunk in the 17th century, possibly in the first half of that century. This was encouragement enough to undertake a systematic exploration — in any case, to leave the wreck where it was, i.e. on the site of the future anchorage, was tantamount to its almost certain destruction.

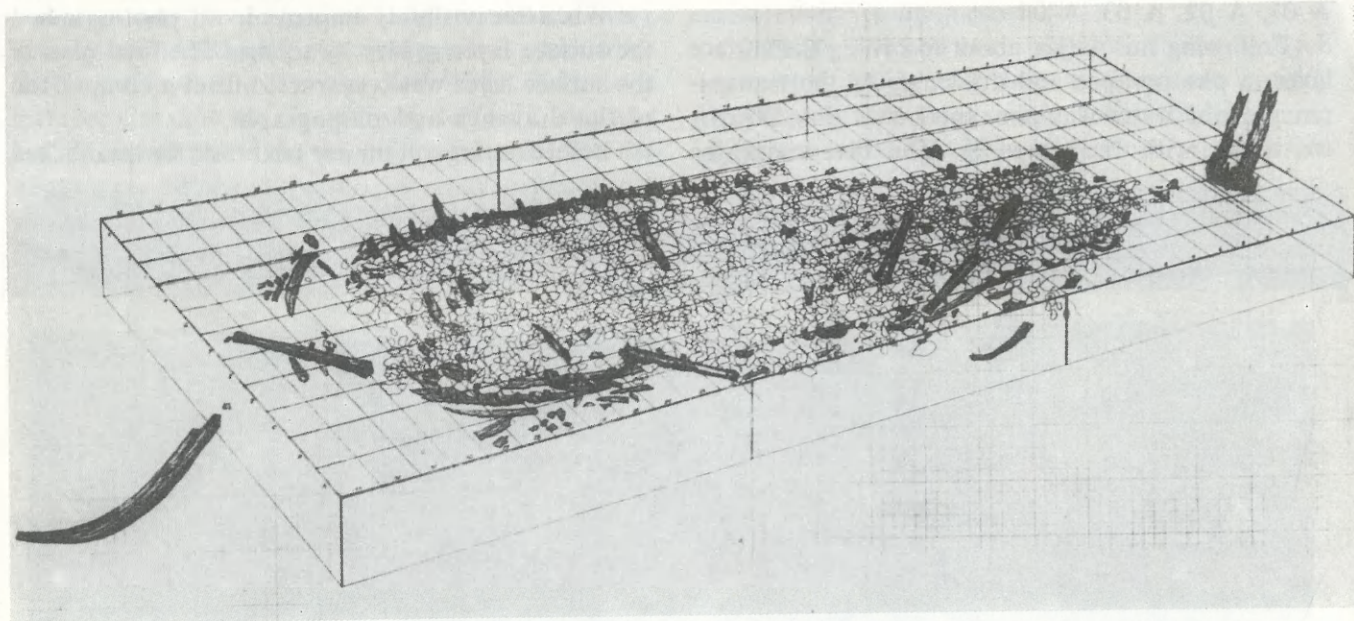
Fig. 6. Measuring frame and overall plan of the W-6 wreck — perspective projection — carried out in summer 1970.
Drawn by W. Krzyżaniak

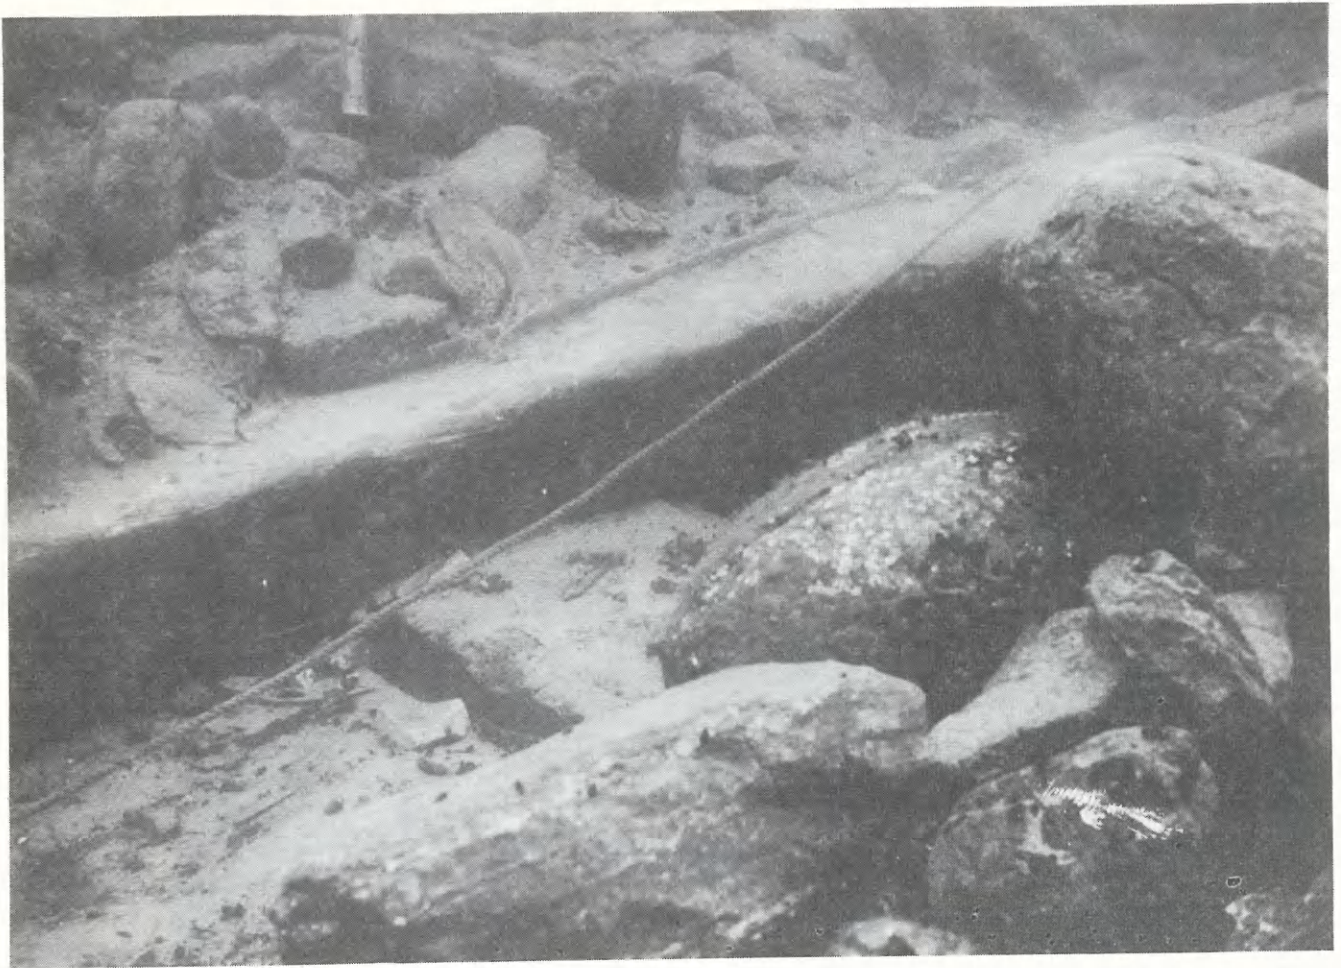
Fig. 7. Execution of transverse section in strip 18: fragment of kelson and inner floor timber visible.
Drawn by L. Nowicz

In strip 18 we found the keelson, running more or less along the wreck's axis of symmetry, and either side of it 10 strakes of the inner planking; the tenth strake began the bilge. From the side adjoining strip 17 a bottom timber placed on the keelson ran across the hull. To the left it was extended by an adjoining fragment of a frame which passed into the damaged port side.

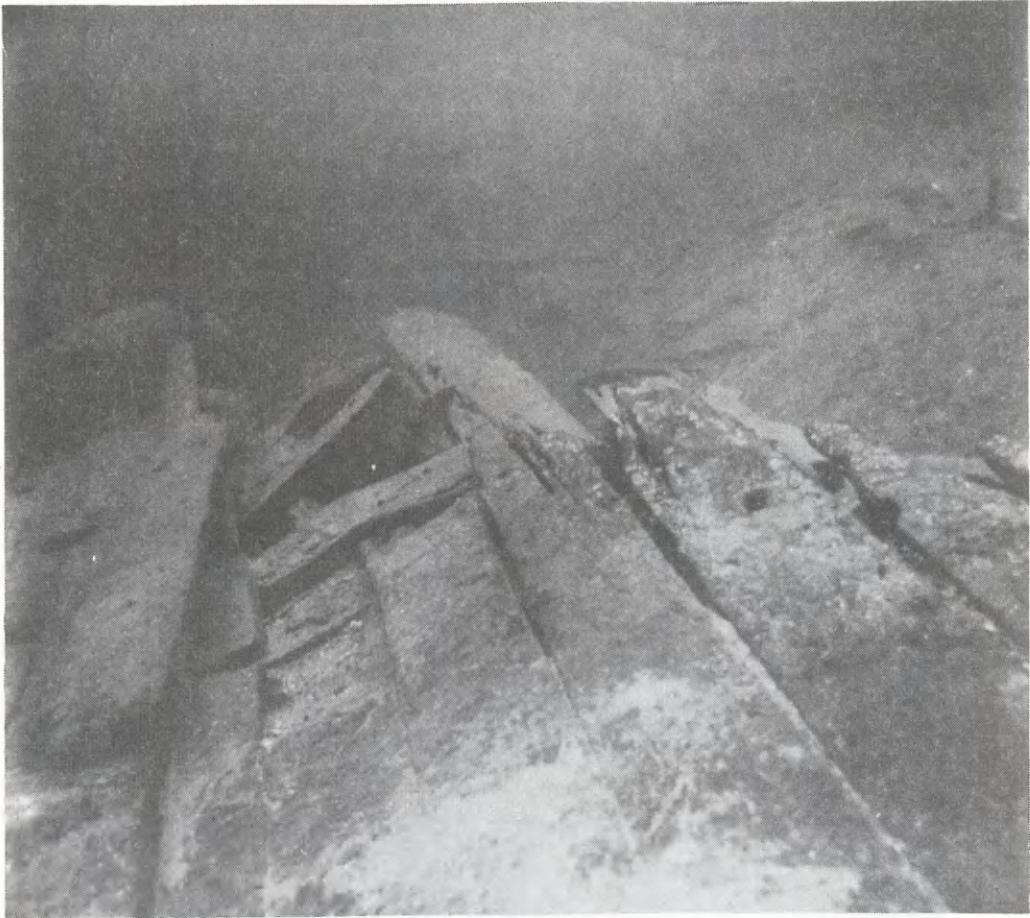
Fig. 10. Fragment of port-side stern part of the W-6 wreck, after removing ballast stones and cleaning inner planking.
Photo. L. Nowicz

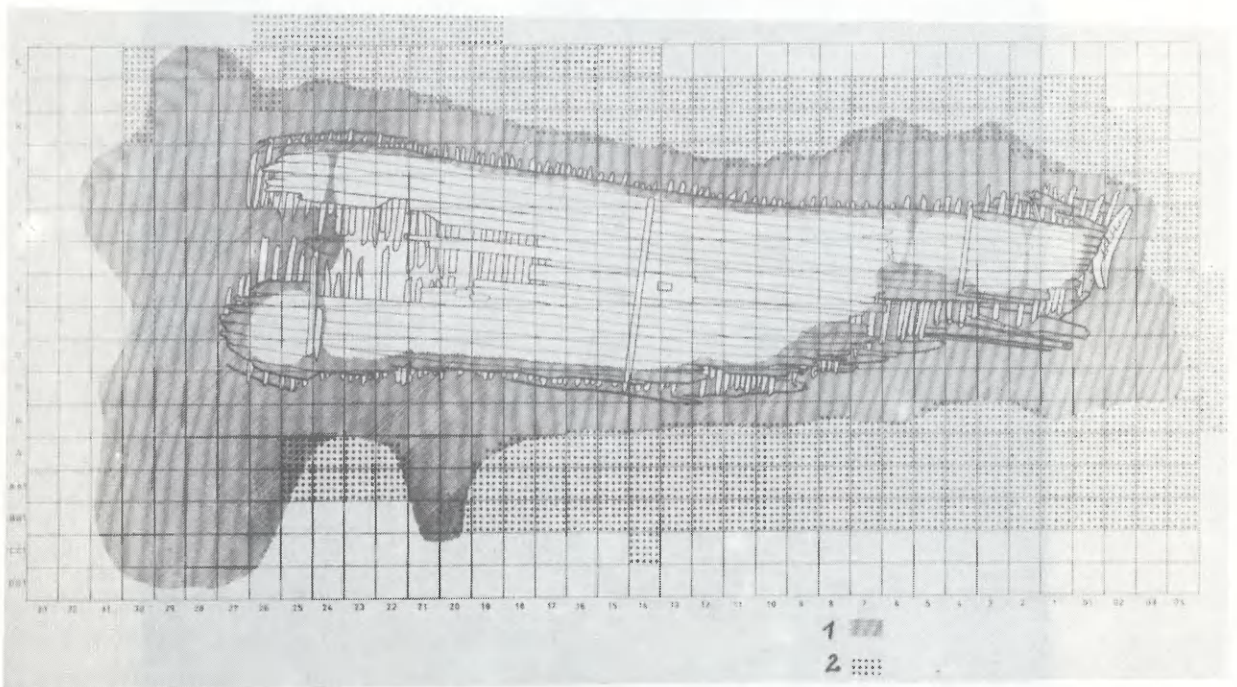
Fig. 11. W-6 wreck after removing ballast stones //// – reach of trench surrounding wreck ∴ – area adjacent to the trench, checked with water jets.

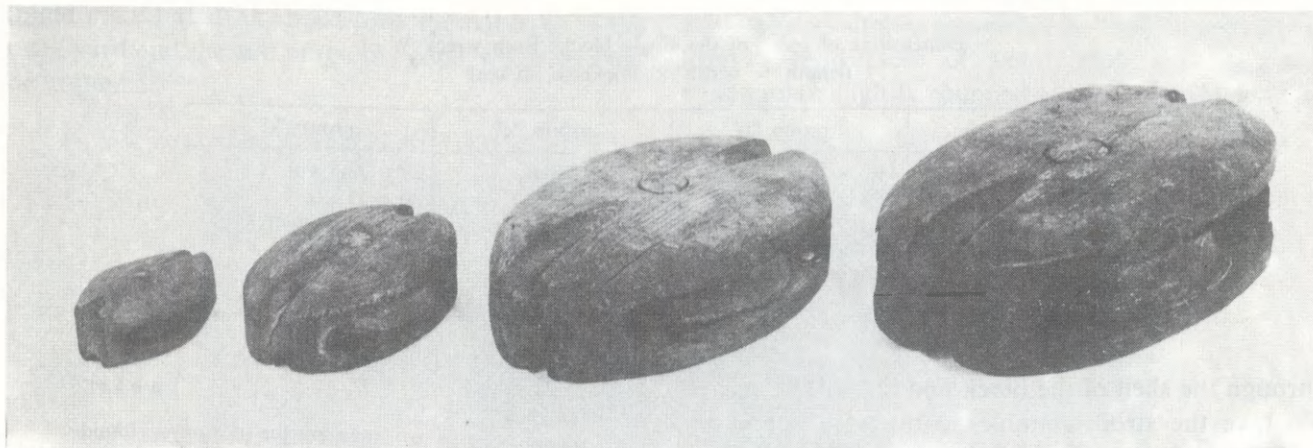
Fig. 13. Single blocks from the W-6 wreck (from the left – “a”, “b”, “c” and “d” group blocks).
Photo. E. Meksiakowa

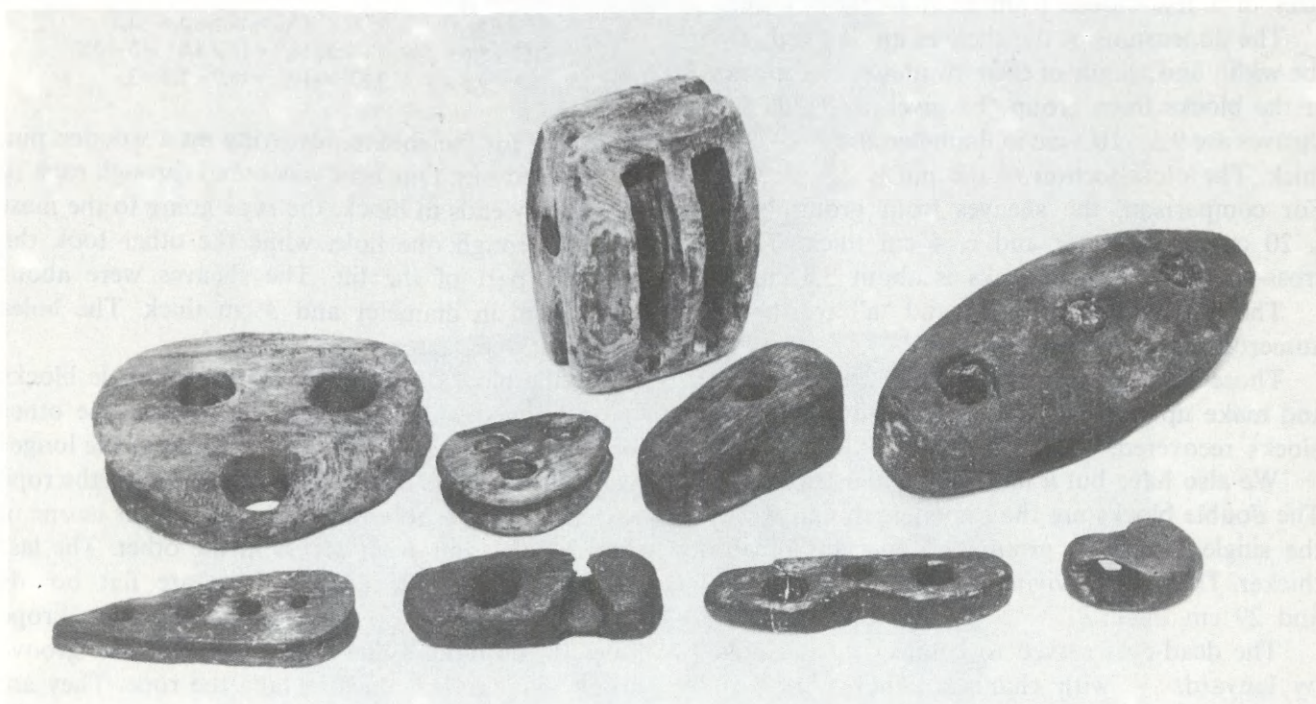
Fig. 14. Selected types of blocks from the W-6 wreck, incl.: – double block, larger and smaller dead-eyes, lift block and other items of the ship's fittings.
Photo. E. Meksiakowa

The dead-eyes found in the wreck correspond in principle to this pattern. Oval or slightly elongated, they are small or large (see Table 3). In some of them, fragments of ropes were found in the gorge running round the circumference of the dead-eye.

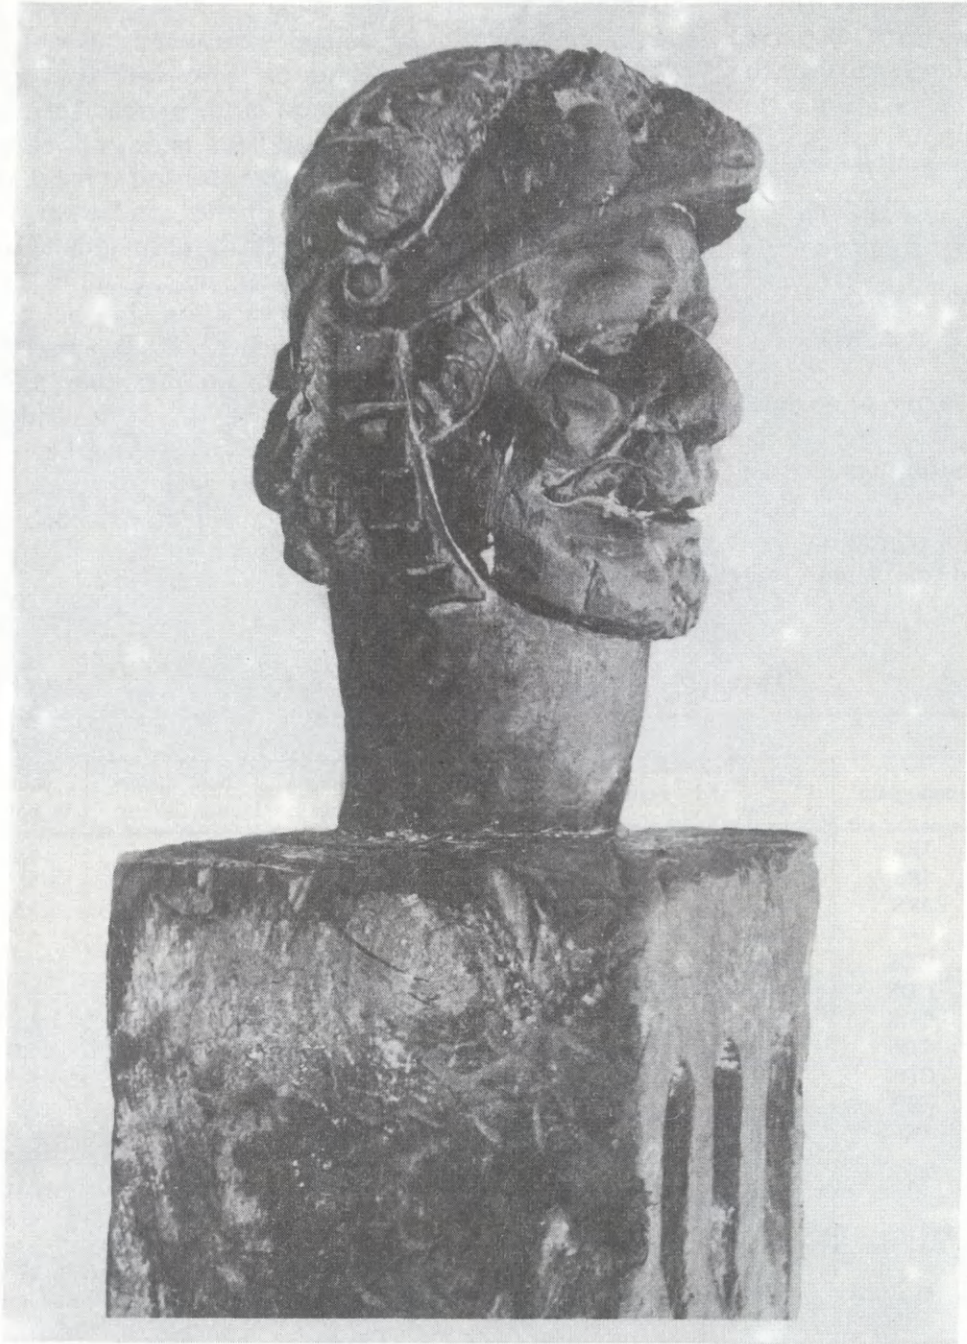
Fig. 15. The "Knight's" head from the W-6 wreck.
Photo. E. Meksiakowa

crowned with the sculpture of a knight's head. The knight placed abaft the mast took the halyards of the lower yard and the end of the top rope, which hoisted the topmast.¹⁶

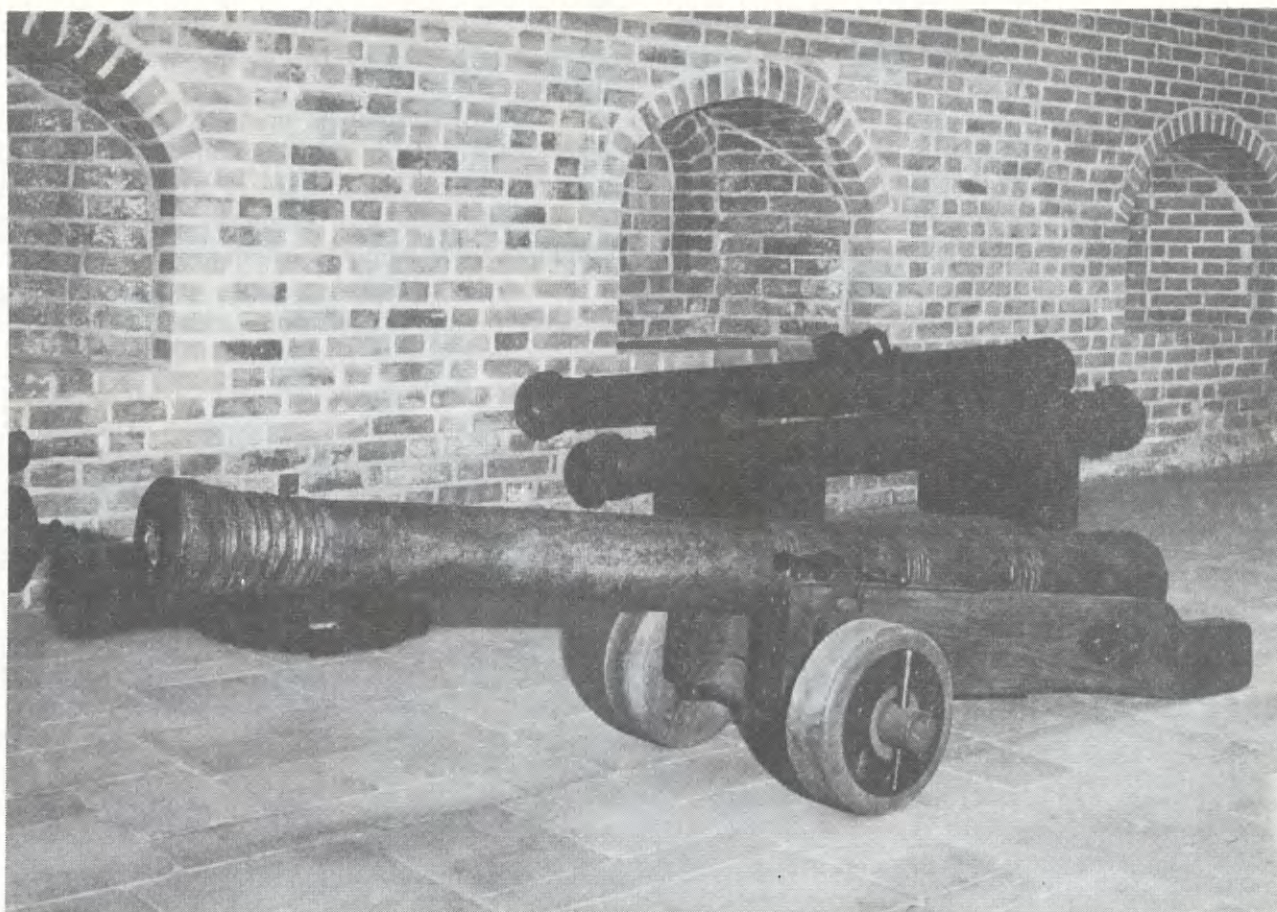
Fig. 16. So-called “Russian” cannon (after conservation) — on a single-axle gun-carriage reconstructed in the Museum. Fragment of the exhibition in the Polish Maritime Museum at Gdańsk.

The cyrillic inscription "Delal Bogdan" is visible on two of the cannon. They may therefore have come

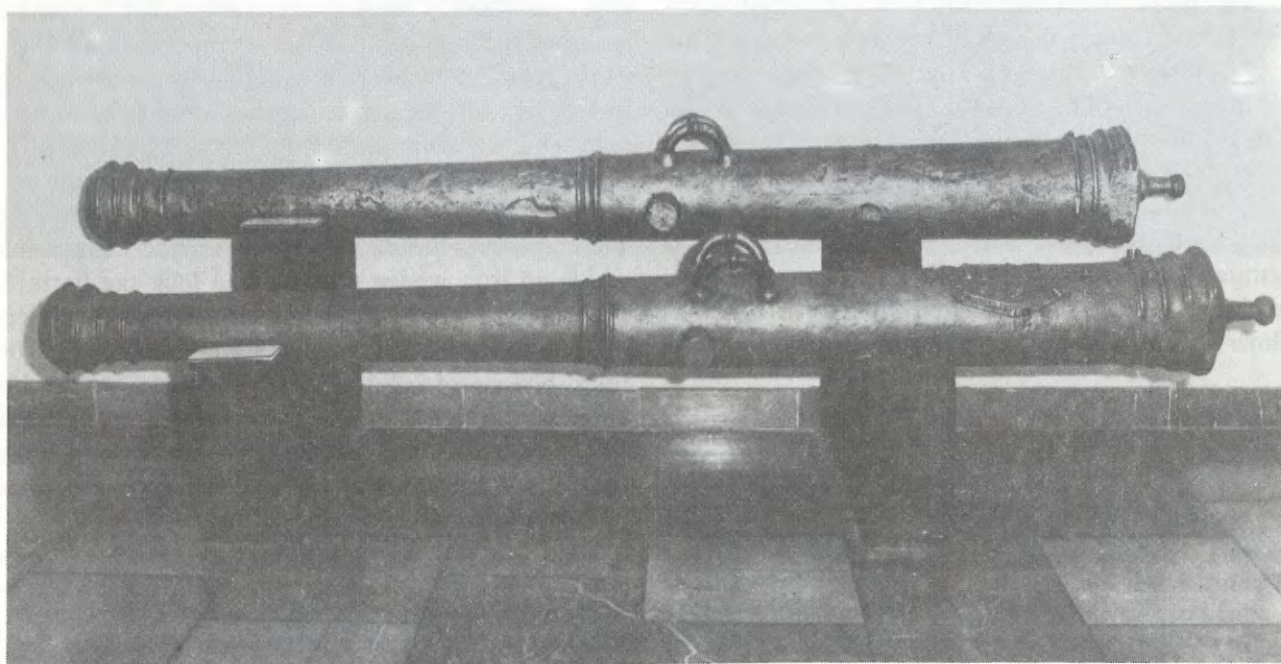
Fig. 17. Polish cannons from the W-6 wreck: lower — bronze cannon cast for King Zygmunt August in 1560, upper — cannon cast for the Radziwiłłs.

The Polish cannon is of a bronze alloy considerably enriched with tin, which made it harder and more resistant to wear and tear. Furthermore, enrichment of this alloy with antimony and keeping the sulphur and iron contents low, improved its mechanical properties and its resistance to low and high temperatures and to corrosion. Indeed, this particular barrel is in the best condition of them all.

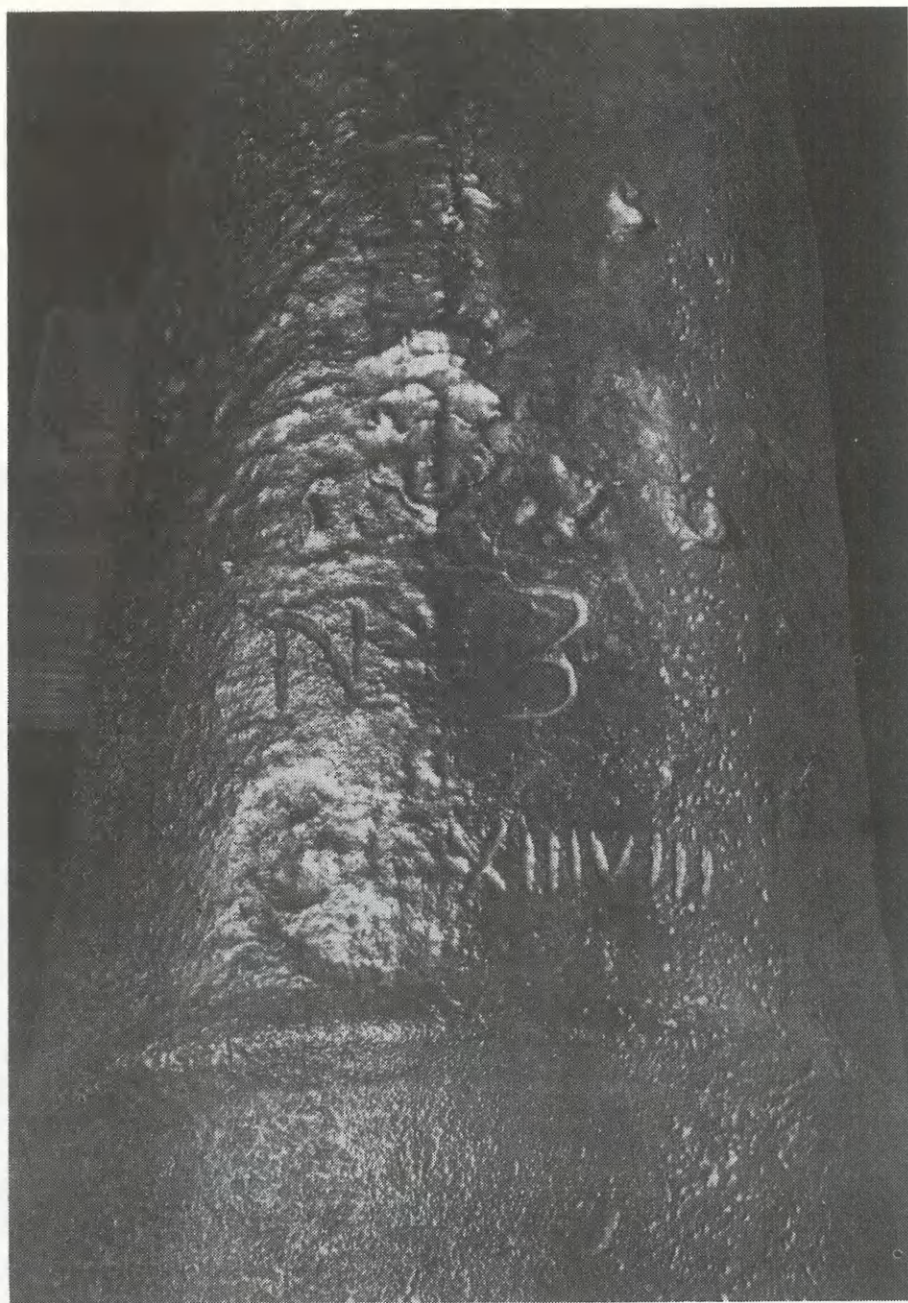
Fig. 19. Bronze cannon cast for the Swedish King Johan III in 1570. Vasa coat-of-arms and arsenal number visible.
Photo. E. Meksiakowa

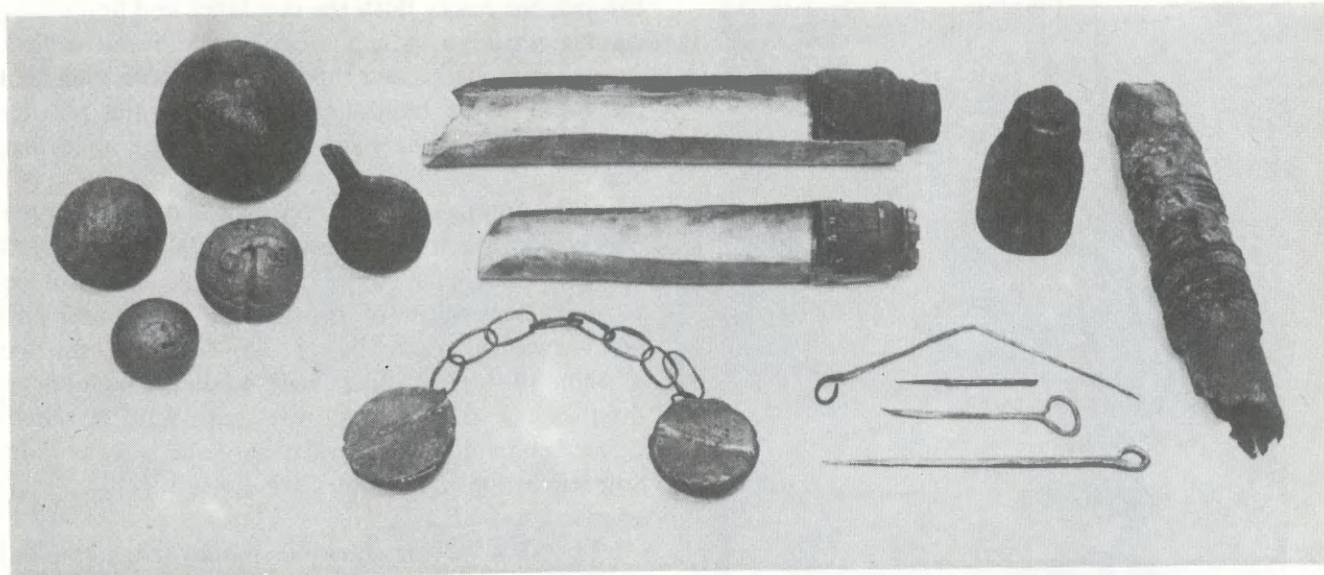
Fig. 20. Cannon balls, powder ladles, rammer head, fragment of cleaning brush and reamers, from the W-6 wreck.
Photo. E. Meksiakowa

They were made in a similar way, and differ only in their dimensions. They had long, wooden poles at the end of which there were wooden heads. These heads had a hole bored through them along their axis of symmetry into which the pole was inserted. The round body of the heads, narrower somewhat at their inner ends, served to fix the metal part of the scoop to the pole. The scoops were made from rectangular sheets of metal bent inwards. The lower part of the scoop, cut off straight, was affixed to the head with copper nails. The upper end was cut semicircularly. The width of the scoop was appropriate to the calibre

of the cannon. One of the scoops found is 42 cm long, 8,9 cm wide at the head and 8,4 cm wide at the other end, and 5,5 cm deep. The smaller scoop is 31 cm long, 6,3 cm wide at the base and 6 cm wide at the open end, and 4 cm deep.

The construction of the cleaning brushes and rammers was quite similar to that of the ladles. Heads were fixed on the wooden staff, except that in brushes, the scoop was replaced by a packing of oakum or fur. One of the rammers was constructed slightly differently: the staff was replaced by a rope.

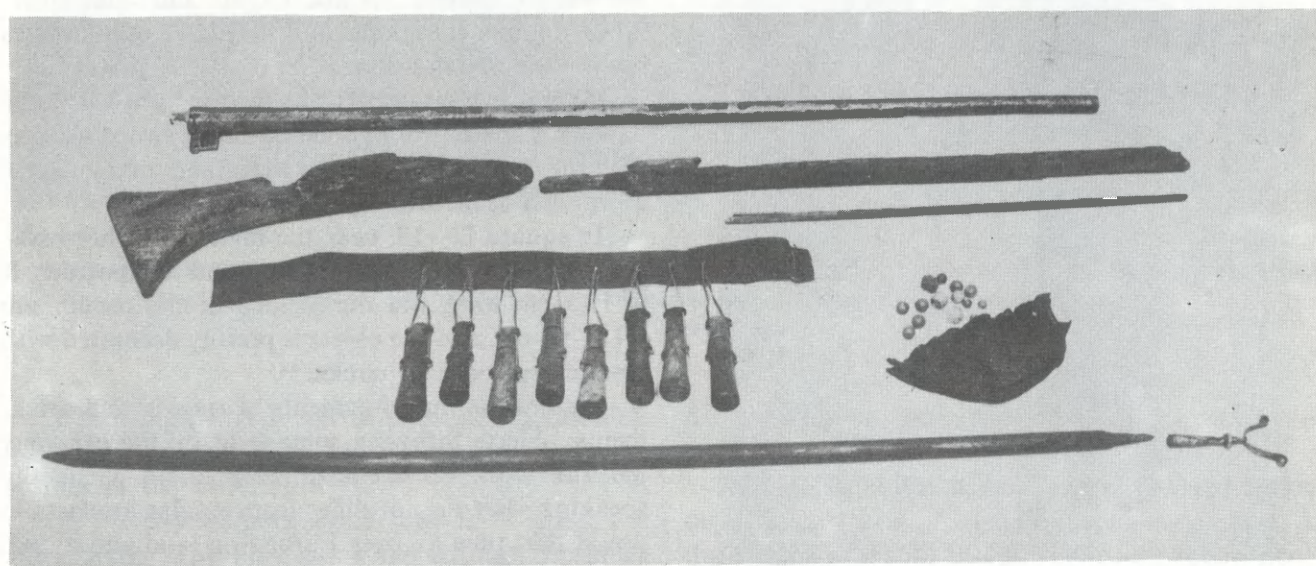
Fig. 21. Musket parts (butt, barrel, stock, cleaning rod), bandolier with powder bags, shot pouch, ammunition and musket rest.
W-6 wreck.
Photo. E. Meksiakowa

The musket rests consist of wooden props and metal forks. The props are from 107 to 123,5 cm long (mostly c. 118 cm), and 1,9 to 2,4 cm in cross-section. Some have had marks of ownership engraved on them. Their lower parts are sharpened to a point but no possible metal fittings were found. The upper parts

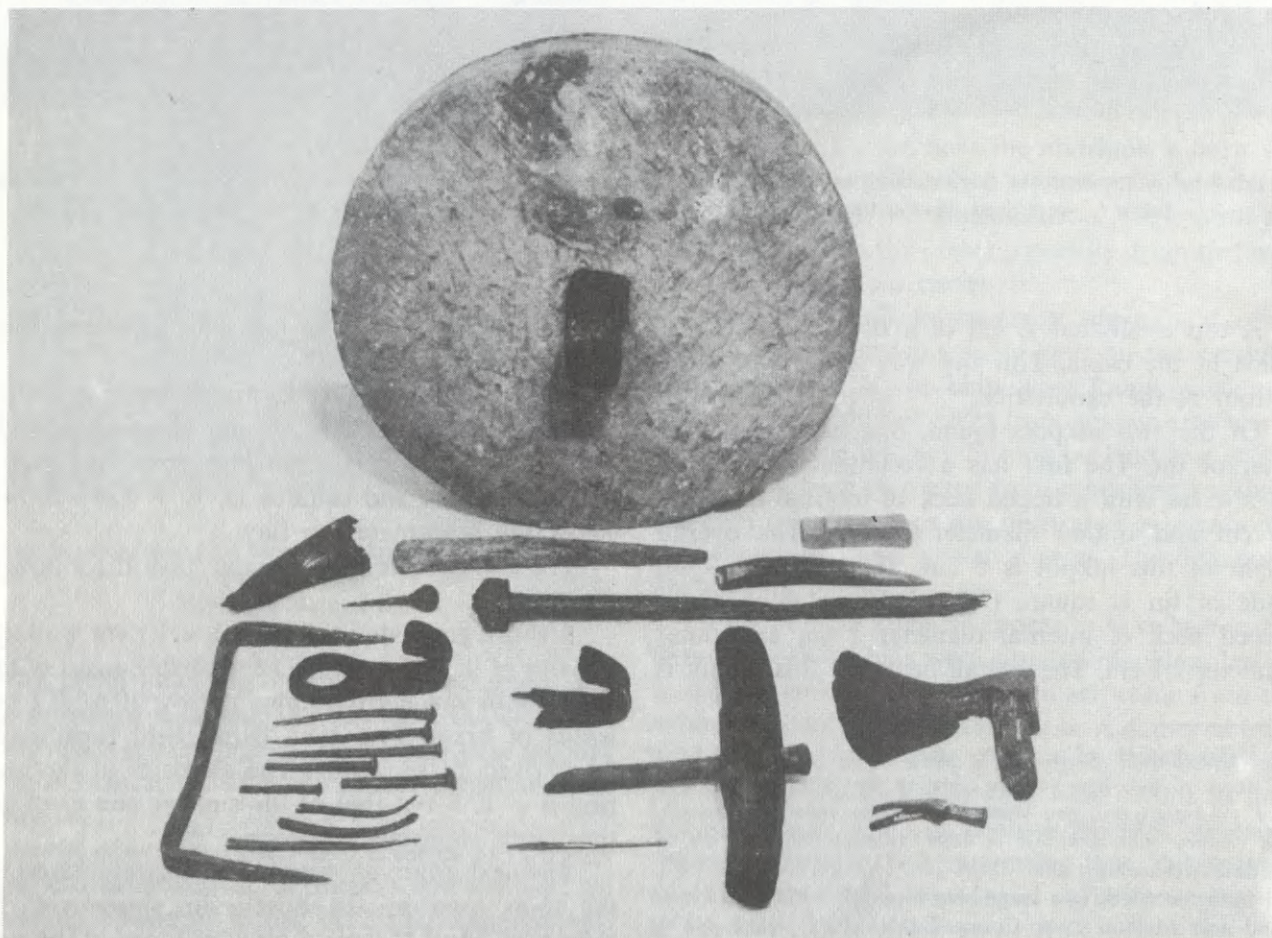
Fig. 24. Tools from the W-6 wreck: grinding wheel and whetstone. Below (from the left): horn for holding needles, awl and two marline spikes. Lower: bolt, clasp, lifting slings, ails, chisel, mallet, claw hammer and hatchet.

The grinding wheel, made from sandstone, and in excellent condition is 55 cm in diameter and 10,3 cm thick, and revolved on a wooden axle $5,4 \times 6$ cm in cross-section. Part of this axle has also survived. The whetstone, also of sandstone, is 11,5 cm long, and is rectangular in cross-section.

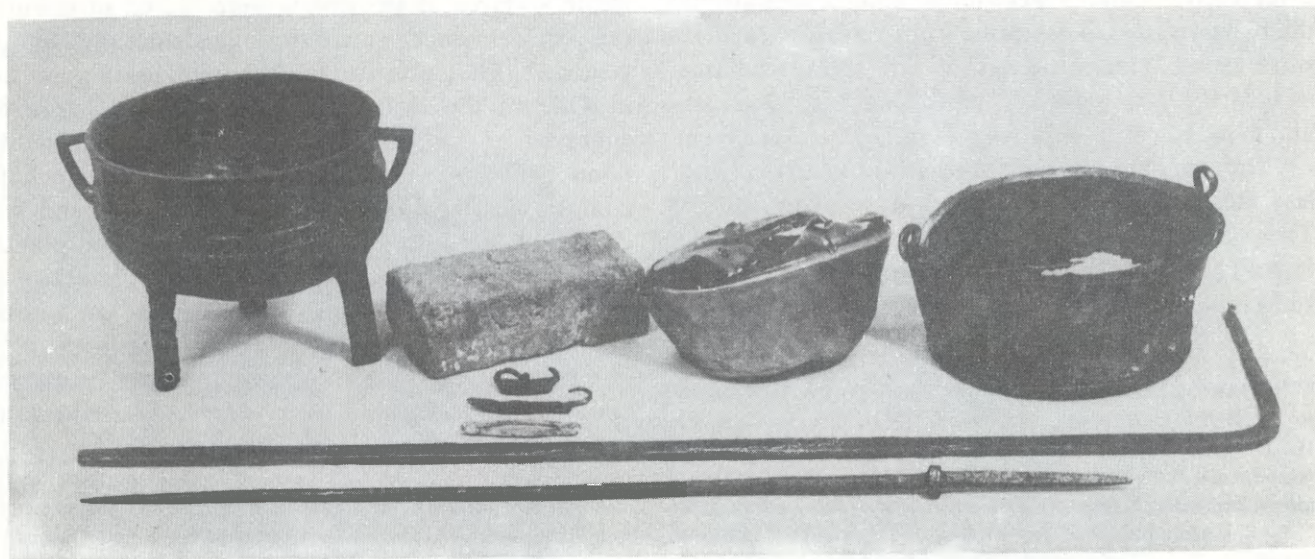
Fig. 25. Galley utensils: iron kettle with three legs, hearth brick, cauldrones, tinder-boxes, hanger?, spit.
Photo. E. Meksiakowa

The bricks found in squares 18 C and 18 E, i.e. before the mainmast are probably from the ship's galley. One of them, No 89/74 in good condition, measures $28 \times 15 \times 9$ cm. Near these bricks, in square 18 A there was a metal object, No 90/74, which could have been a hanger affixed above the fire-place. This presumed hanger, rectangular in cross-section is now right-angled in shape; its longer arm is 131 cm long, the shorter one is 35 cm long. There are two pairs of holes in the longer arm, the

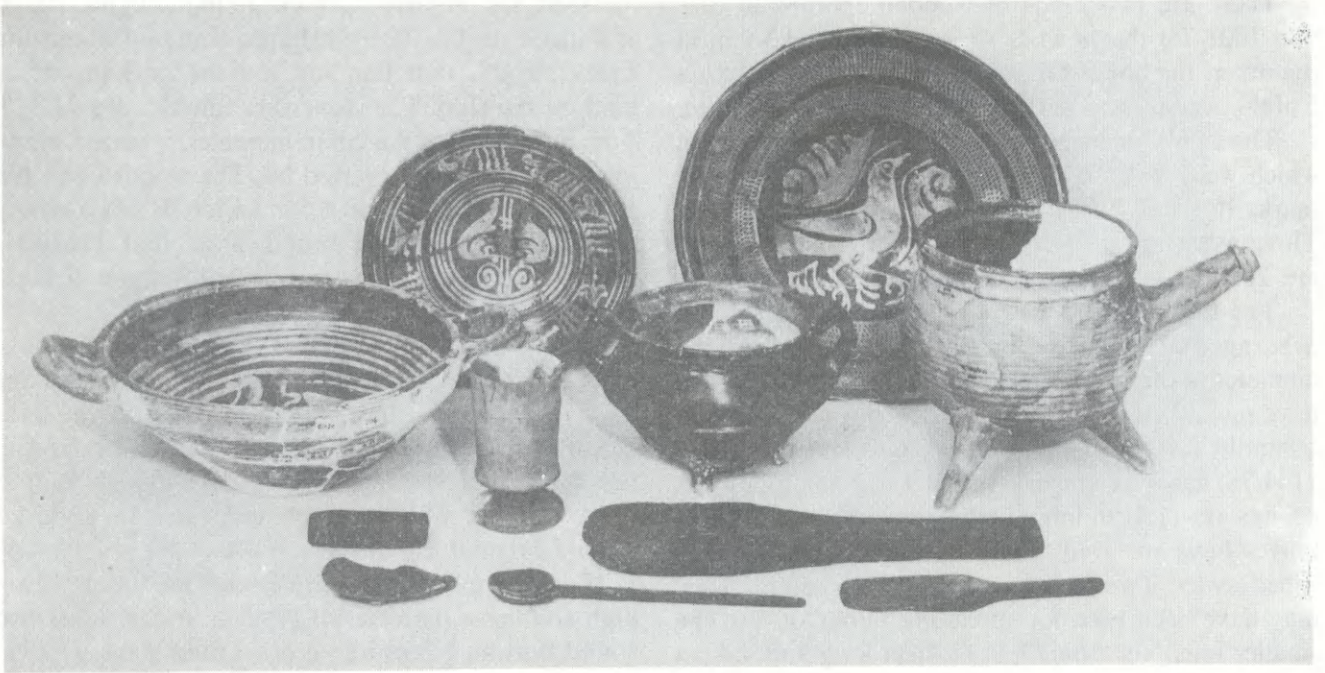
Fig. 26. Wooden and ceramic utensils; below right: spoons and spatulas.
Photo. E. Meksiakowa

There are two kinds of wooden spoons. In one, (No 1001/78) the bowl is roundish, 4,5 × 4,3 cm, in the other, the bowl is more elongated oval. There are 5 of the second type in the set of spoons that survived.

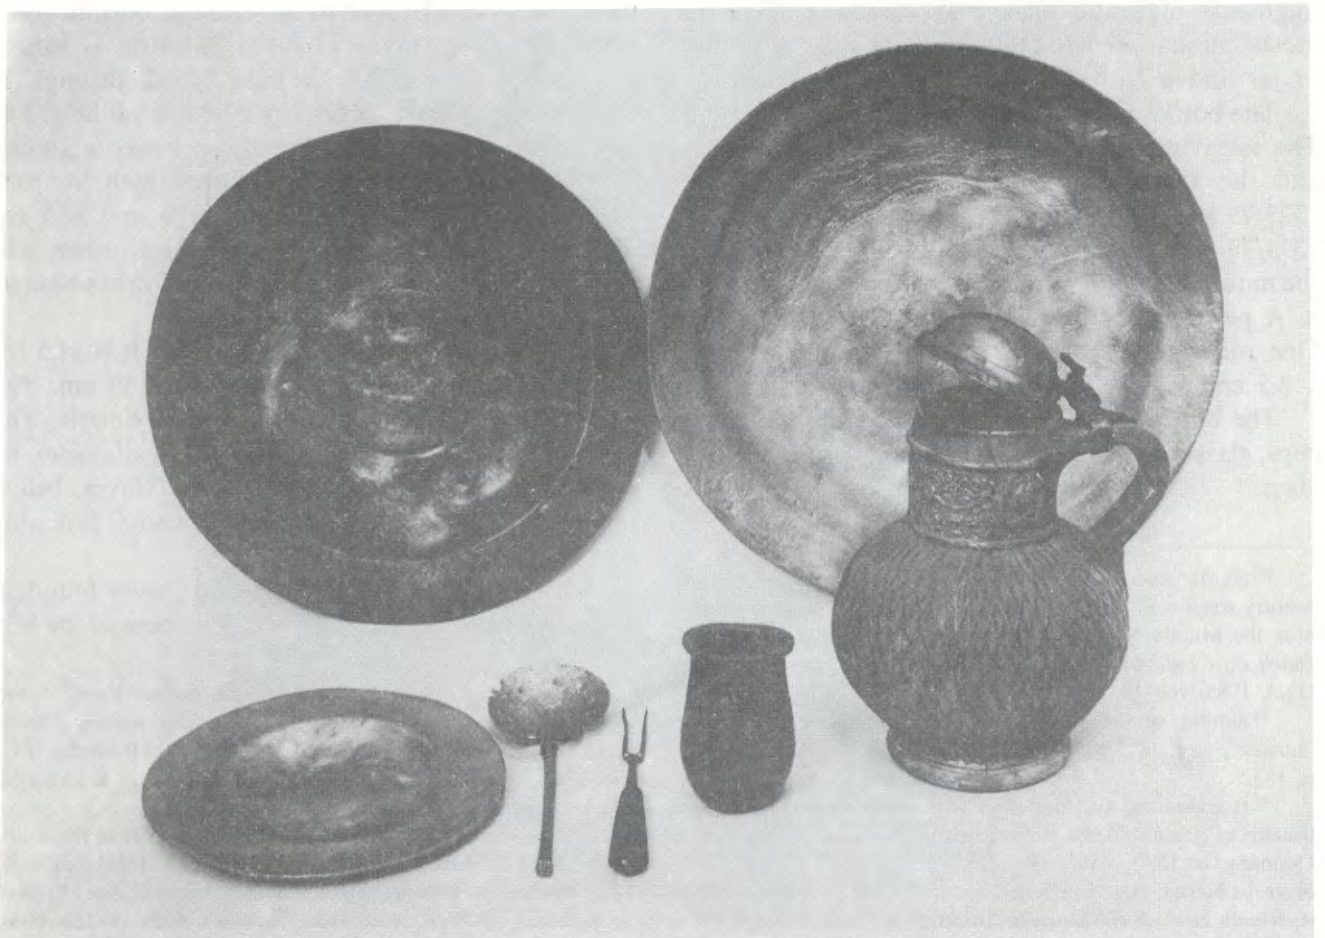
Fig. 27. Pewter bowls and plates, spoon, fork, stoneware cup and jug.
Photo. E. Meksiakowa
