RB/50/2017

**Photogrammetry
with application to
fresco documentation**

**R. Bieńkowski, A. Kaliszewska,
S. Łapiński, J. Markiewicz**

Instytut Badań Systemowych
Polska Akademia Nauk

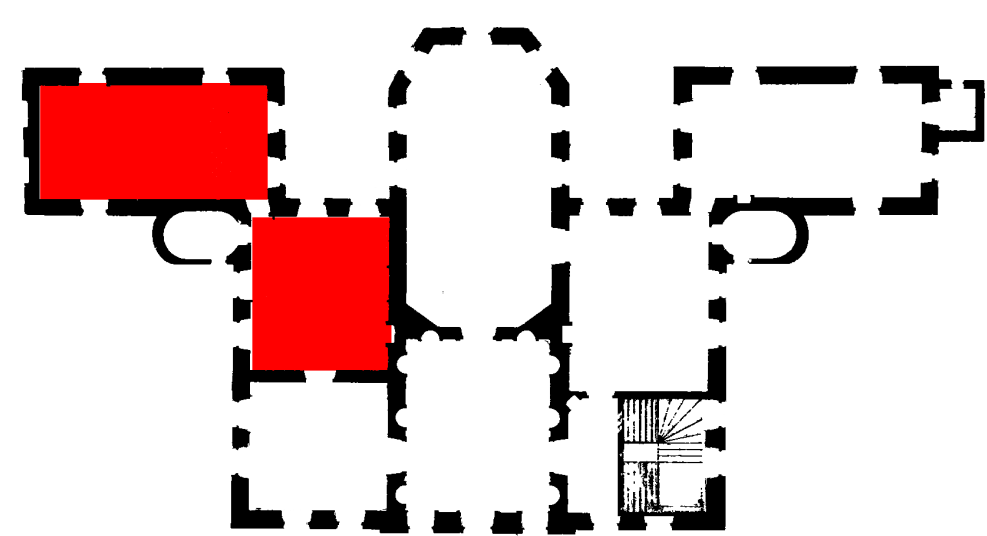
Fig.2. The Bieleński Palace floor plan. The investigated rooms shown in red.

lected data on the room through geodesic measurements and photos. A series of geodetic measurements was conducted in the investigated room as well as an adjacent room, in order to establish the ground control points, used for the orientation of the close-range images (Fig.2). As a result

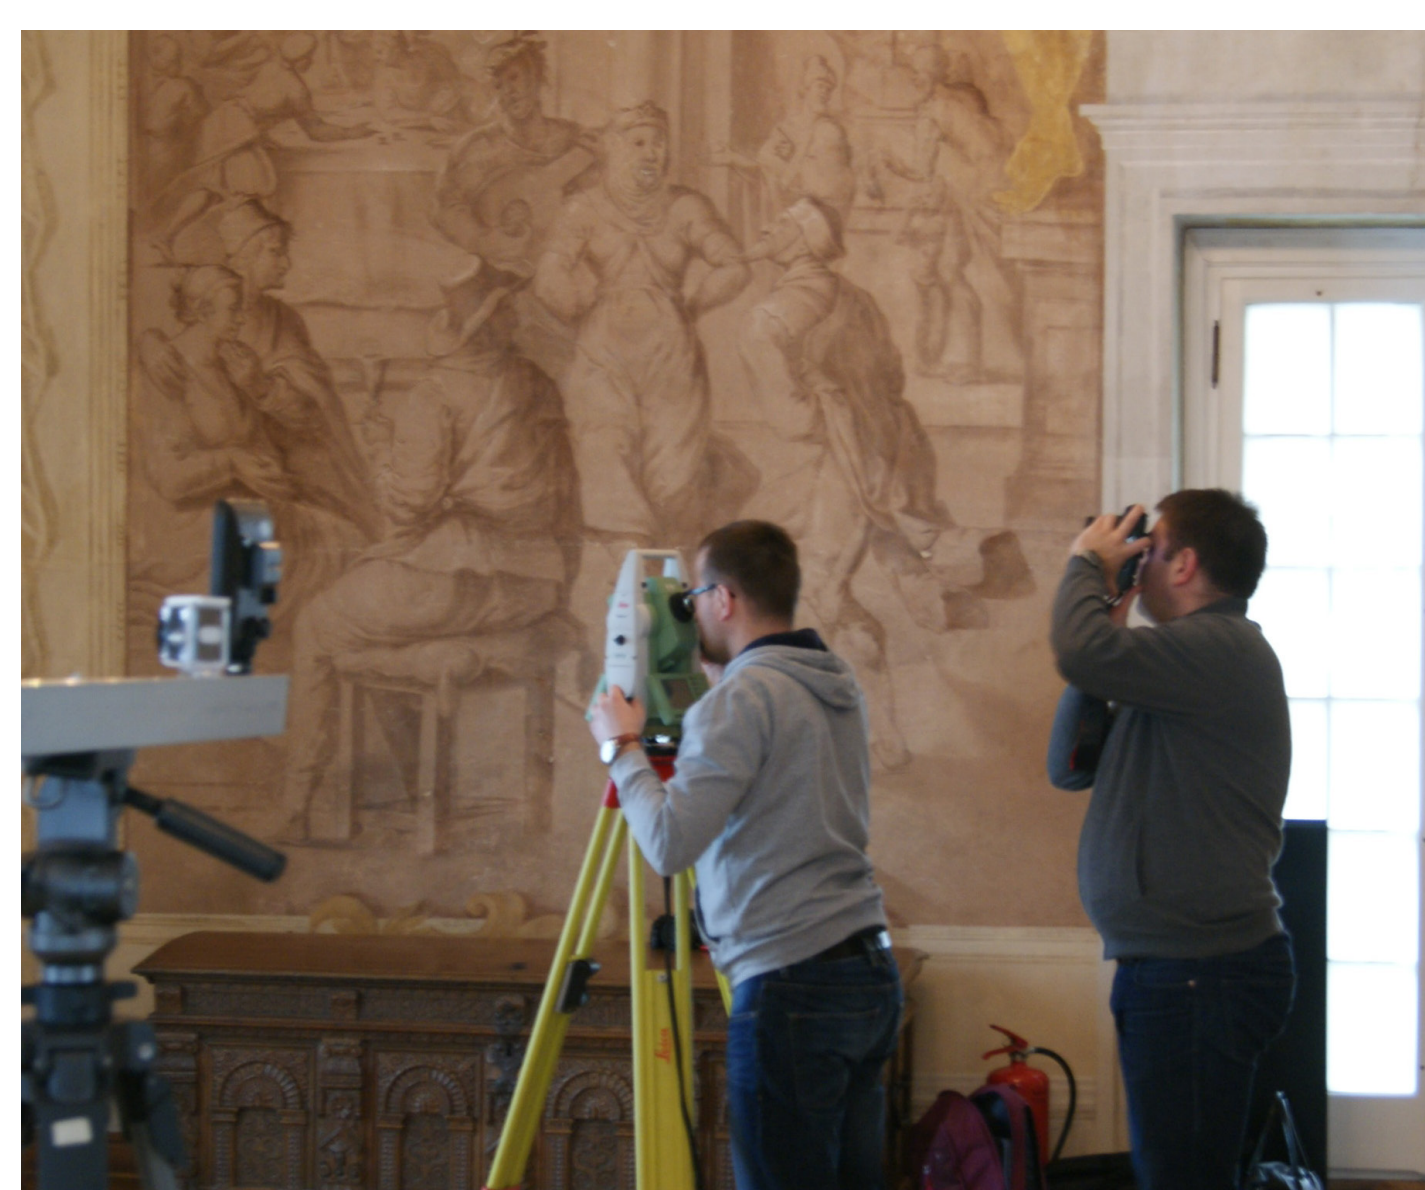
Fig.3. Gathering of the data.

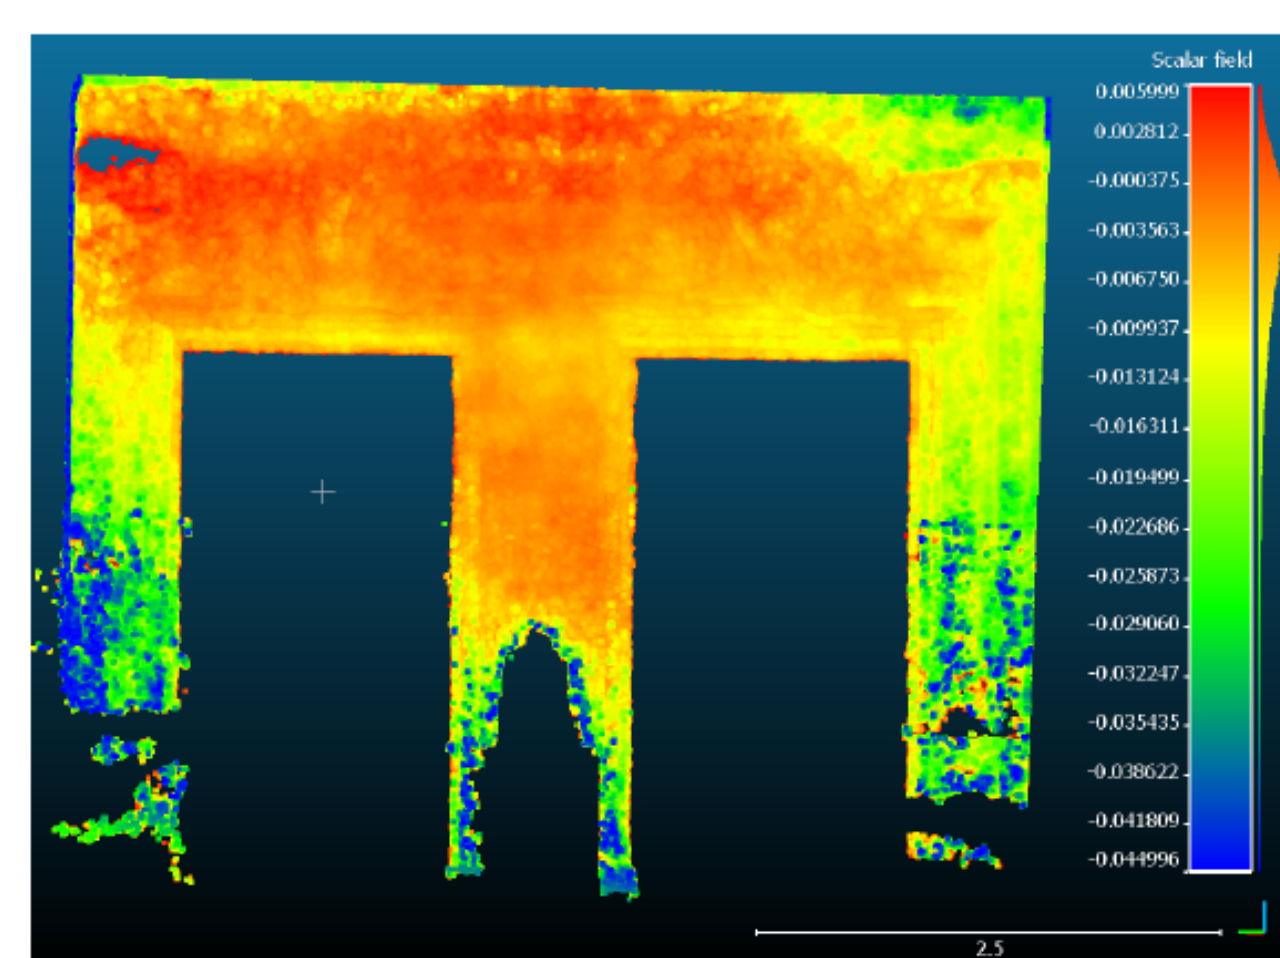
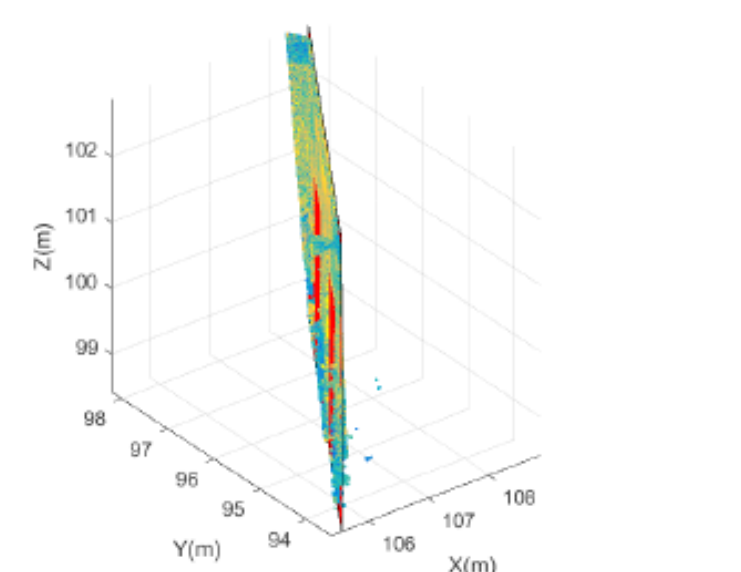
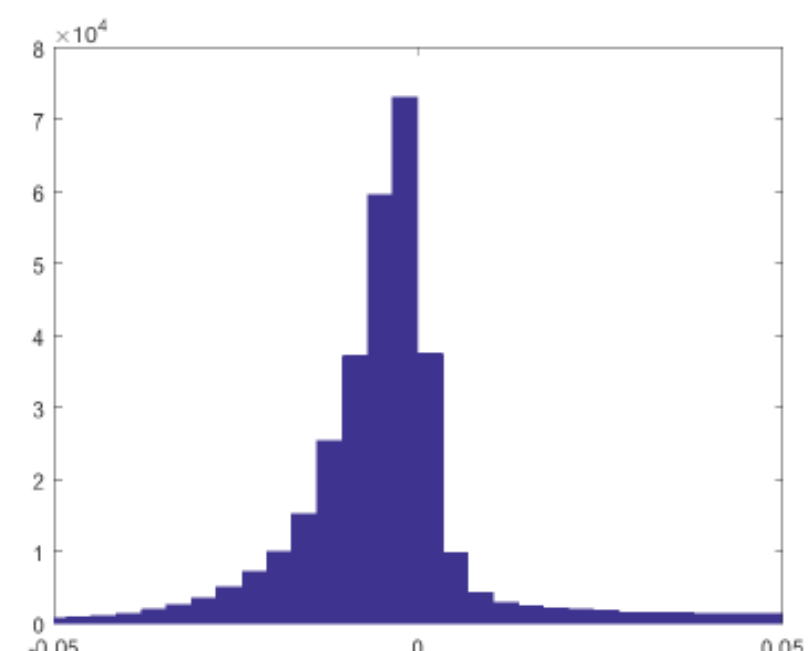
Fig. 4. A) Map of point deviation from a fitted plane, B) Point cloud with fitted plane, C) Histogram of point deviations from a plane- Xiaomi Yi 4k

We decided to use the point cloud to perform the analysis of the wall flatness. To that aim an application has been created in the MatLab program allowing the automatic fitting of a plane into a point cloud. In order to achieve that the function `pcfitplane` was used. Figure 3 shows a visualization of the results, where the colours show the distance of the points from the fitted plane.

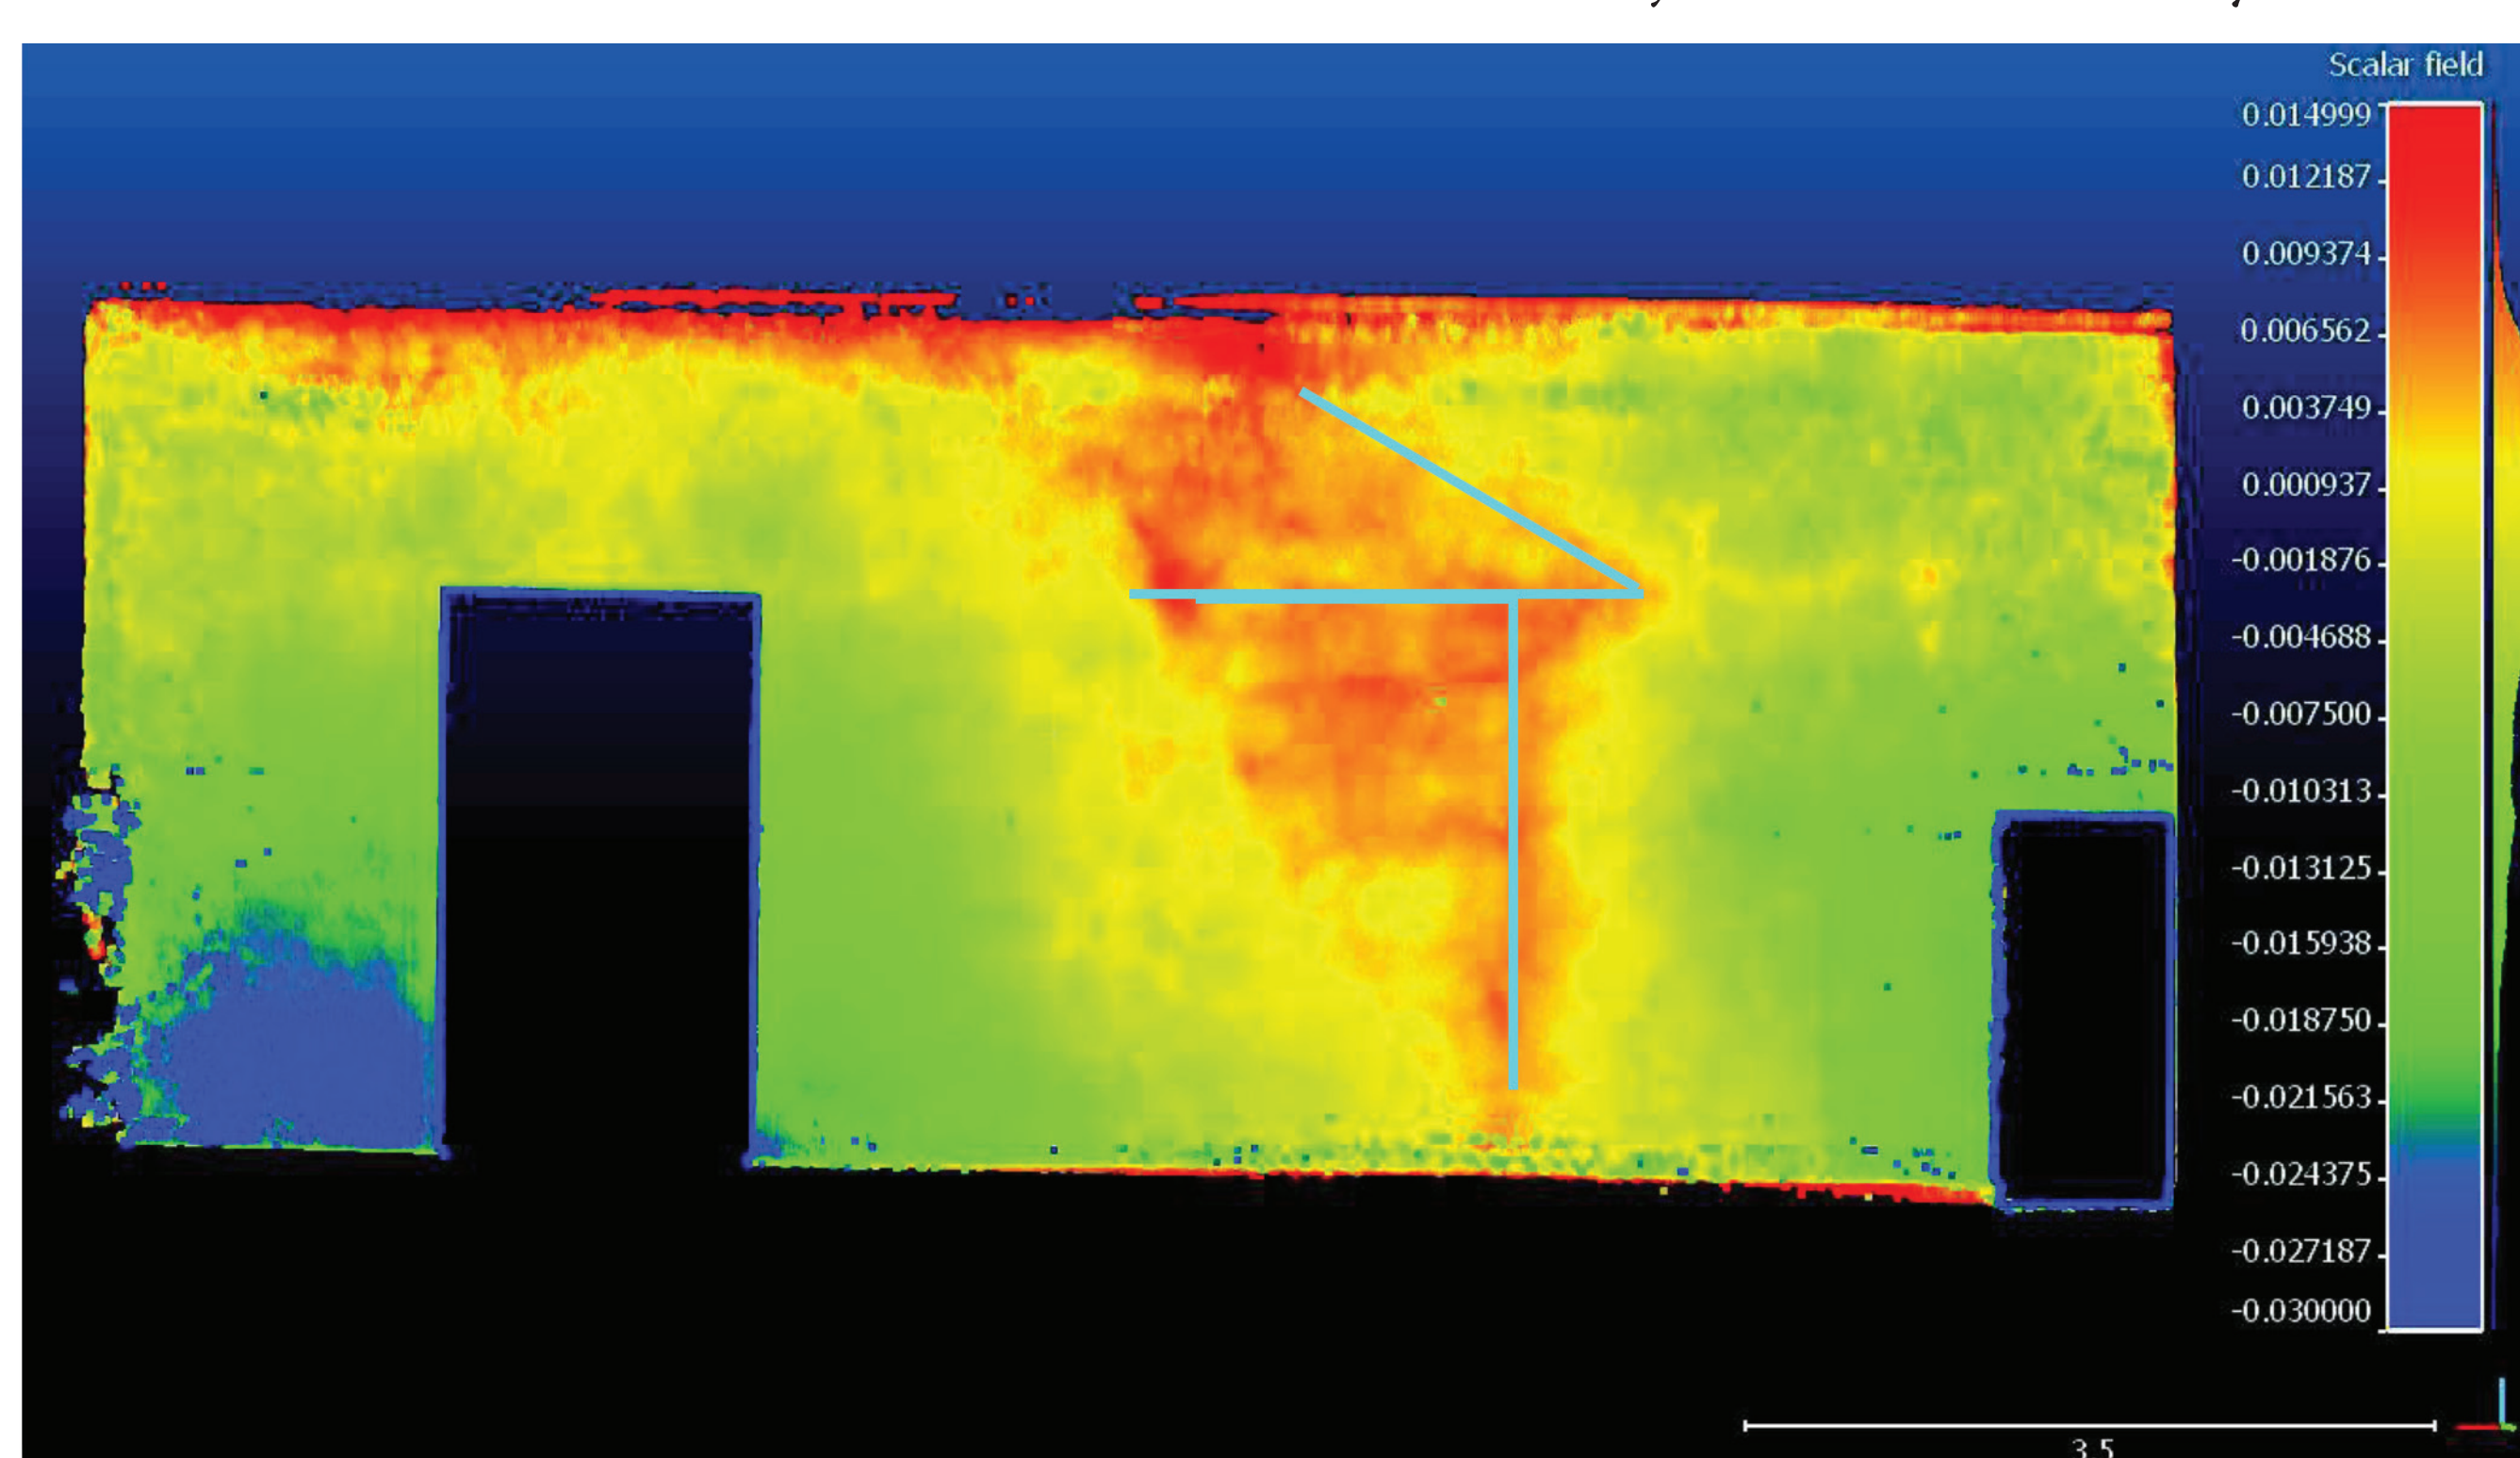
Fig.5. The analysis of the wall flatness with a blocked door clearly showing under the frescoes. Data for the analysis gathered with the low-cost camera Xiaomi Yi 4k.

During the analysis of the flatness of the walls of the investigated rooms patterns in the deviation begun to emerge prompting us for a more detailed investigation of the issue. By mapping the points deviation on the North wall of the room we discovered an outline of an earlier door, now blocked and covered with the frescoes. This outline is clearly visible not only on the point cloud generated from the Canon 5D Mark II camera, but also the one from Xiaomi Yi 4k and 2k (Fig.4)). The height of the door opening clearly coincides with the height of the existing doors and the outline of a tympanum crowning the doors is visible. This proves the usefulness and scientific value of low-cost camera photogrammetric documentation of architecture.

The results of the non-invasive examination allowed us to identify a door that led to the tower in the first phase of the palace, and which was later blocked and covered by the frescoes. The effects of the project show how digital documentation methods can be applied to the analysis of architecture and subtle changes on the surfaces of walls that are often invisible to the naked eye, and that might be evidences of remodeling. If it wasn't for the digital documentation the information about the remodeling would have been inaccessible for us, without the use invasive methods. Such information enriches our knowledge about the architectural objects, and their history.

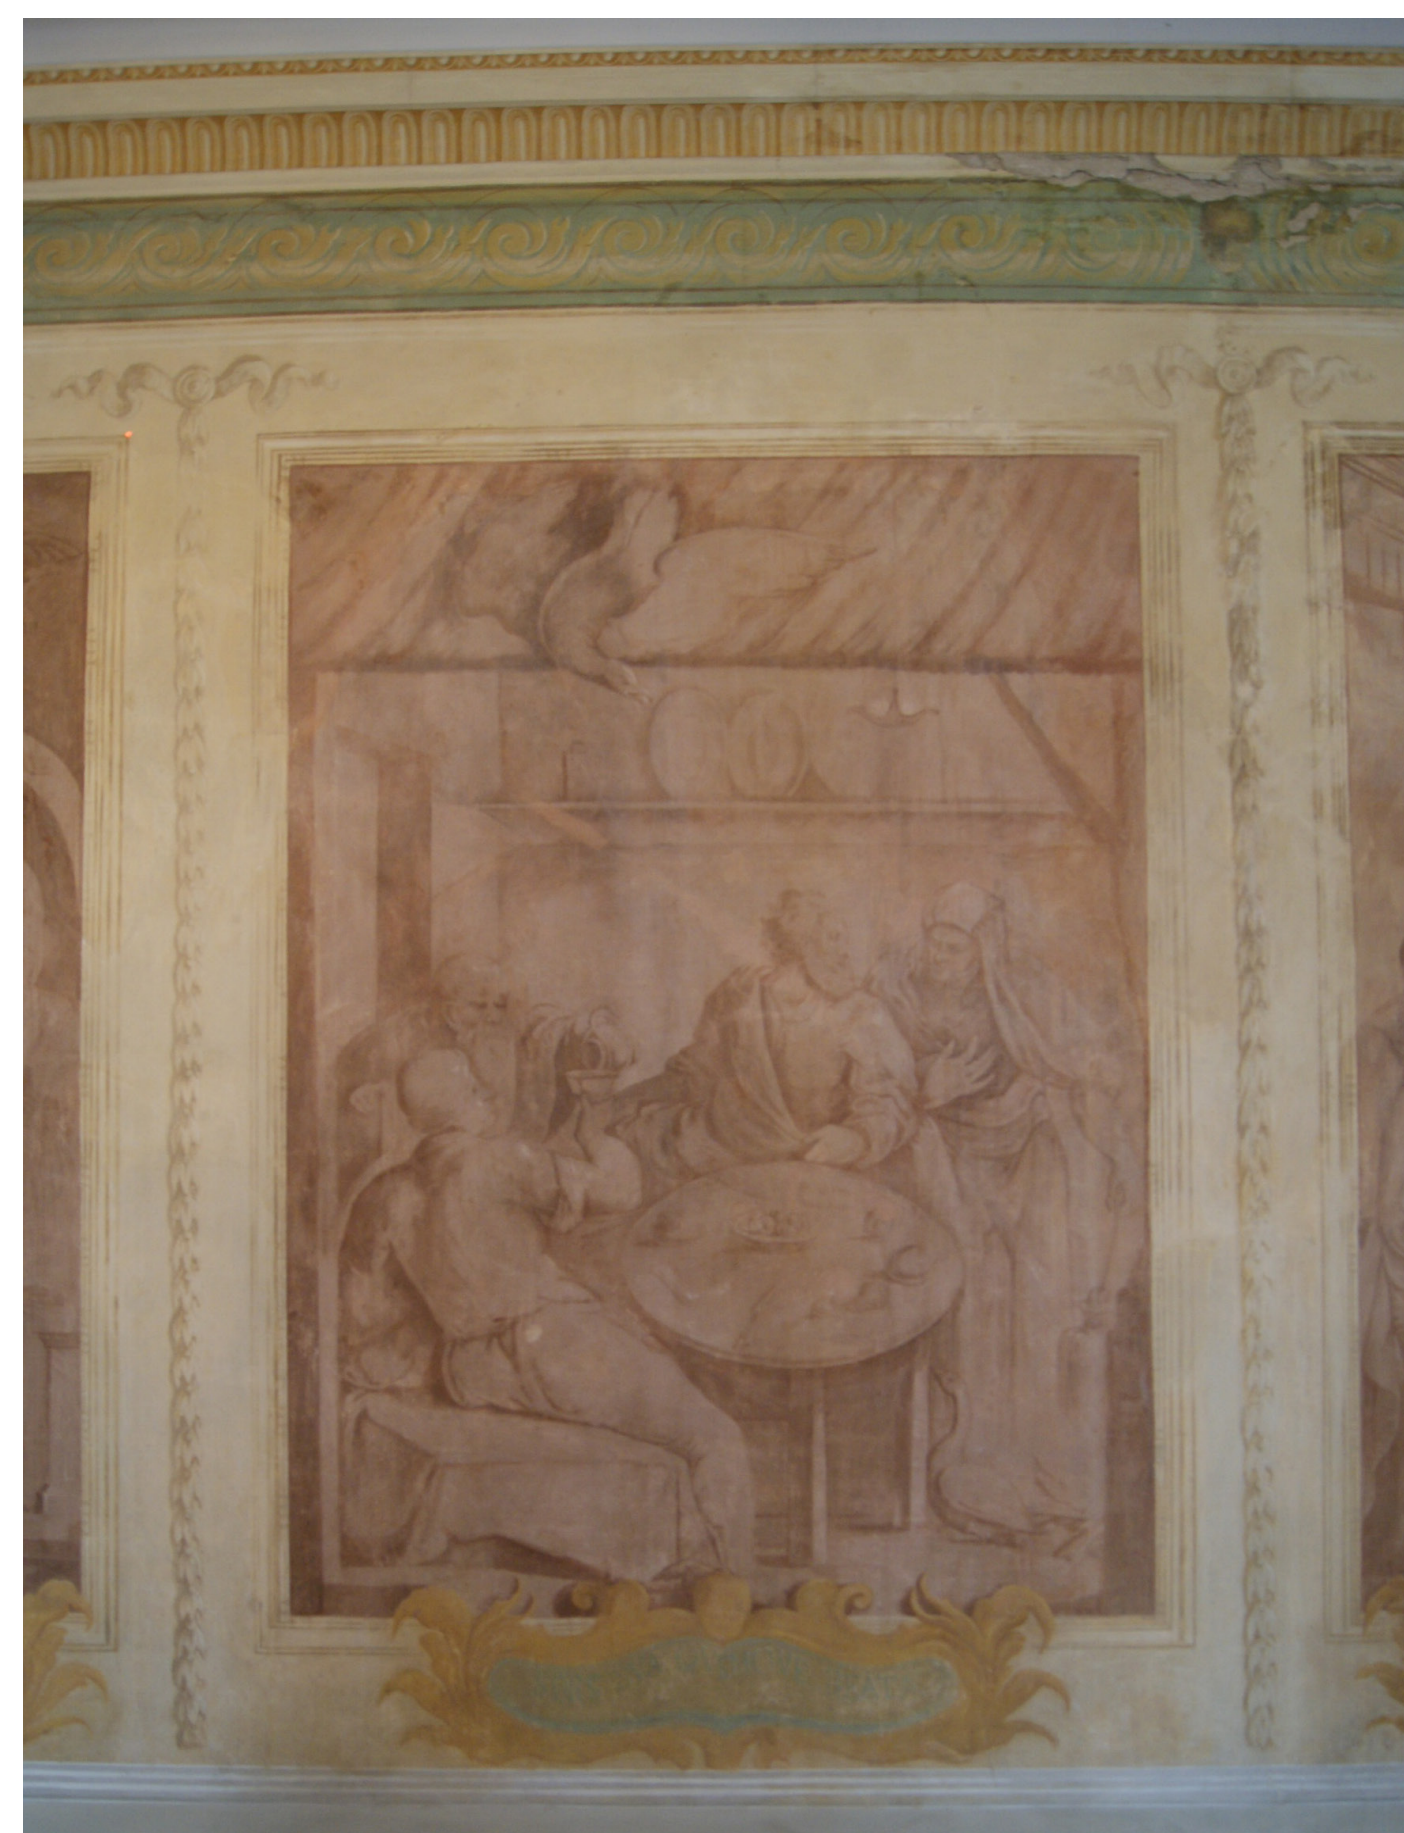
Fig. 6. The fragment of the fresco, behind which the blocked door is located.
