## EVOLUTION OF THE PAGLAJHORA SLUMP VALLEY IN THE SHIV KHOLA BASIN, THE DARJEELING HIMALAYA, INDIA

**Abstract:** The morphologic configuration of the Paglajhora slump valley is controlled by geologic structure and remodelled by the hydro-geomorphic processes. The slope forms exhibit a combination of convex – concave – irregular profiles with highly variable inclination ( $10^{\circ}$  to  $35^{\circ}$ ). Overland flow feeding the uppermost niche during heavy rains transformed into concentrated sub-surface flow over the permeable colluvium. The observed rills and cracks facilitate the piping and deep drainage towards the slumped areas. The high intensity of the processes as well as the relative heights and steep gradients are the limiting factors in the stabilization of the Paglajhora slumps. At present, the form reached quasi-unstable equilibrium. Each extreme rainfall (above 300 mm/day) causes substantial changes in its morphology.

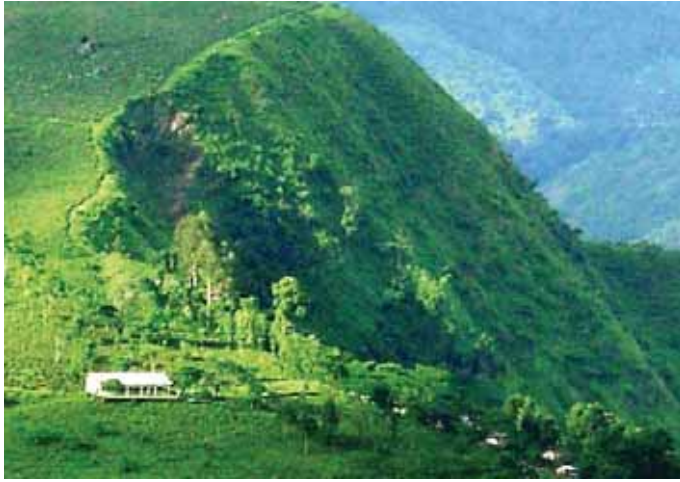
Figure 3. Paleo landslide scar in the upper Shiv Khola basin (Mahaldiram Range)

The investigator, based on his earlier study in Bunkulung and Ambootia (Froehlich et al., 1992; Starkel and Froehlich, 2000), strongly believes that such colluvial material/debris was the product of gigantic palaeo-mass movements that took place along the southern margin of the Mahahaldiram massif even during the close of the Pleistocene. Such mass movements were probably caused by a catastrophic rainstorm. Existence of large palaeo-scars in the Mahahaldiram ridge (concavity in convex slope element) proves such contention (Fig. 3).

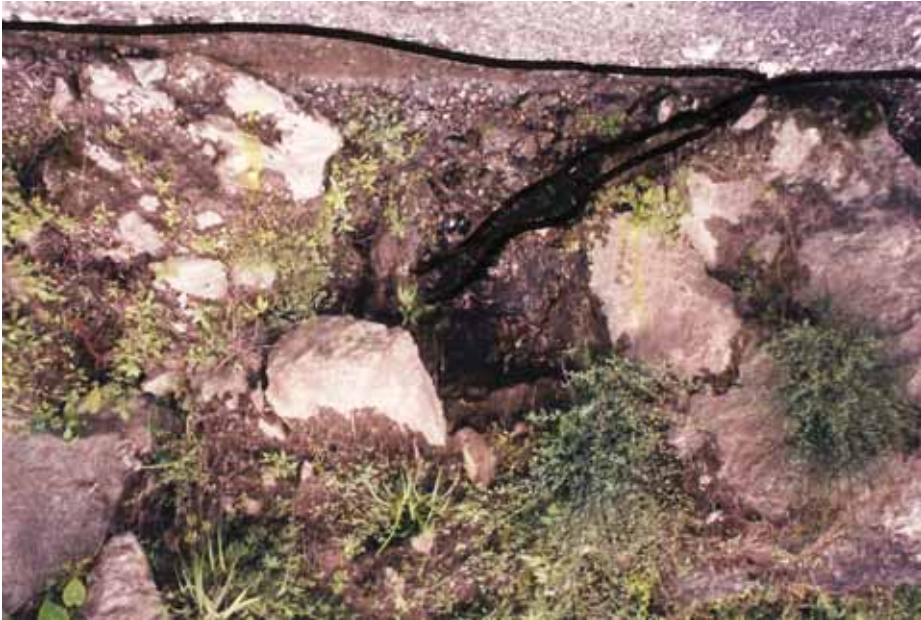
Figure 4. Visible cracks and fissures facilitate the piping and deep drainage

Based on field observation it is suggested that overland flow feeding the uppermost niche during heavy rains transformed into concentrated sub-surface flow over the less permeable gneissic bedrock. The observed fissures and cracks facilitate the piping and deep drainage towards the slumped areas (Fig. 4). Thus, the sub-surface flow is connected with the continuous beds in the colluvial sequence and jointing of bedrock. It is probably much higher during heavy rains with superposition of an overland flow and with seepage pressure. The existing topography of the flattening suggests a subsurface runoff towards the SSE.

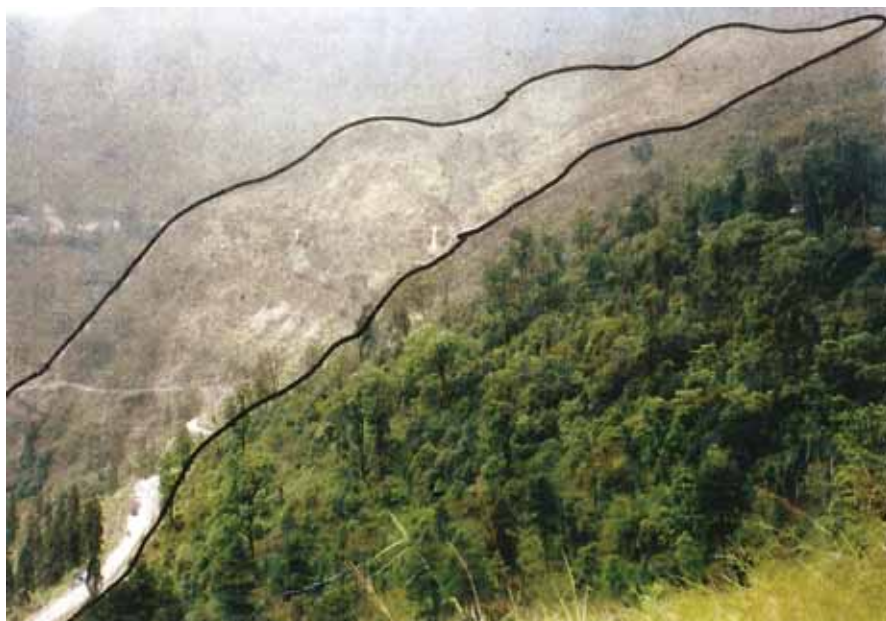
Figure 5. Paglajhora (upper Shiv Khola) slump valley

valley are probably related to gigantic palaeo-mass movements. Topographic expression including valley forms and slope morphology indicate that the Paglajhora (upper Shiv Khola) is an erosion valley over complex colluvium (Fig. 5). A valley form developing by long lasting mass movements was differentiated in space and time. Its continuous formation is controlled by very favourable coincidence of various factors:

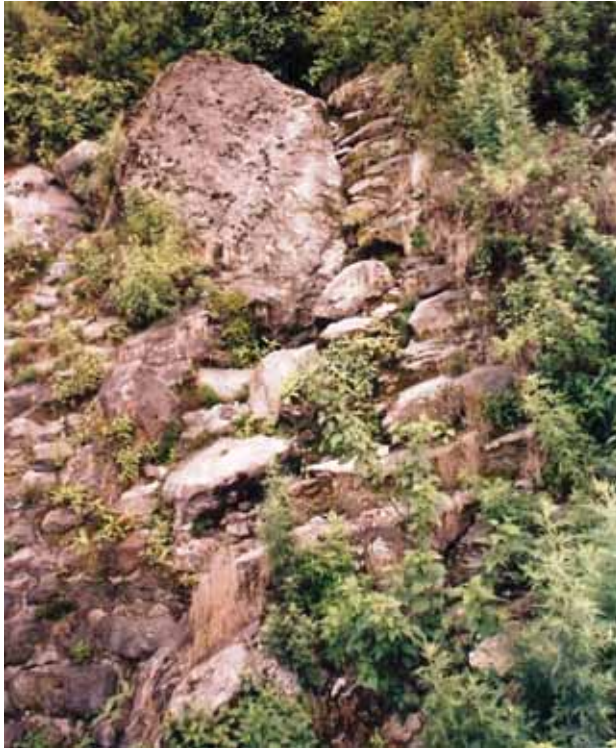
Figure 6. Colluviums in the Shiv Khola basin

The gigantic palaeo-mass movement (as mentioned earlier) along the southern margin of the Mahaldiram massif (elevation 1,700 to 2,200 m a.s.l., as revealed from the palaeo-scars) caused the transport of huge amount of debris towards the lower segment of the Shiv Khola/Paglajhora basin. Portion of this debris was deposited along the mid-slopes and transformed the pre-existing topography and drainage. Field observation reveals numerous sites with huge gneissic boulders even at an altitude of 1,550 m a.s.l. (Fig. 6).

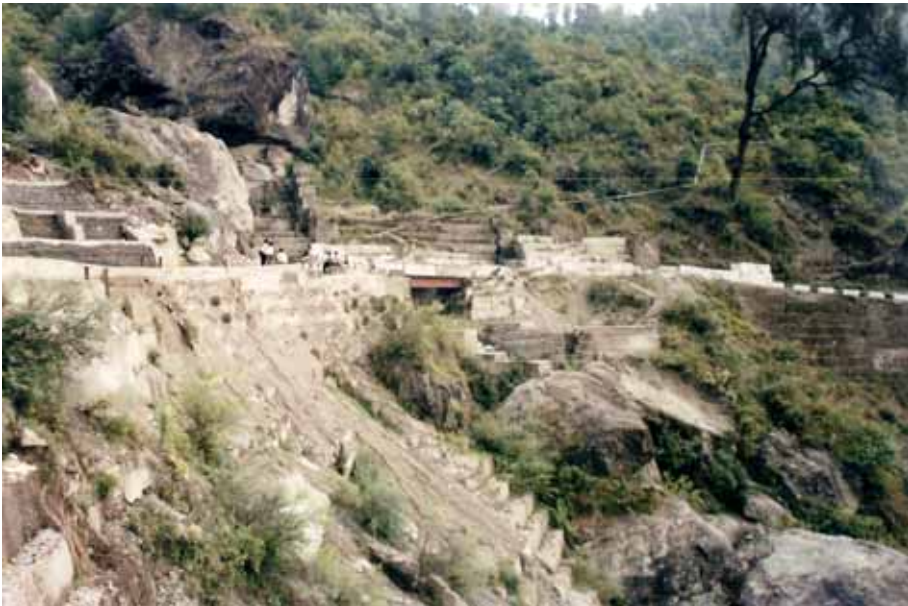
Figure 7. The Lower Paglajhora active slump

walls and other protective structure) on the one hand and ever increasing interference (settlements, arable farming, deforestation, overgrazing, heavy vehicle movement, diverting of *jhora*, etc.) on the other, with the natural hydro-geomorphic processes. The outcome has been found disastrous. Since 1980 onwards, the incidences of slumps have become a regular feature (Fig. 7).
