PAVEL DRNOVSKÝ*

HIGH MEDIEVAL FORTIFICATIONS IN VILLAGES NEAR HRADEC KRÁLOVÉ. MANORIAL RESIDENCES OF LOWER NOBILITY IN EAST BOHEMIA

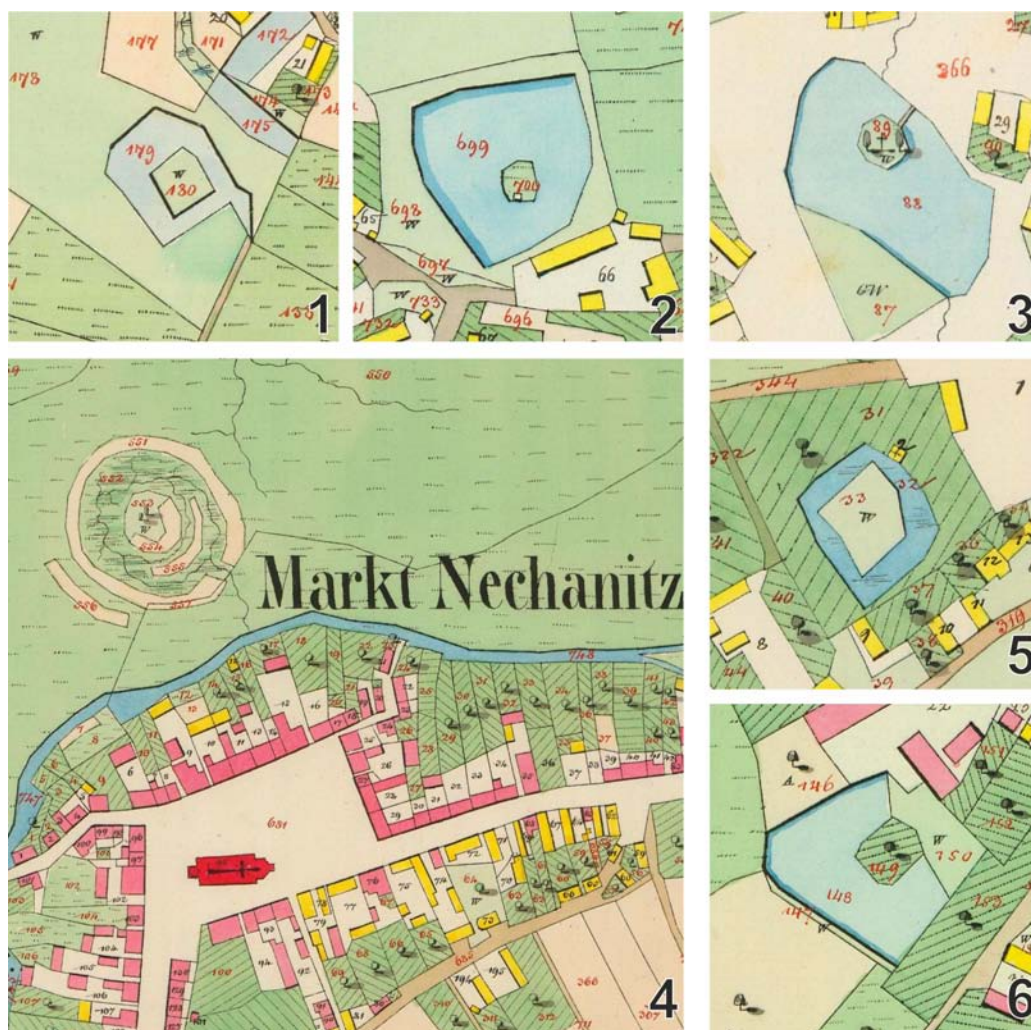
Fig. 2. Examples of 19th century cadastral maps depicting the extent of fortified manor houses: (1) Ohništany, (2) Libeň, (3) Obědovice, (4) Nechanice, (5) Radikovice, (6) Libčany. © Czech Office for Surveying, Mapping and Cadastre.

At the beginning of our research, we investigated the basic compendia of written sources related to the existence and localisation of manorial residences in the given region. Special attention was paid to the study of archival maps from the 18th and 19th centuries, with which we can follow the distribution of settlements in the past. Showing plot allotment in villages and in their fieldscapes, 19th century land register maps provided much valuable information. These maps often depict plots of land corresponding to the extent of original settlements, which were still visible in terrain at the time of mapping or their land allotment was at least partly detectable (Fig. 2).

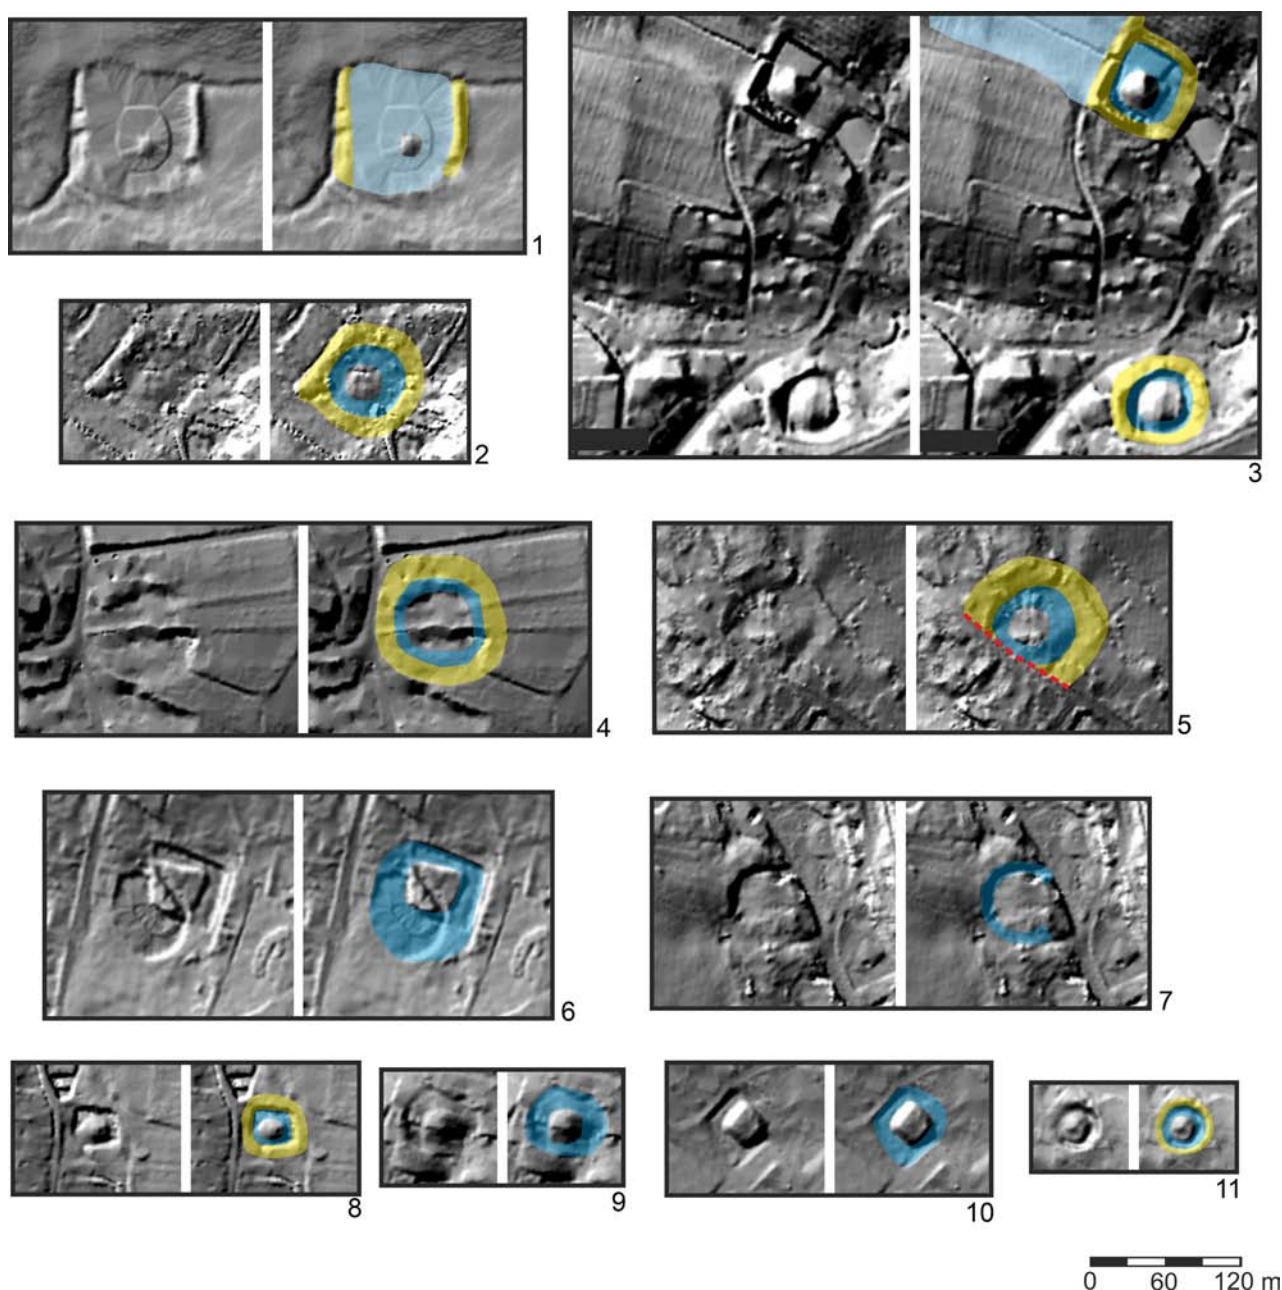
Fig. 5. Plans of fortified manor houses and their surroundings on a digital elevation model. On the left is a hillshade model, on the right is the interpretation of relics: dark blue – ditch, light blue – bodies of water (river, pond), yellow – rampart, central mounds without marking. (1) Libeň, (2) Ohnišťany, (3) Sekeřice 1 (northern fortified manor house) and 2 (southern fortified manor house), (4) Hustiřany, (5) Petrovičky, (6) Stračov, (7) Hrádek, (8) Chloumky, (9) Třebnouševs, (10) Habřina, (11) Dobeř. Graphic design: Pavel Drnovský.

rural development. The fortified manor house in the village of Dobeš is one of the better-preserved sites (Fig. 5:11). It is a residence of small dimensions with a preserved artificial mound, ditch, and rampart. The central mound is 22 metres in diameter, while the total diameter of the fortified area is 50 metres. Other fortified manor houses which were situated within the area of a village include those at Habřina (Fig. 5:10), Chloumky (Fig. 5:8), Hrádek (Fig. 5:7), Hustířany (Fig. 5:4), Ohništany (Fig. 5:2), Petrovičky (Fig. 5:5), Rakov, Sekeřice (southern fortified manor house) (Fig. 5:3), Stračov (Fig. 5:6), and Třebnouševy (Fig. 5:9).

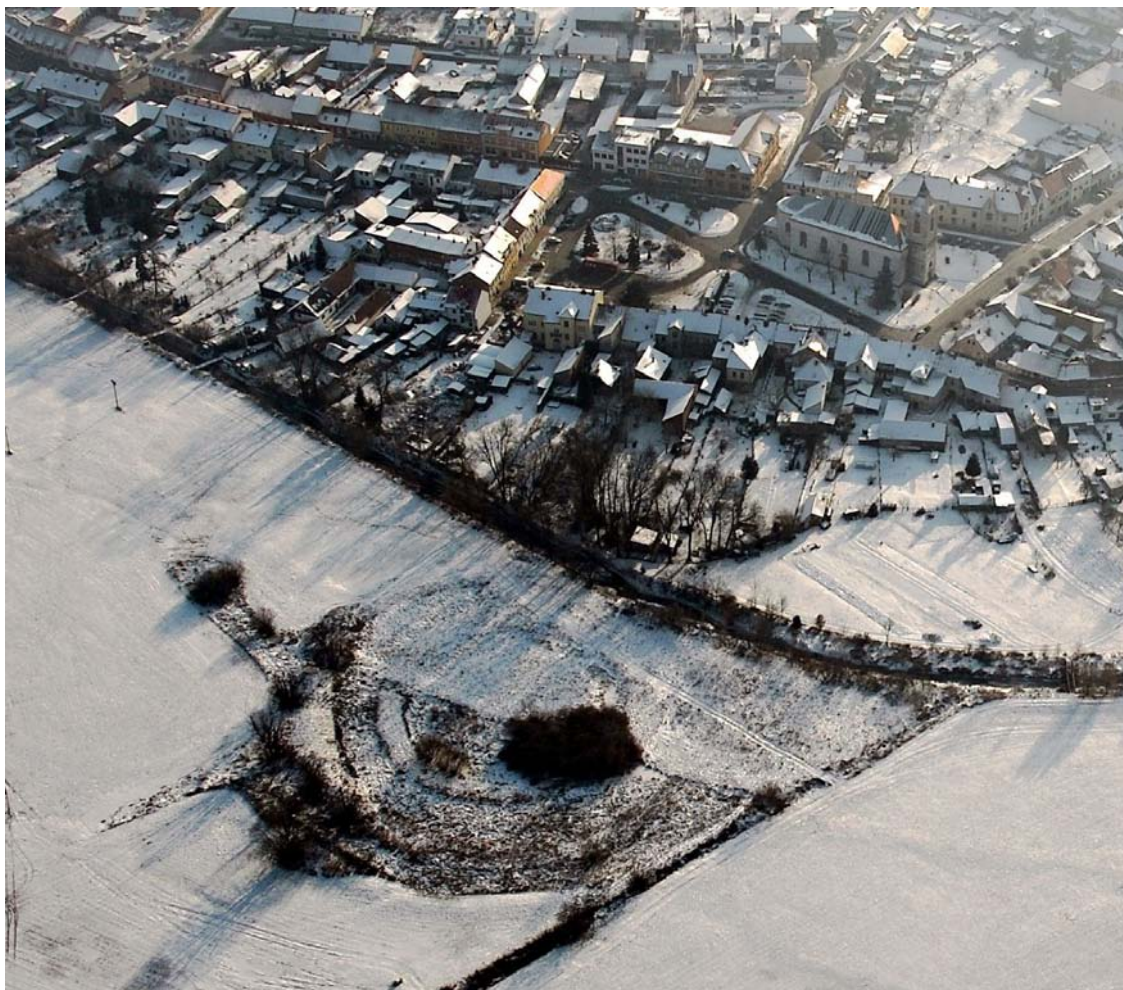
Fig. 6. Nechanice, example of relics of a fortified manor house by a river and town. Source: Gojda 2012.

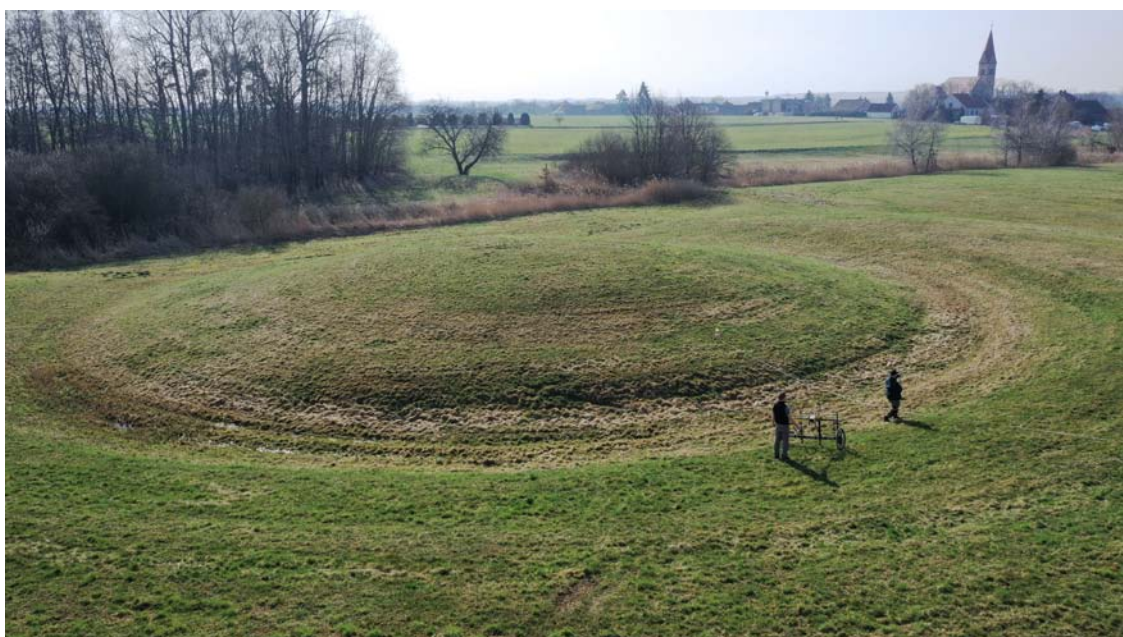
Fig. 7. Babice, example of relics of a fortified manor house by a pond and near a town. Photo: Š. Kravcic.

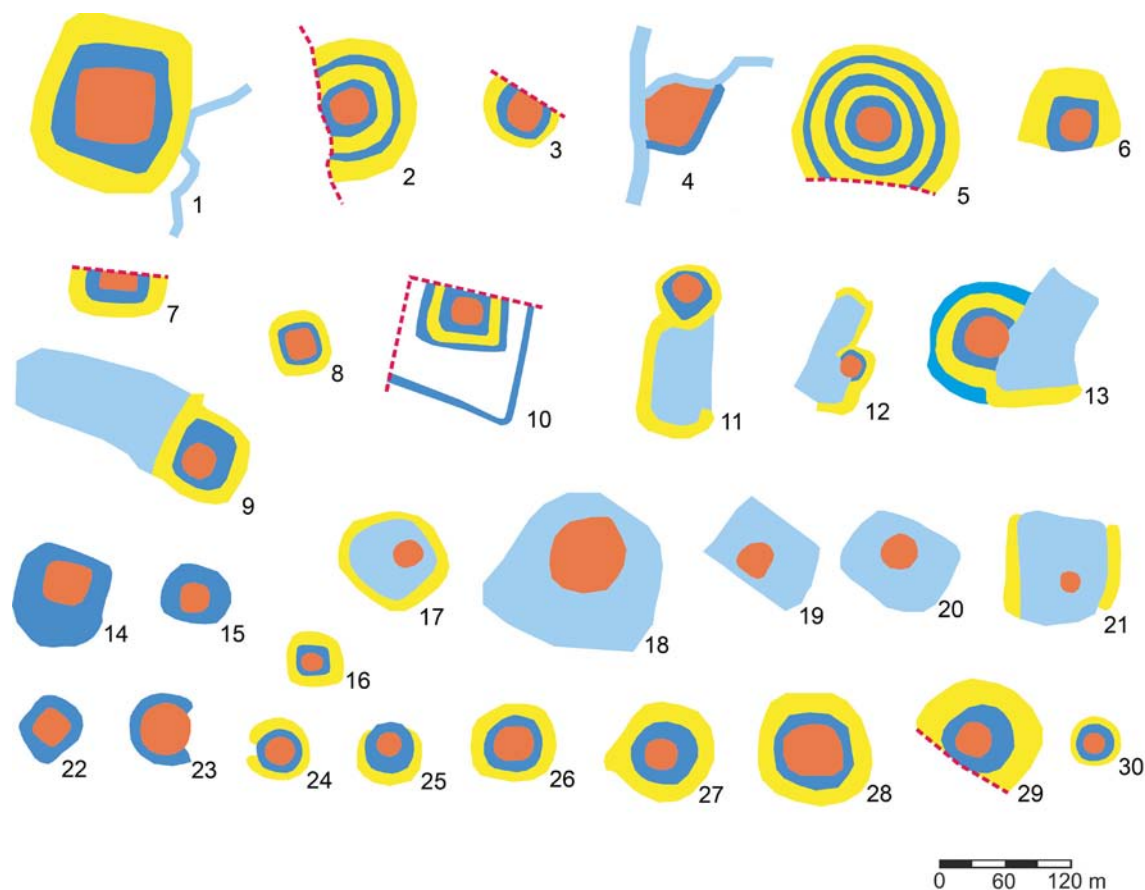
Fig. 9. Comparison of ground plans and forms of individual fortified manor houses. Orange – core, dark blue – ditch, light blue – bodies of water (river, pond), yellow – rampart, dashed line – recent intrusion. (1) Staré Smrkovice, (2) Radíkovice, (3) Přestavlky, (4) Mokrovousy, (5) Nechanice, (6) Lubno, (7) Kosice 1, western fortified manor house, (8) Kosice 2, eastern fortified manor house, (9) Sekeřice, northern fortified manor house, (10) Třesice, (11) Vysoká, (12) Kasaličky, (13) Babice, (14) Stračov, (15) Třebnouševy, (16) Chloumky, (17) Libčany, (18) Klamoš, (19) Kovač, (20) Obědovice, (21) Libeň, (22) Habřina, (23) Hrádek, (24) Mlázovice, (25) Lískovice, (26) Sekeřice, southern fortified manor house, (27) Ohnišřany, (28) Hustřřany, (29) Petrovičky, (30) Dobeř. Graphic design: P. Drnovský.

The fortified areas can be primarily divided according to the ground plan of the central mound, which can be circular/oval and right-angled/rectangular. The first group encompasses a total of 28 sites and the second includes 7 sites. Artificial mounds were in most cases surrounded by ditches, identified at 28 sites. The presence of a ditch cannot be proved in the case of the fortified manor house at Bříšťany, which was completely levelled to the ground. The fortifications at Babice, Radíkovice, and Třesice had two perimeter ditches and the fortification at Nechanice comprised three ditches. The presence of a rampart adjacent to the external edge of the first inner ditch is rare. Nevertheless, the absence of such ramparts in a total of twelve cases might be caused by the transformations and terrain alterations which most residences underwent after their decline. Nineteen residences were equipped with at least one rampart which, however, was not always preserved along the whole perimeter of the site. The fortified manor houses at Radíkovice and Třesice were encircled by two ramparts and the fortified manor house at Nechanice was protected by three ramparts.

The number of ditches and ramparts defines the total extent of individual residences. All fortified sites with two or more ditches exceed the width of one hundred metres (measured on the longer axis): Nechanice c. 154 metres, Radíkovice c. 140 metres, Babice c. 120 metres, and Třesice c. 118 metres. The largest fortified site was Staré Smrkovice, where the area enclosed
