Geographia Polonica

2024, Volume 97, Issue 3, pp. 327-354
<https://doi.org/10.7163/GPol.0282>

UNOBVIOUS GEOHERITAGE IN SACRAL BUILDINGS: MILLSTONES IN CHURCHES OF NE POLAND FROM A GEOLOGICAL AND GEOMORPHOLOGICAL PERSPECTIVE

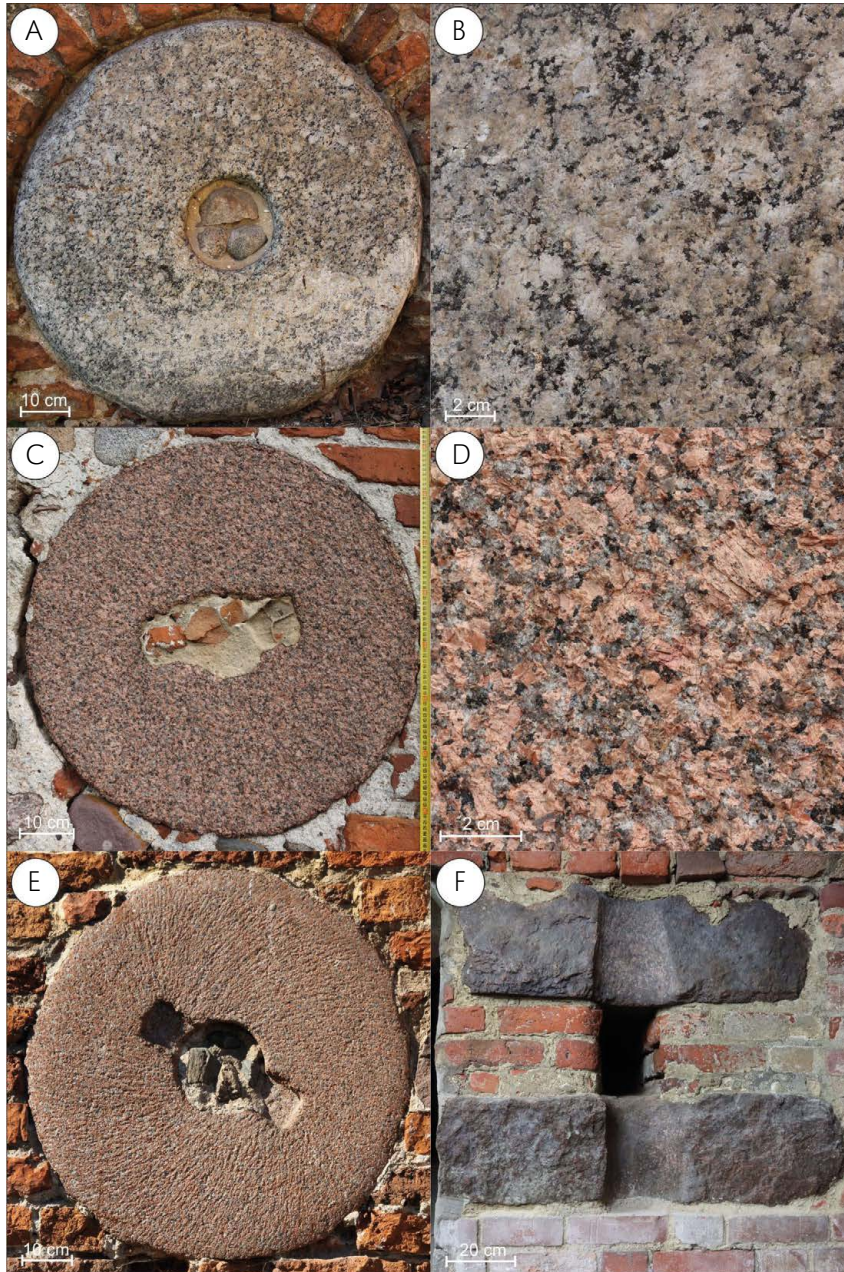
Figure 3. Millstones made of Scandinavian granitoids; A, B – stone embedded in the southern wall of the former church in Pułtusk, Revsund granite (erratic), C, D – stone embedded in the southern wall of the church in Gryźliny (Warmia), Finnish or Åland rapakivi granite (erratic), E – stone embedded in the eastern wall of the former church in Pułtusk, Scandinavian granitoid – Småland granite (erratic), F – two halves of a large millstone embedded in the wall of the castle in Olsztyn, coarse crystalline Finnish rapakivi granite (erratic). (Photos by P. Czubla)

The raw material used for the production of millstones was almost exclusively various types of Scandinavian granitoids present throughout Poland as erratic boulders (Fig. 3; Czubla, 2015). Among these, rapakivi granites (both viborgites and pyterlites) were relatively numerous. Revsund, Siljan, Småland, Sala, Uppsala granites, as well as Bornholm granitoids, were also identified. Generally, these rocks exhibit coarse- and medium-crystalline textures and are relatively poor in dark minerals susceptible to weathering, such as biotite.

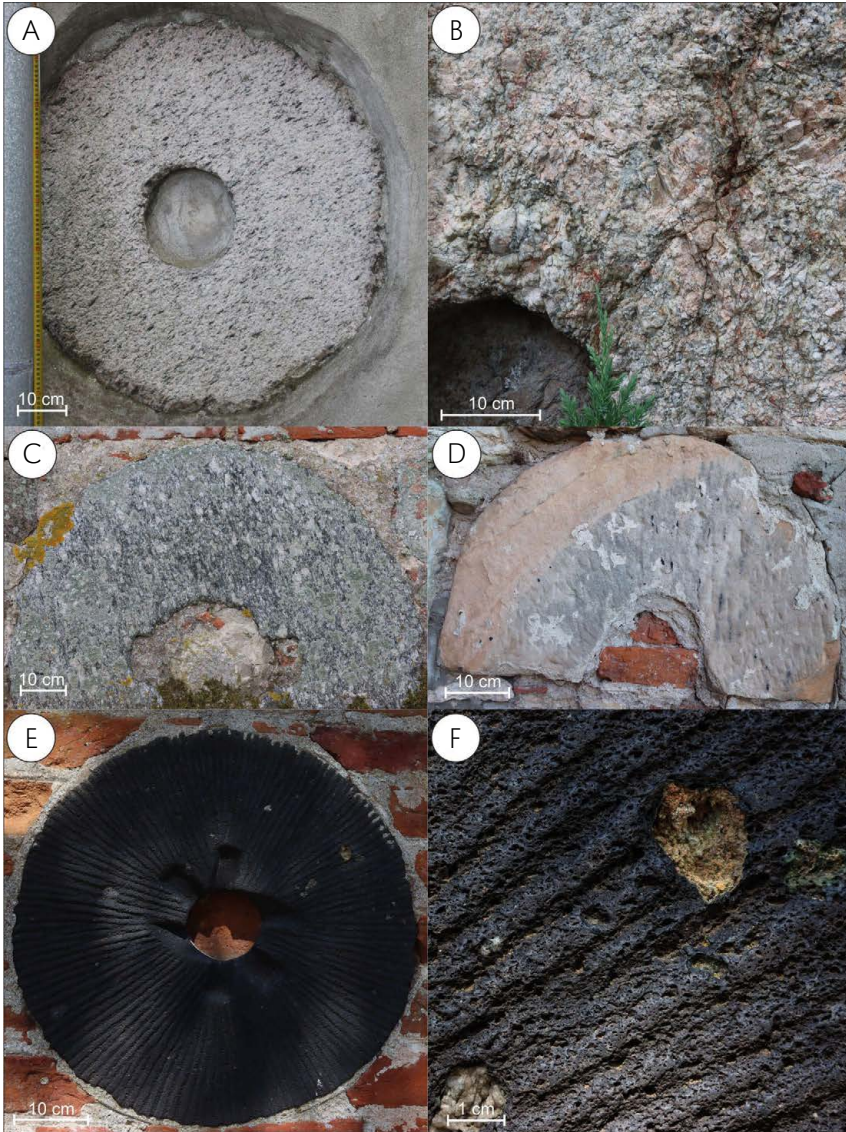
Figure 4. Millstones in church walls; A - millstone or semi-finished product in Bodzanów in Mazovia, leucocratic gneiss (erratic), B - semi-finished product at the entrance to the church in Kraskowo (Masuria), coarse crystalline pegmatite (erratic), C - worn millstone or semi-finished product in Rogiedle (Warmia), gneiss with small crystals (erratic), D - semi-finished product used as building material in the monastery church in Sulejów, sandstone from the vicinity of Wąchock (northern Mesozoic margin of the Holy Cross Mountains), E, F - worn millstone in the ruins of the church in Wocławy in Żuławy, porous volcanic rock, most likely imported from the Eifel massif (?). (Photos by P. Czubla)
