The German Margarete defensive line from World War II in southwestern Slovakia. Archaeological evidence and historical facts

Author: Pavol Šteiner, Jozef Kónya

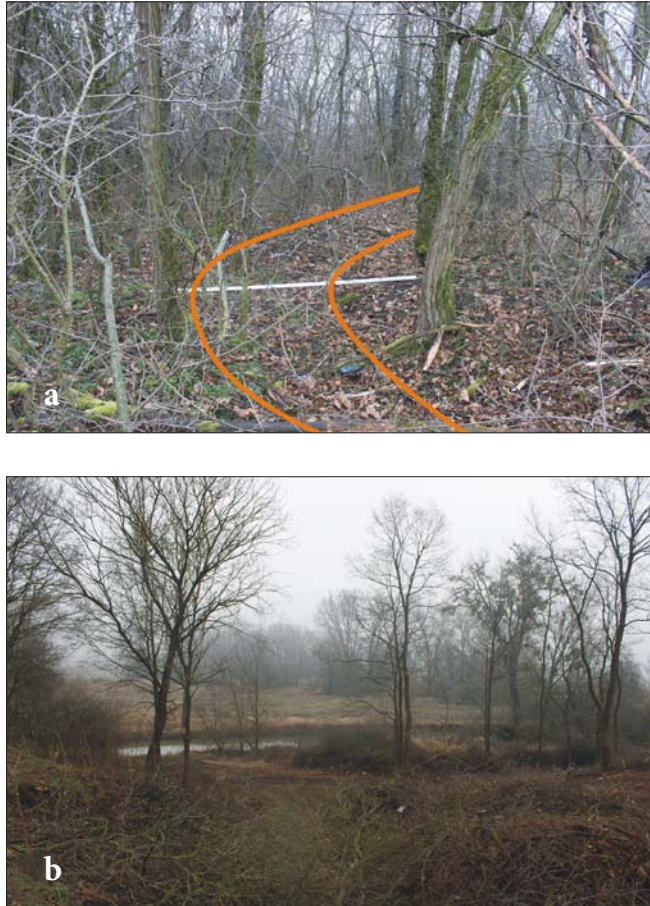
Fig. 4. The German Margarete defensive line in Slovakia: a – partly preserved shallow trench in the section near the river; b – a view of the Ipeľ river from the lower section of the trench system. Photo and graphic design by P. Šteiner.

A section of the trench, which starts about 10 m to the right of the main road from Šahy to Ipel'ské Predmostie, directly on the bank of the meandering Ipeľ river, runs parallel to the road for approximately 150 m. Several small subsidiary trench lines, each several meters long, branch off from the main trench (**Fig. 2:b**). This section down by the river, where machine-gun positions have been preserved at just 131 m above sea level, the lowest point in the system, seems to have been of special importance. It is not as well preserved because of flooding (**Fig. 4:a**), but it shows that Germans were aware of the necessity of positioning some of their troops next to the water in order to prevent the Soviets from a surprise crossing of the Ipeľ (**Fig. 4:b**). At the eastern edge, part of the trench has been destroyed by an unpaved access road to the river. Beyond this road it turns north and ends at the main road, continuing again on the other side. Overall, this section of the trench system can be considered as a forward position, built to block the passage where the Ipeľ stream approaches the slopes of the Drienok hill. Attacking Soviet troops could easily have crossed it otherwise, unobserved in conditions of reduced visibility.

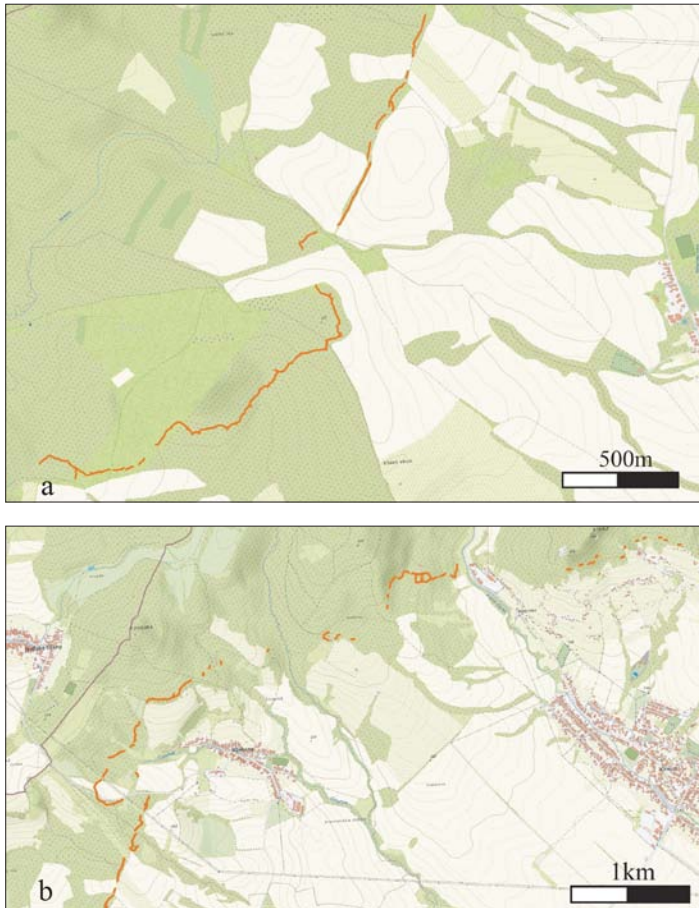
Fig. 6. The German Margarete defensive line in Slovakia: a – section west of Sečianky; b – eastern edge at Kleňany and Vinica. After: ZBGIS[®], Office of Geodesy, Cartography and Cadastre of the Slovak Republic; graphic design by the authors.

Beginning 215 m beyond the described section the trench forms a continuous line (**Fig. 6:a**), apparently bypassing a large erosion gully even though it looks as if it were eroding the feature. From there it continues steadily in an easterly direction, branching off after 135 m. A minor branch runs southwards for about 50 m until it is disturbed by a woodland track. At the point of branching, the main line is also interrupted or damaged by another forest road and after about 40 m it is again interrupted by the next forest road. After 300 m the trench ends at another large erosion gully. Beyond the gully, the trench continues uninterrupted, but after approximately 660 m it ends again at the erosion gully and continues beyond it. After 100 m, a small spur line leading northwards, about 15 m in length, becomes disconnected. After about 260 m from this point, the continuous trench

It is likely that this trench, due to its location and orientation, was part of the same defensive line as the part under observation. Ultimately, the trench system ends on the southern slopes between the Povojná and Stráž hills in the cadastral territories of the municipalities of Kleňany and Vinica. It consists mostly of short sections, with the exception of a roughly 600-m-long continuous section northwest of Vinica (**Fig. 6:b**).

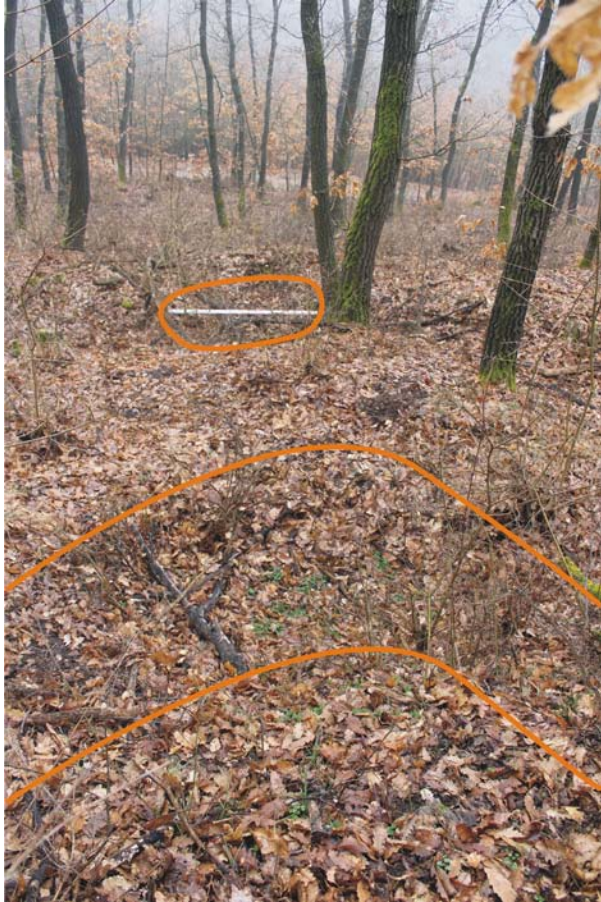
Fig. 8. The German Margarete defensive line in Slovakia. Part of the trench system and a circular firing position above. Photo and graphic design by P. Šteiner.

machine guns mounted on a stable tripod. For any larger weapons, the positions in question are too small and do not correspond in location or shape to positions for heavy artillery or rocket launchers (Rottmann 2004, p. 47). In total, the trench system contains eleven such emplacements.
