KAZIMIERZ PASTERNAK

**Obserwacje nad przeformowaniem się brzegów zbiornika
w Goczałkowicach — Observations on the transformation
of banks in the Goczałkowice Reservoir**

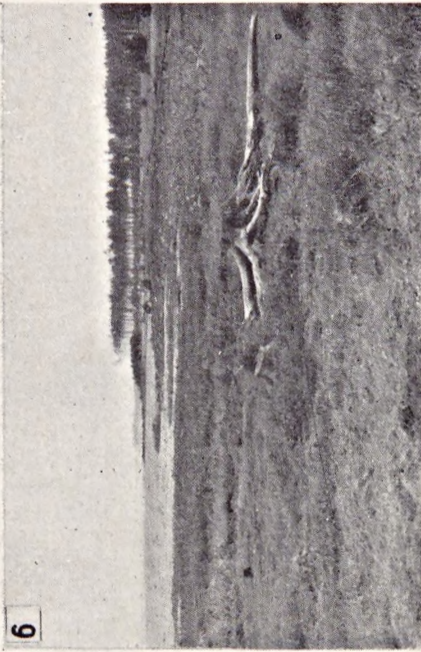
Fig. 4-7. Fragments of reservoir banks: 4. left bank in the region of Wielka Wisła; 5. Goczałkowice; 6. right bank near Podjazd; 7. protective dike near Frelichów reinforced with concrete (Phot. J. Starmach)

No transformation of the flat right bank is observed in the sector from the dam to the mouth of the Bajerka river. This bank is only subject to superficial erosion within the scope of the wave. The artificial protective dike forming its further sector used to be washed out by waves in the first years, but has lately been reinforced in its major part with concrete slabs.

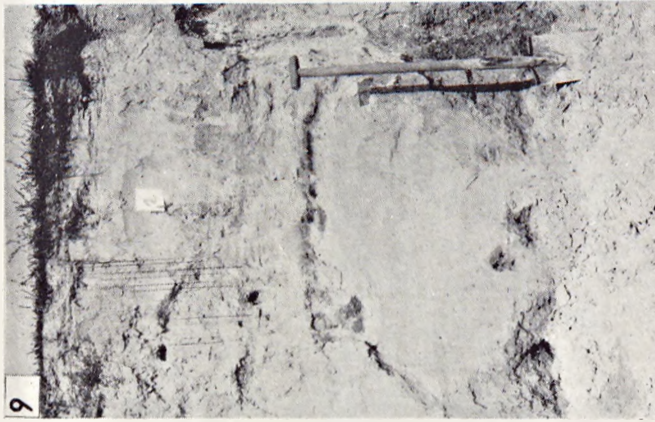
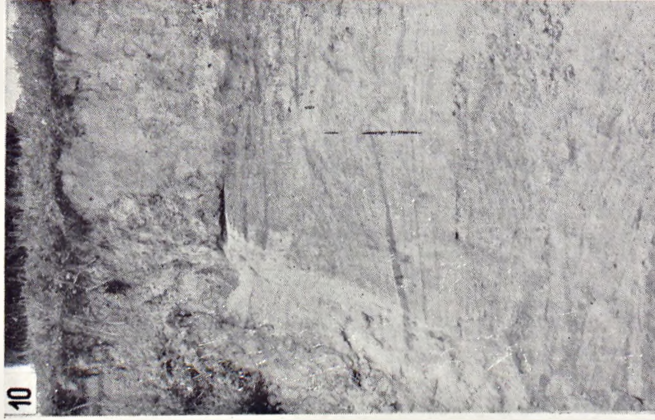
Figs. 8-10. Typical soil profiles of the northern destructible embankment in the localities: 8. Goczałkowice; 9. Łąka; 10. Wisła Wielka (Phot. J. Starmach)

The rather high, steep bank of the reservoir in the sector between the dam and the intake composed of fluvioglacial sands lined at various depths with a layer of Miocene loams of a higher level mostly 1-2 m. thick. On these sands acid sandy podsollic soils were formed. Figure 8 presents the profile of this soil. The upper stratum of this light-grey sandy soil is formed of clayey strong sand, the lower one, of a rusty brown colour, of argillaceous light sand. In the entire sandy part of the profile appear fragments of loam of various size, disposed irregularly. The layer of underlining greyish-blue loam is a heavy clay with a considerable content of silt and clay parts (51 per cent) and a higher content of sand than that of pure loams.

The short, steep sector of the bank between the waterwork intake and the village Łąka is formed of very thick, light yellow loess formations (0-97 cm.) with a characteristic lower layer of greenish-yellow sub-loess loams lined with fluvioglacial sands. The profile of this bank is presented in Fig. 9. As results from analyses of the mechanical composition the upper stratum of the bank (arable podsollic soil) is a loamy silt soil formation with a slight addition of sand. The lower layer of the loams (< 97 cm.) is also a loamy silt soil formation, but with a much higher content of loamy parts and a smaller fraction of sand.

The sector of the embankment from the village of Łąka to the end of the reservoir is also composed of loess formations (arable podsollic soils containing sand) (profile 4 and 5) with a thickness of about 1 m. below Wielka Wisła and a greater one above. Underneath lie very thick greyish-yellow loose fluvioglacial sands with grains of various size or, as in the vicinity of Łąka, brown (morainic) light clayey and silt sands. The stratification and aspect of profile 5 is presented in Fig. 10. The amount of sand in the upper silt stratum of this soil is greater than in silt formations of aqueous origin on the right bank of the reservoir or in typical sub-Carpathian loesses. The upper terrains of the bottom of the valley which emerge periodically from the reservoir (profile 16) are mostly composed of old riverside alluvial silt soils covered with a minimal layer of reservoir sediments.

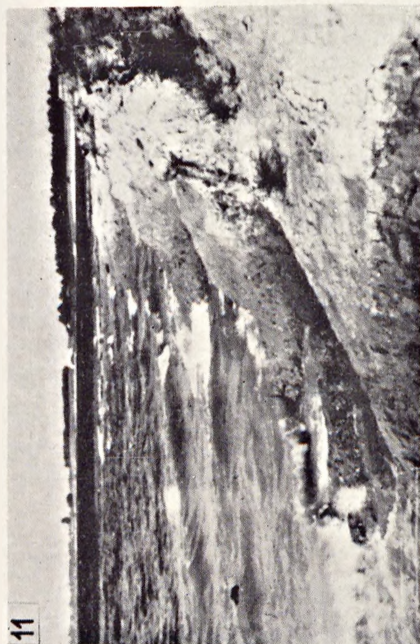
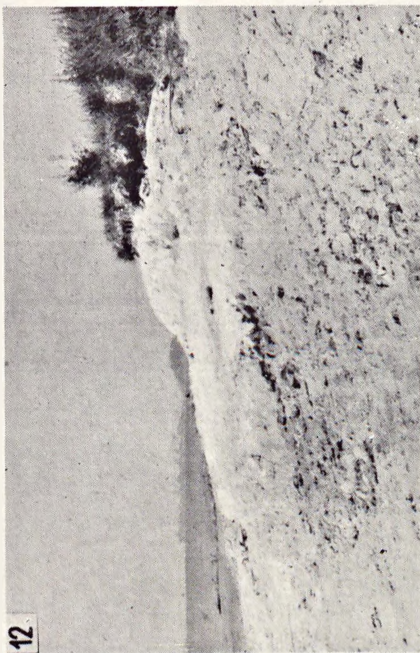
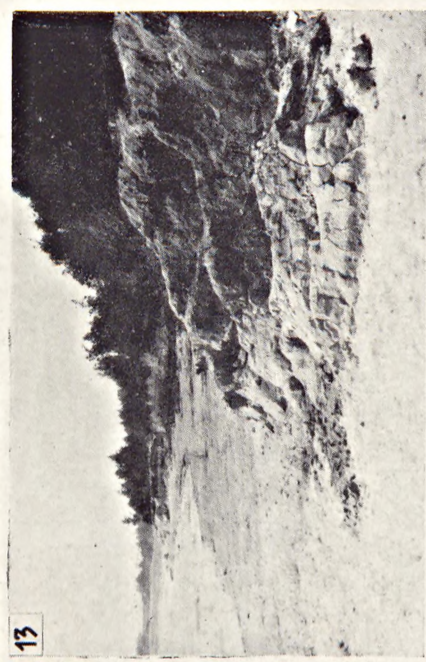
Figs. 11-13. Sector of the washed out embankment between the dam and the intake: 11. in 1957; 12. in 1959; 13. in 1992.
(Figs. 12, 13 phot. J. Starmach)

In the sector from the dam to the intake the waves break against the rather high (2 m.), steep bank, washing out the poorly resistant, from this point of view, strata of sandy soil and leaving the lower loamy layer of the bank washed out in a lesser degree (Fig. 12). This being more resistant, owing to its high upper limit of plasticity (Chalfin 1954). This layer, when the sand carried by the reflected waves settles upon it, forms at present a vast sandy beach which limits the strength of the beating waves at normal water level in the reservoir. The identification of this process in the years 1957-1962 is illustrated by Figs. 11, 12, and 13. The photographs show that the transposition of the line of the banks in this sector during

these five years is considerable: it amounts to about 10 to 25 m. This is facilitated by a very unresistant and loose sand stratum and sources of ground-water flowing out of the bank which remain on the impermeable loams. The water saturates the soil of the bank to a maximum, thus increasing its fluidity and therefore its tendency to subsidence.

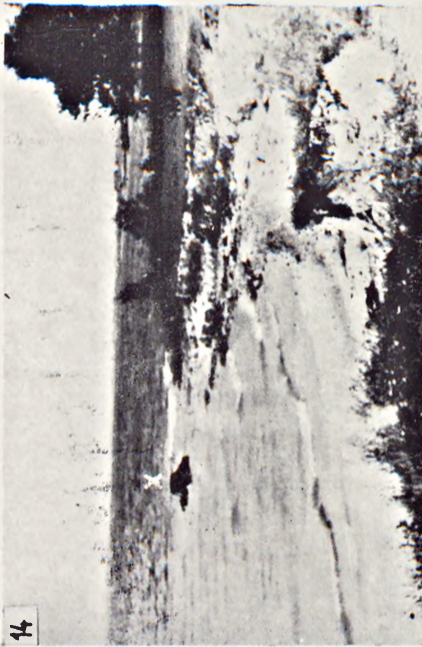
Figs. 14-16. Transformation of the bank between the water intake and the village Łąka with a view of the oak trunk (x) forming a stable point: 14. in 1957; 15. in 1959; 16. in 1962. (Figs. 15, 16 phot. J. Starmach)

The destruction of the bank constructed of loess silt soil lined with sub-loess clays is no less intensive between the intake and the village of Łąka. This is shown in Fig. 14, 15, and 16 with a sight on a fixed point formed by a big oak trunk located on the bottom and Figs. 17, 18, and 19 which represent the situation near the house No. 227 in Łąka. It can be seen that in 1957 the line of the bank ran quite near the trunk and far away from the above-mentioned house, while in 1959 it shifted away from the trunk far into the embankment, up to the very wall of the house which the inhabitants had abandoned in the meantime. In 1962 the trunk was already at a distance of 25 m. from the bank and only rubble of the former house remained on the shore. It must be noted that in the region of the trunk the retreating of the bank, overgrown with trees and shrubs, is relatively smaller. In the nearest neighbourhood (Fig. 20) the reservoir cut much further, for about 35 m., into cultivated fields. This is an example of how shrubs and trees can reinforce this type of bank.

The high degree of transformation of the bank in this sector results from a considerable intensification of subsidence processes. The cause of this state of affairs must be sought in the physical and chemical properties of this kind of soil. When a higher water level of the reservoir causes a rise of the ground-water in the embankment, the silt material of the soil in the lower part of the profile (sub-loess clays), owing to its finely porous texture, becomes saturated with water up to its maximum absorberancy (gleyings are visible at 1,5-1,8 m. above the water level of the reservoir), thus increasing the fluidity of these strata and rendering their washing-out earlier. The saturated layers of sub-loess clay, owing to a considerable content of loamy parts (Table I) expand and afterwards, when the water in the reservoir falls and the pressure of its outflow is negative, they dry up and contract, causing cracks, disturbing the stability of the soil on the bank and thus increasing its subsidence.

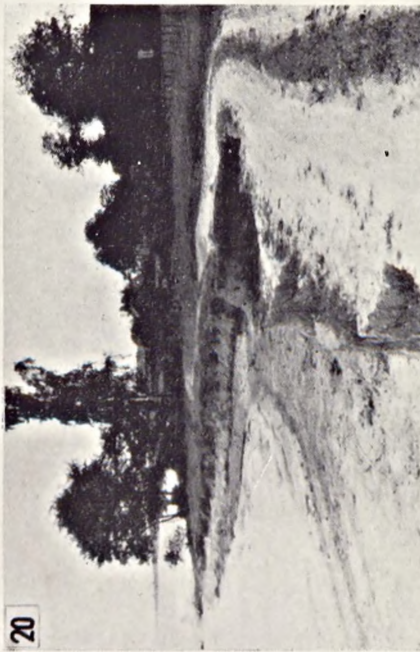
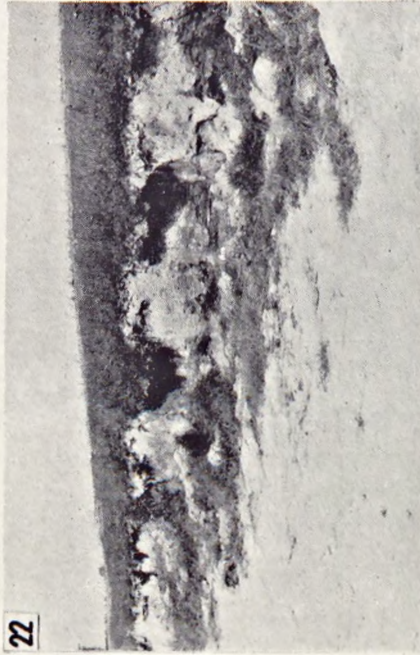
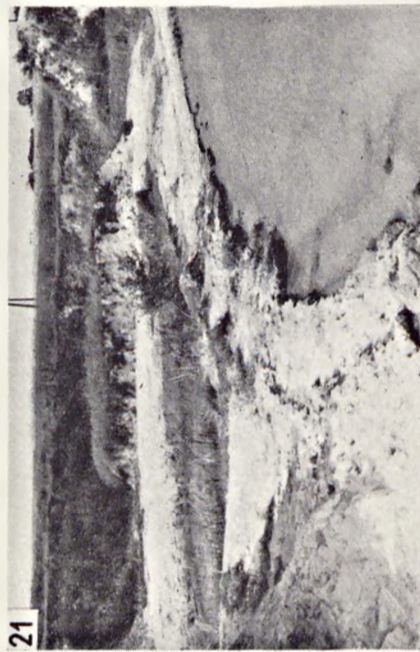
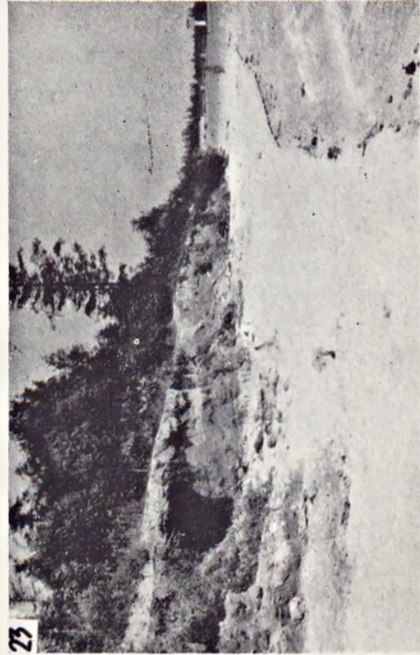
From this place onwards, up to the end of the reservoir near Strumień, the left bank is formed of loess silt soils of considerable thickness. Destruction of the embankment takes place here, in a lesser degree, up to the locality of Wisła Wielka and only in places where the banks are higher and steeper (Fig. 22). Above this locality, in the upper part of the reservoir, greater deformations of banks were not observed. This is probably explained by the more gentler slope of the banks (Fig. 4) and only a slight fluctuation of water on the shallow offshore parts of the reservoir, overgrown by aquatic vegetation. The old protective dikes of the Wisła river, emerging from the water of the reservoir, also have a certain influence and may play the role of breakwaters.

In the last year of observation, when offshore beaches and underwater shoals on which the waves broke were being formed, regression of the line of the bank was slower. When the water level in the reservoir falls the waves partly wash out the newly formed beaches (Fig. 23).

Fig. 20. Encroachment of the reservoir into cultivated fields between the water intake and the village Łąka
Fig. 21. Fragment of the beach formed on the terrain of the former sand-pit
Fig. 22. Undermined banks in the neighbourhood of Wielka Wisła
Fig. 23. View of the destructive secondary action of waves on the previously formed shore (Phot. J. Starmach)
