Ph. D. Thesis

INSTITUTE OF PHYSICAL CHEMISTRY

HYDROGEN EMBRITTLEMENT AND
STRESS CORROSION CRACKING
OF BAINITE HIGH STRENGTH STEELS
IN Cl⁻ CONTAINING ENVIRONMENT

Warsaw 2004

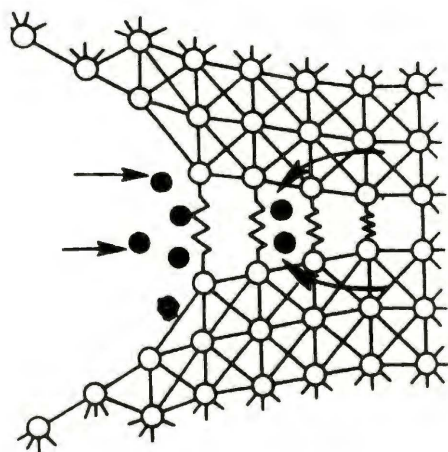
Figure 2.1. Model of hydrogen interaction with the metal lattice at the crack tip.
 • - hydrogen atoms, ° - metal atoms [6].

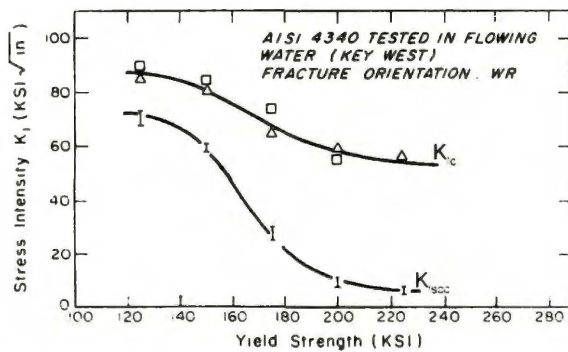
Figure 2.5. Effect of the strength level on K_{Ic} and K_{Isc} for AISI 4340 steel [21].

With the increase in the strength of the low carbon low alloy steels the critical stress intensity decreases (Figure 2.5) [21] and the crack propagation velocity increases (Figure 2.6) [22], as measured in the water [21] and in the Cl^- containing solutions of various pH [22]. This has been associated with the hydrogen effects, since the similar relationships have been found at the steels testing in gaseous hydrogen [23, 24, 25]. As discussed in [25], all the parameters characterizing the susceptibility of high strength steels to HE deteriorate more eager at the increase in the metal strength. The detrimental effect of hydrogen on the loss of plasticity by the steel of different strength is shown in Figure 2.7 [26]: the same amount of hydrogen produces the more pronounced decrease in plasticity in the case of the steel of higher strength.

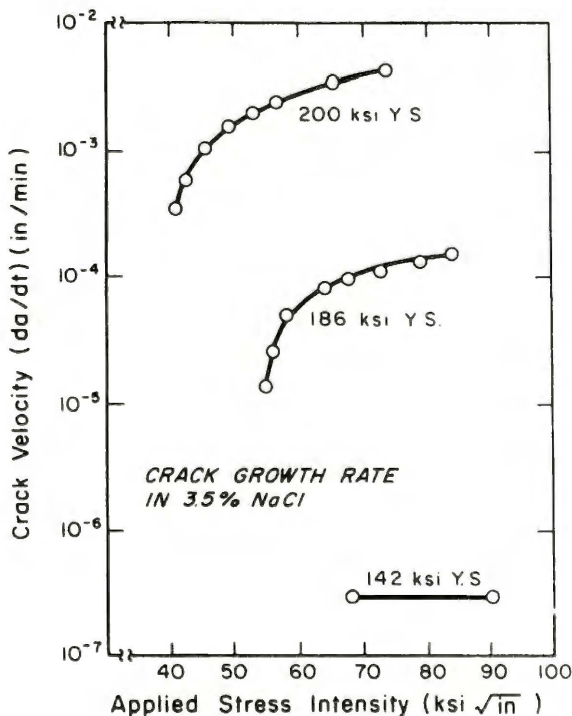
Figure 2.6 Effect of the applied stress intensity on the crack growth rate for AISI 4340 [22] for different level of steel strength.

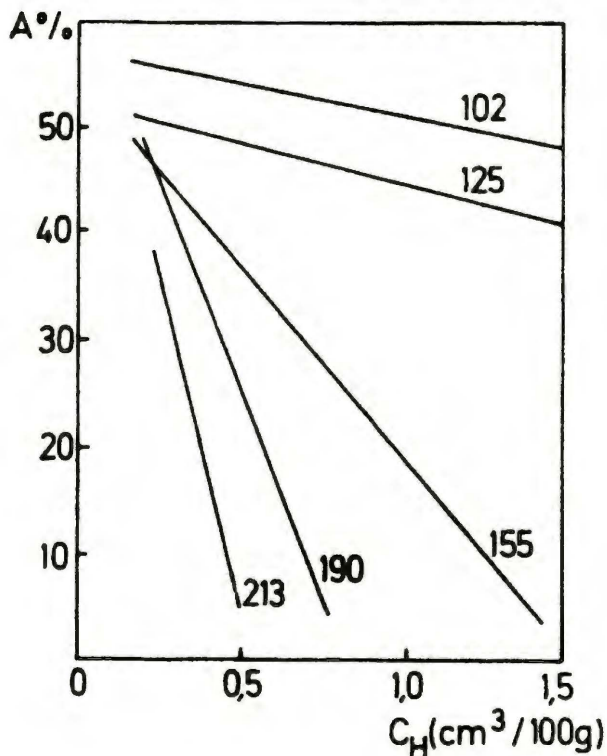
Figure 2.7. Effect of the steel strength on decrease in plasticity, depending on the hydrogen content. Numbers at curves represent the specimen strength in kg/mm^2 [26].

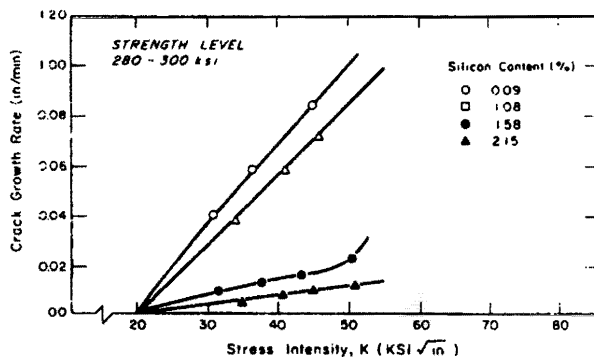
Figure 2.11 Effect of the Si content on the crack velocity in AISI 4340 steel, as tested in 3.5% NaCl[57]

The effect of **Si** addition on the stress corrosion crack propagation has been found [57] to depend on its content. At $Si < 1.5\%$ no effect of the increased Si concentration has been observed in AISI 4340 steel tested in 3.5% NaCl solution. In the case of increase in the Si content from 0.03 to 0.36%, accompanied by the increase of Mn from 0.02% to 0.9%, the substantial decrease in the threshold stress intensity has been stated [48]. However, with the increase in Si content higher than 1.6%, the time to fracture increases and the crack propagation velocity significantly decreases (Figure 2.11) [57].

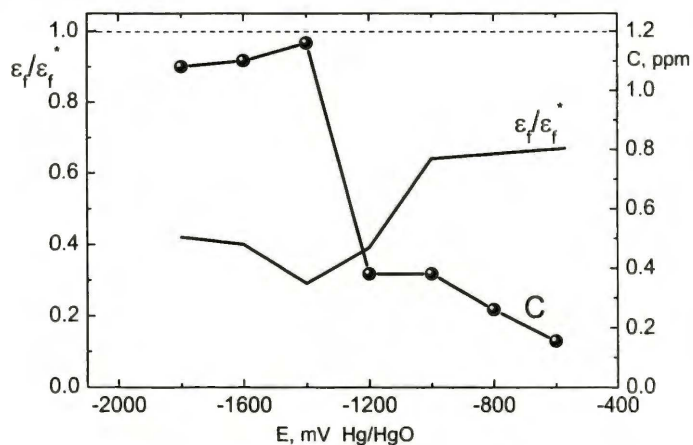
Figure 2.16. Effect of polarization on the plasticity loss, and on the content of permeable hydrogen (C) for 30HGSNAŽ steel tested in NaCl+Na₂SO₄ solution [127]

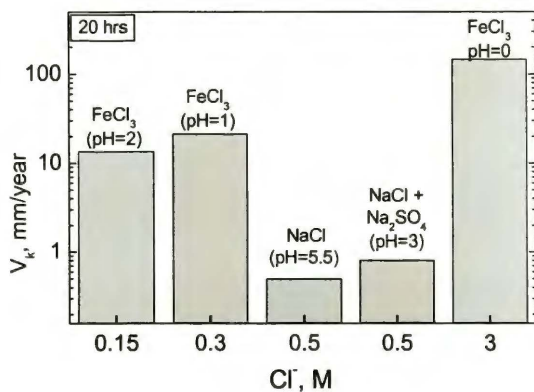
Figure 4.4. General corrosion rate estimated for steel in solutions of different Cl⁻ ions concentration.

As seen in Figure 4.4, the rate of general corrosion was few orders of magnitude lower in NaCl and in NaCl+ Na_2SO_4 solutions than that in FeCl_3 solutions of different concentration. Pitting corrosion was observed only in FeCl_3 solutions. As seen in Figure 4.5, the number and the diameter of the pits did not depend on Cl^- ion concentration for exposition longer than 20 hours. On the other hand, the influence of exposition time was not so pronounced in the case of higher concentration of Cl^- ions. Taking into account the preliminary results shown in Figures 4.4 and 4.5, the immersion in non deaerated solution containing 0.1M FeCl_3 ($C_{\text{Cl}^-}=0.3\text{ M}$) for 22 hrs was decided to fulfill the above mentioned requirements and those parameters were selected to evaluate the susceptibility to pitting corrosion of studied materials.

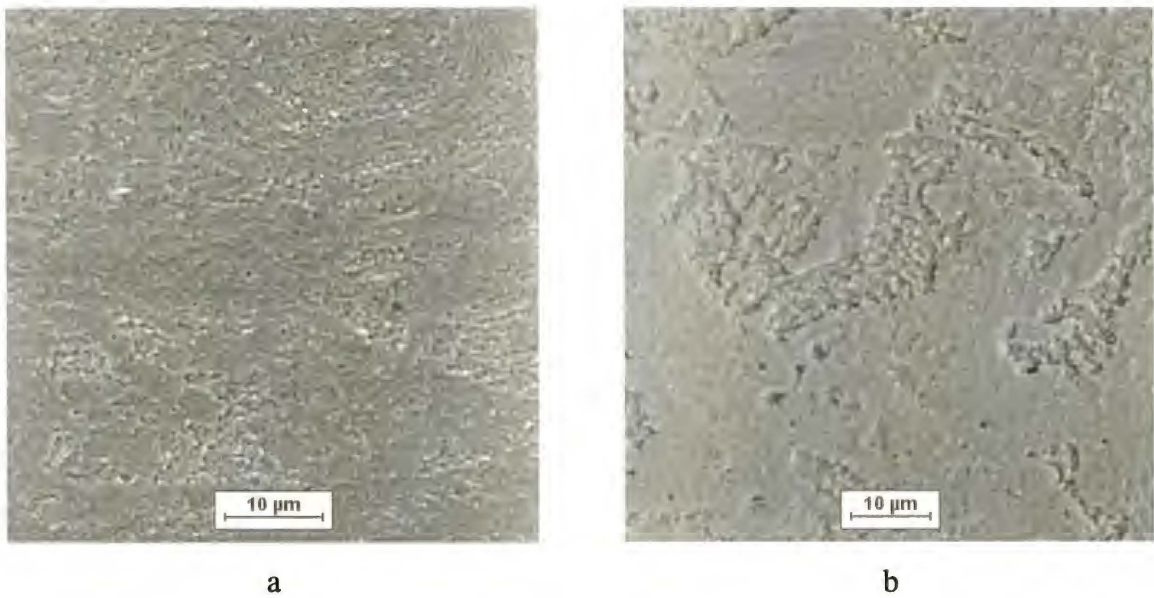
Figure 5.4. Change of the microstructure of subsurface layer of 25N steel due to the shot peening: a – shot peened layer; b- bulk material (SEM).

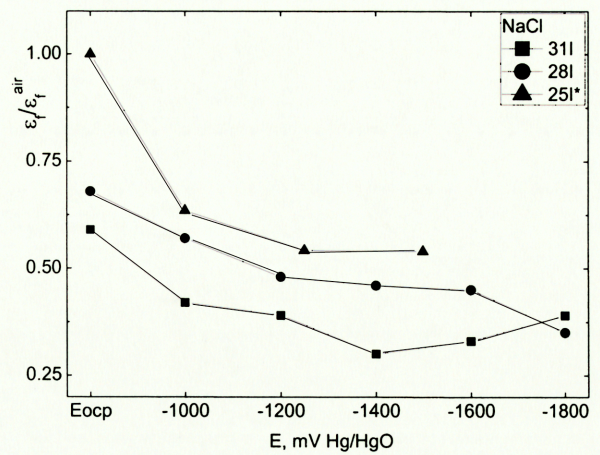
Figure 5.20. Effect of carbon content on elongation to fracture at the testing in solution at open circuit potential (Eocp) and at cathodic polarization.

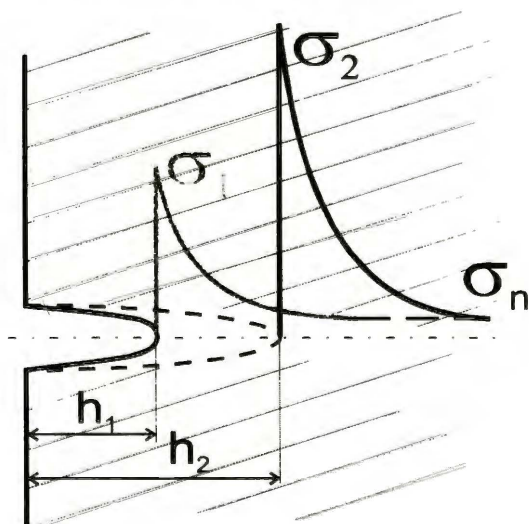
Figure 6.1. Schematic presentation of the effect of notch depth on stress concentration.

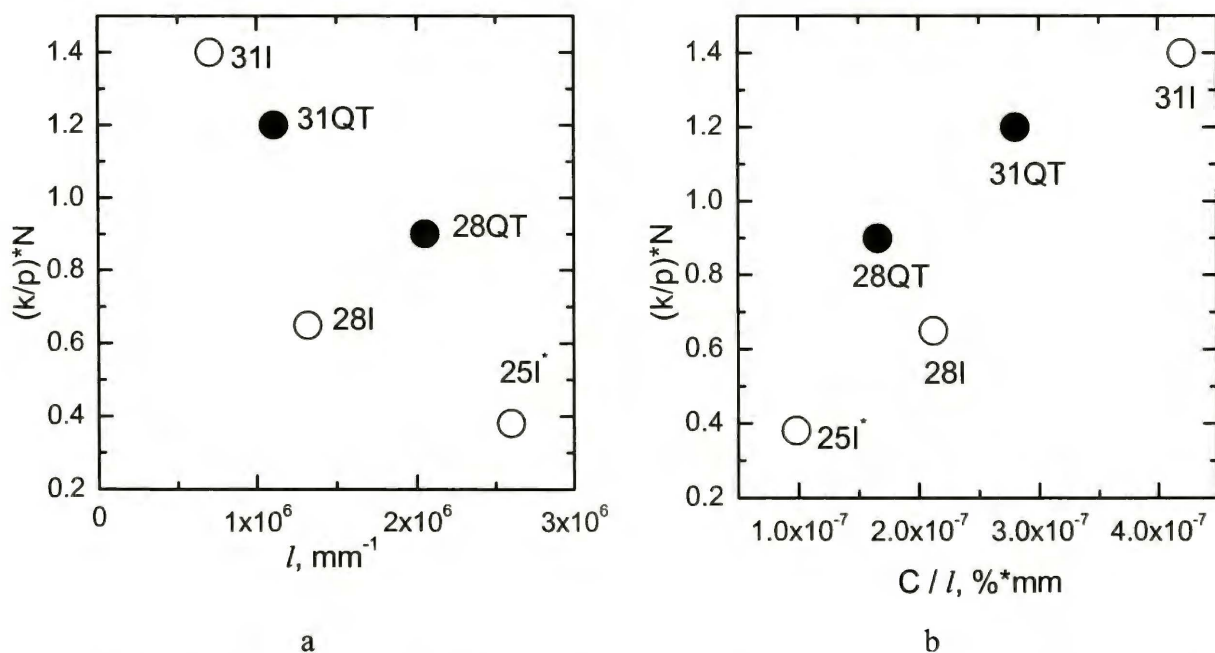
Figure 6.8. (a) - relationship between the hydrogen trapping efficiency and the relative length of the boundaries of bainite laths and parent austenite grains;
 (b) - relationship between the hydrogen trapping efficiency and the carbon segregation on the boundaries of bainite laths and parent austenite grains.

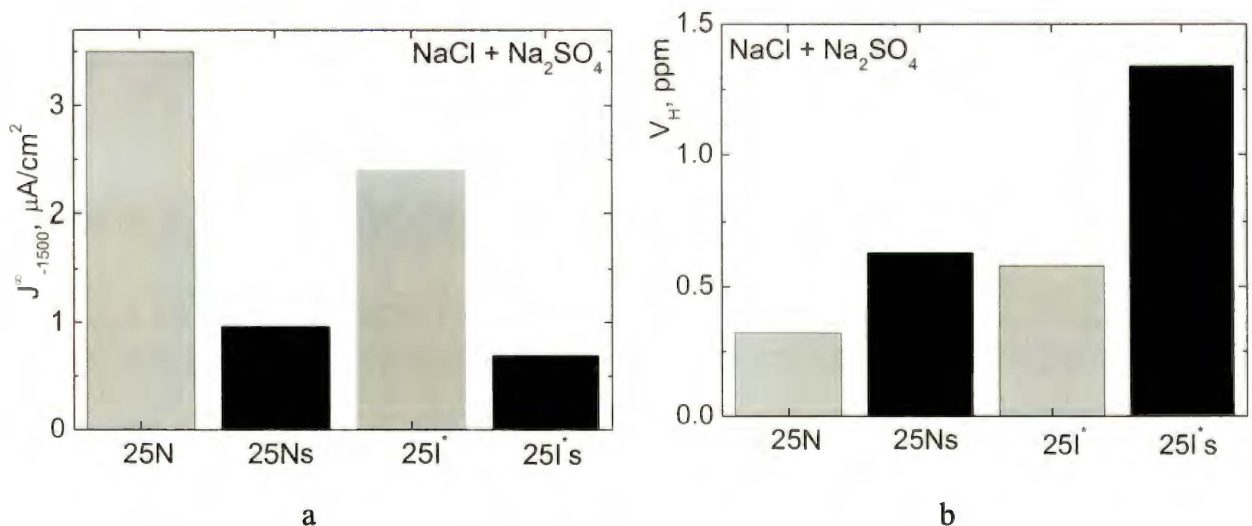
Figure 6.13. Effect of shot peening of 25N and 25I* steels on the steady state hydrogen permeation (a) and on the mean value of residual hydrogen content (b).

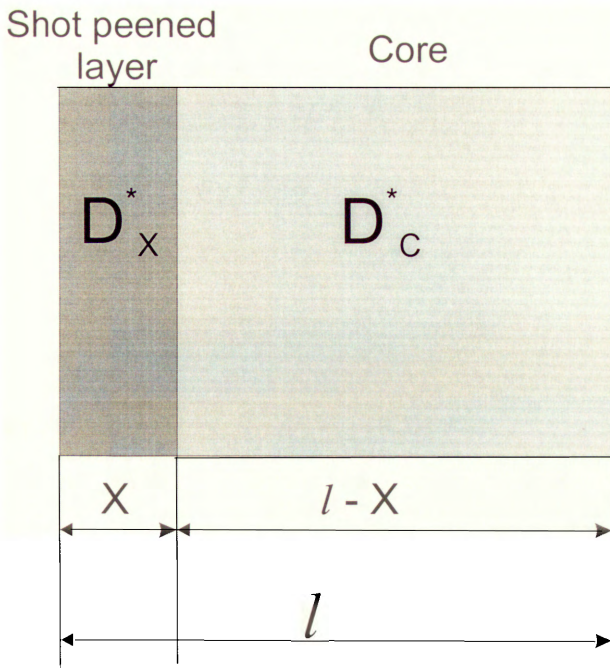
Figure 6.14. Schematic presentation of hydrogen diffusivity in shot peened layer and in the core.

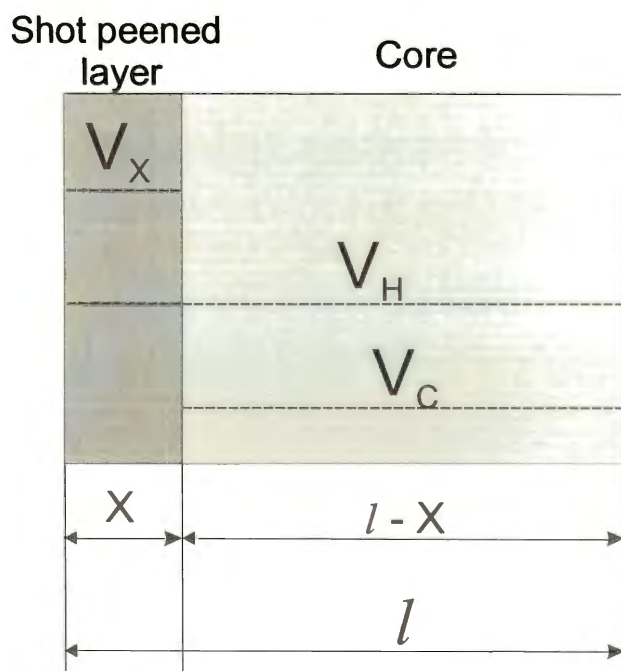
Figure 6.15. Distribution of the mean content of residual hydrogen between the shot peened layer and the core.
