HYDROTECHNIC STRUCTURES ON THE POMERANIAN RIVERS – A REACTION TO EXTREME HYDROLOGIC PHENOMENA IN THE 19TH CENTURY (IN THE EXAMPLE OF THE UPPER WIEPRZA)

WACŁAW FLOREK, JOLANTA JAROMIŁ, MAGDALENA SKWIERAWSKA
Department of Geomorphology and Quaternary Geology,
Institute of Geography and Regional Studies, Pomeranian University in Słupsk,
Partyzantów 27, 76-200 Słupsk, Poland
Email: florekw@apsl.edu.pl; jj@powiat.slupsk.pl; badylka@wp.pl

Key words: hydrotechnic structures, Wieprza river, flood, river bed response, reservoir, floodplain.

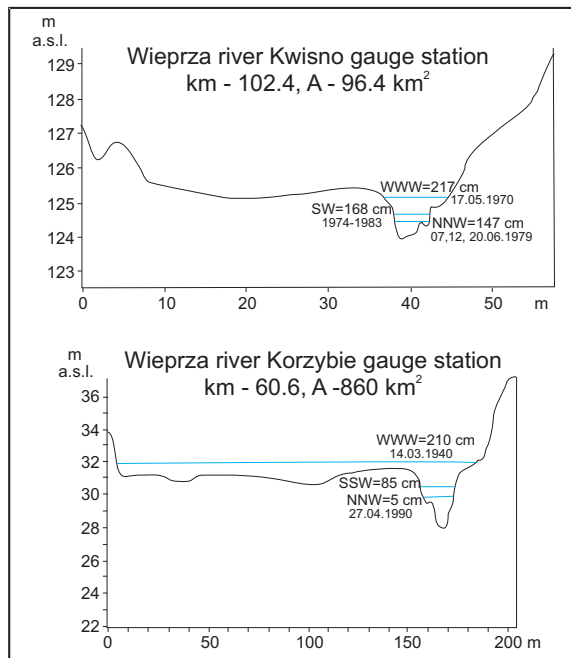
Figure 2. Transverse profiles of the upper Wieprza river bed at Kwisno and Korzybie; the reach of extreme water levels and the average water level in the decade 1974-1983.

A comparison of data on the variability of water level and discharge on the upper Wieprza with the cross-section at Kwisno (Fig. 2) shows that even during the highest water levels the water is contained in the river bed, and does not flow out onto the floodplain. The situation is different at Korzybie, where extreme water levels caused the inundation of the whole floodplain.
