**Geographia Polonica**  
2015, Volume 88, Issue 3, pp. 393-405  
<http://dx.doi.org/10.7163/GPol.2015.3>

## **BED MATERIAL EXTRACTION AND ITS EFFECTS ON THE FORMS AND PROCESSES OF THE LOWER BALASON RIVER IN THE DARJEELING HIMALAYAS, INDIA**

**Lakpa Tamang • Deepak Kumar Mandal**

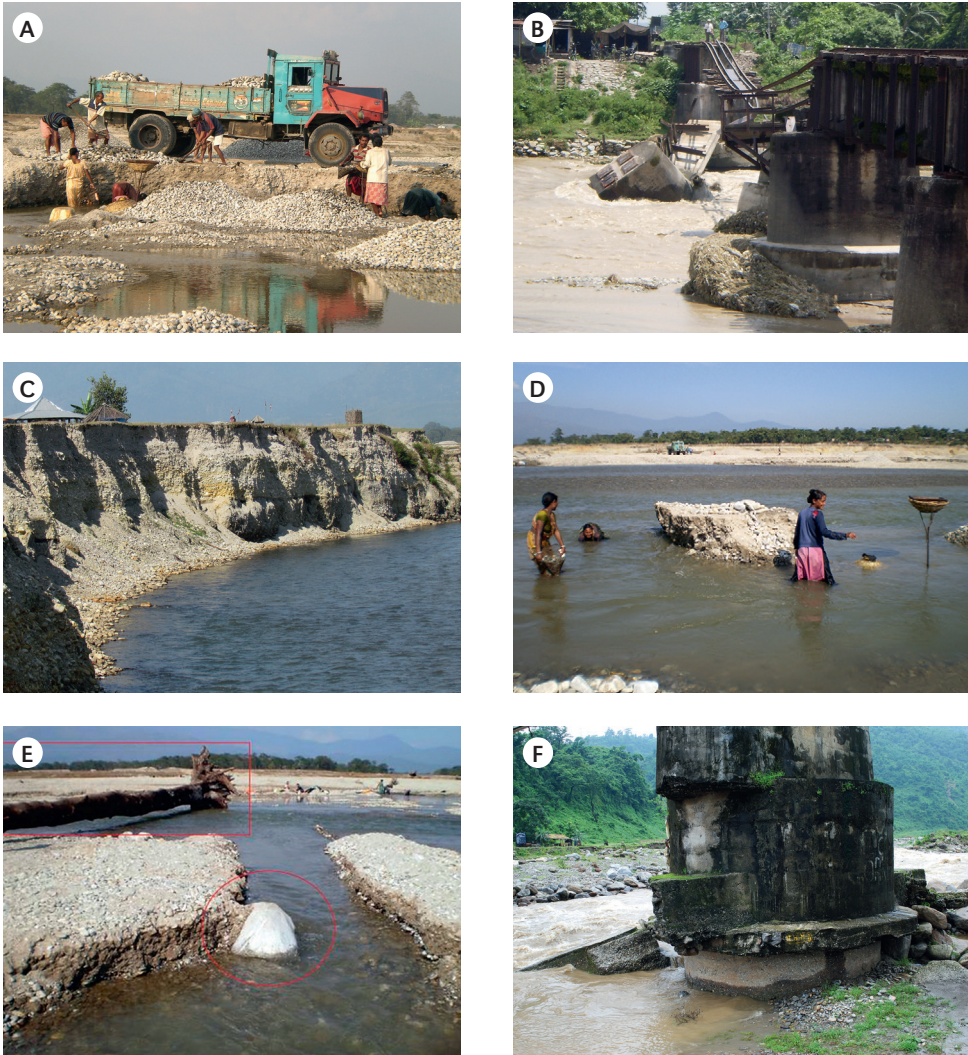
**Figure 2.** A – Bed material extraction from the riverbed in segment II; B – Damage of Railway Bridge downstream of N.H 31, in 2009; C – Exposed retreating banks upstream of N.H 31; D – Extraction of bar deposits upstream of N.H 31; E – Tree trunk and big boulder exposed due to bed incision at extraction site of segment II; F – Bridge pier at upper piedmont segment along the lower Balason River

Bridge, the extraction of smaller sized gravel, pebbles, and sand, predominates. At the extraction sites, mostly in-stream bed materials are manually extracted, washed, and sieved simultaneously. What is mainly sand extraction, is done on a large scale (Fig. 2A). The important sites are Jitu, Mathapari, Kalam, and Kaukhali.

the effect of a continuous extraction of bed materials from the same place, have been creating extraction pits of more than 2.000 m deep. These pits have increased the channel gradient and consequent bed erosion, upstream and downstream of such extraction pits. Also, the tree trunks from the previously existing forest which were buried under the riverbed are now being exposed due to prolonged extraction on the channel bed. The exposure of the tree trunks are a clear indication of bed-erosion induced incision (Fig. 2E).

of these factors have reduced the vegetation, triggering the exposed banks to retreat further (Fig. 2C). The adjustment by the river in the form of scouring and filling have also resulted in undercuttings below bridges (Fig. 2F) and embankments. The narrow channel width has caused flow retention. There has been destruction of permanent structures, as it happened on 18 August, 2009, when the two piers of the Railway Bridge located downstream of N.H 31 over the riverbed, was uprooted damaging the

whole bridge (Fig. 2B). Such destruction is one of the effects of the river's adjustment under changing fluvial characteristics. Concerned authorities should implement a proper long-term management plan to reduce the effects of bed material extraction on the already degrading lower Balason River.

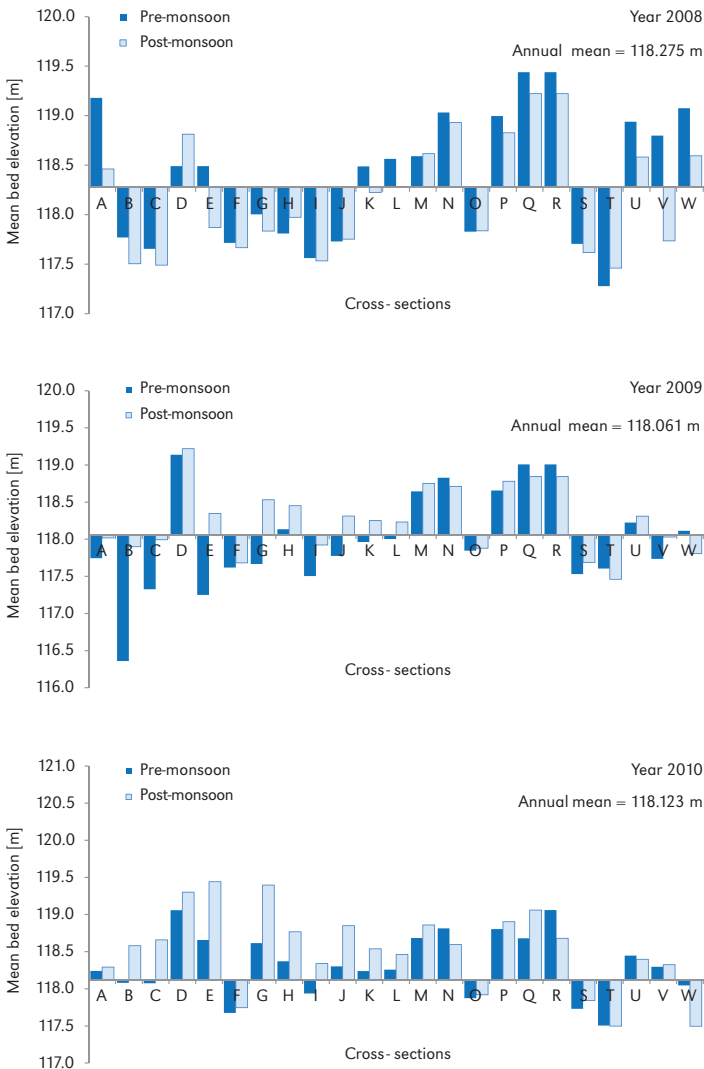
**Figure 5.** The annual variability in mean bed elevation (m) during pre-monsoon and post-monsoon from the annual mean bed elevation during 2008-2010

The mean annual bed elevation also revealed the variability in scouring and filling by the river during the study period. In 2008, the mean bed elevation was 118.275 m which decreased to 118.081 m in 2009, but in 2010 it again increased to 118.123 m (Fig. 5). In 2008, more than 50% of the area experienced scouring, mainly due to the excessive volume of bed materials extracted from this

stretch. But in 2009 and 2010, the filling of the previous lowered channel bed substantially increased the bed elevation in almost all the sections except for some scouring that could be noticed in the upper sections (3.800, 3.200 and 0.200 km sections). Such annual changes are highly variable in almost every section of the selected stretch of the lower Balason River.

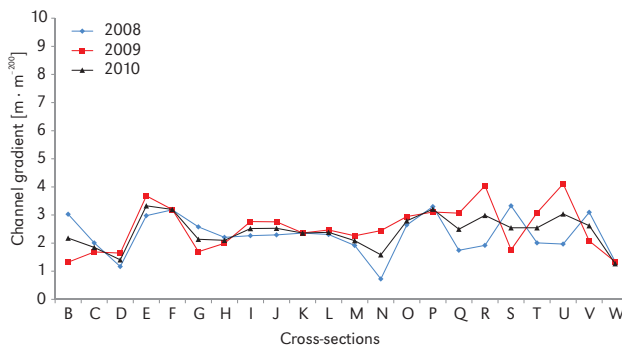
**Figure 8.** The mean annual channel gradient (m) which migrates both upstream and downstream annually due to bed erosion at surveyed cross-sections during 2008-2010

The channel gradient variation between the cross sections is an indication of the channel erosion caused by prolonged bed-material extraction from the river bed. The lowering of bed elevations has caused the channel adjustments. There was an increase in the gradient, resulting in increased stream power and consequent bed erosion (Kondolf 1994). The cross-sections with maximum annual bed erosion (cross-sections B, E, R and U) had a steeper gradient which migrated both upstream and downstream annually (Fig. 8). This means that bed erosion also migrates depending on the active channel. Such migration is called “head cutting or knick point migration” according to Kondolf (1997).
